**Report to** Cabinet  
17 January 2018  
**Report of** Director of neighbourhoods  
**Subject** Fire safety in the council's hi-rise tower blocks

# Tower block review

**January 2018**

**NPS Norwich Ltd**

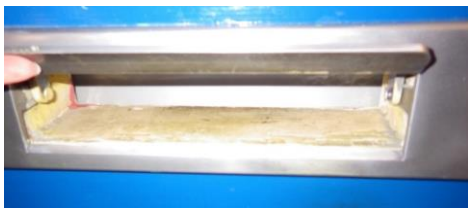
**Example of letter flap with no intumescent liner**

To replace 718 existing front doors and store doors with new fire doors.

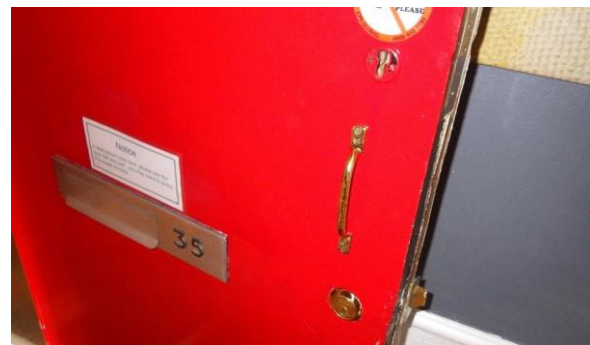
**Additional door furniture added to front door**

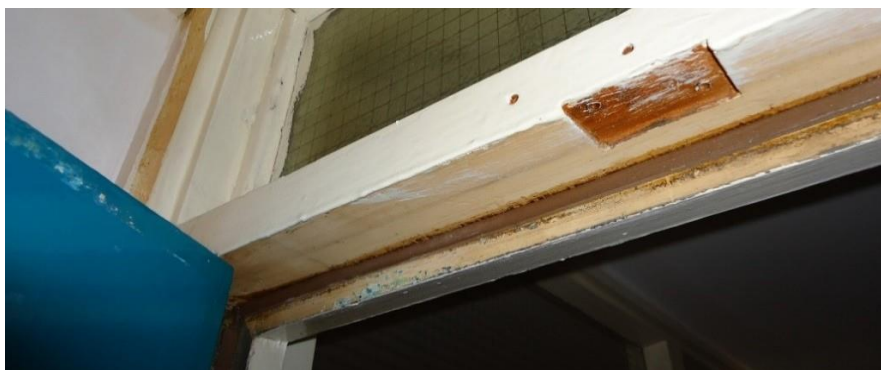
**Door closer removed**

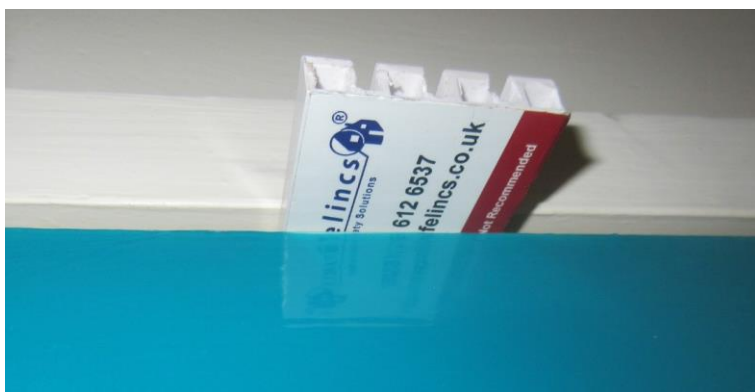
Gap between door and frame exceeding 4 mm recommended tolerance

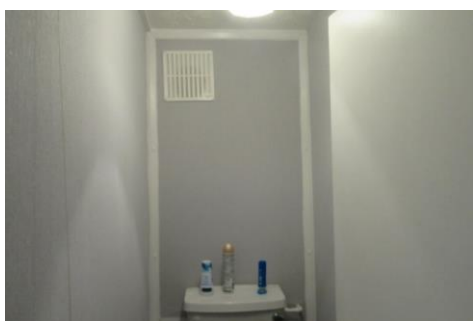
Example of existing panelling

The survey has identified a number of issues that we are already addressing through a planned programme of work. This includes the upgrading of wooden framed removable service riser panels in bathrooms, and replacing them with metal framed fixed panelling. These panels house soil waste pipes and access to these is generally achieved by removing the WCs and not by removing the panels. Fixed, upgraded panelling will further maintain the compartmentalisation of the flats.

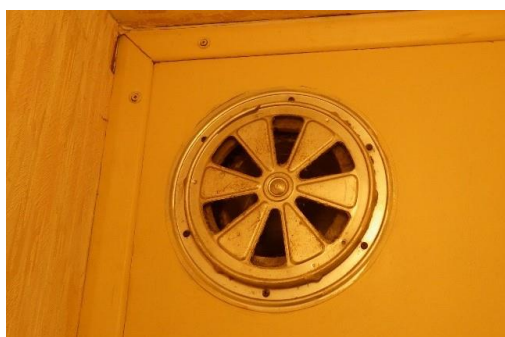
Variety of ventilation ducts with no intumescent liner

The cover grilles to these openings can be replaced with a new cover which includes an intumescent liner. These liners are designed to expand and fill the opening to prevent the spread of smoke and fire. A majority of the upgraded flats in Winchester and Normandie Tower have already been fitted with these types of grille.

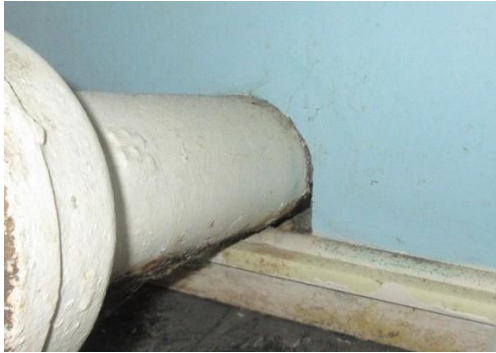
**Waste pipe from WC penetrating compartment panel**

Work will also continue to upgrade waste pipes so they are fitted with an intumescent collar.

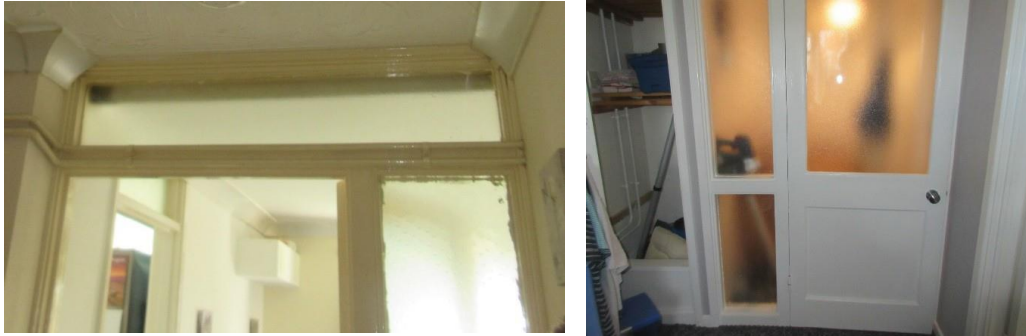
While not a fire door, the dividing door between the hall and lounge protects the means of escape from the bedroom, bathroom and WC from the most likely source of a fire (ie the lounge or kitchen).

Two examples of non-fire rated visual panels to door and side panel.

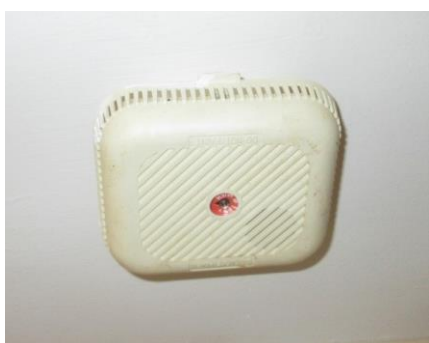
Example of older battery style alarms (left) and newer mains powered alarms (right)

The council already has a programme to install hardwired smoke alarms throughout every flat and is currently half way through the work. The remainder of the programme to install 192 smoke alarms will be accelerated.

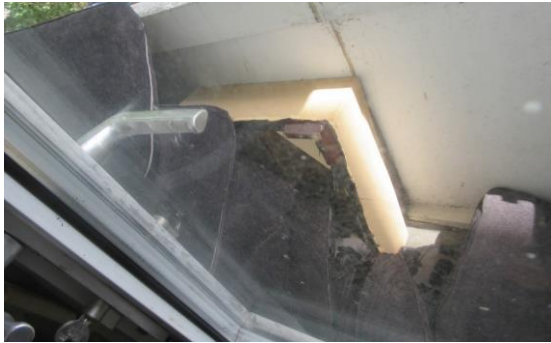
**Flammable Items stored on balcony**

Removal of flammable items stored on balconies

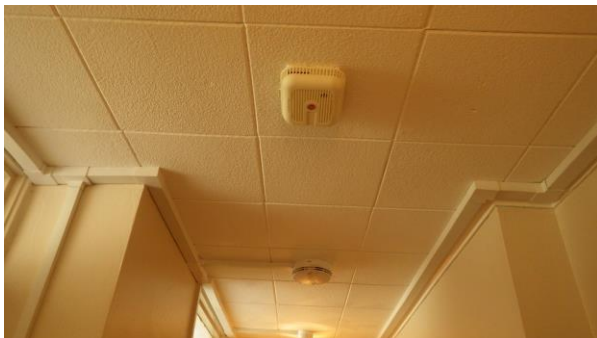
**Decorative polystyrene ceiling tiles**

The replacement of decorative polystyrene ceiling tiles present in some flats.

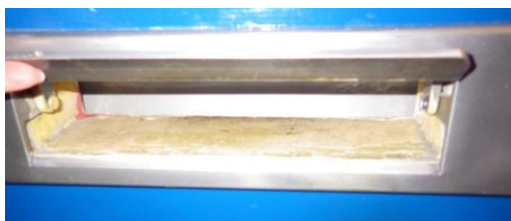
**Non fire-proof letterbox**

Replace 718 existing front doors and store doors with new fire doors in every tower block.

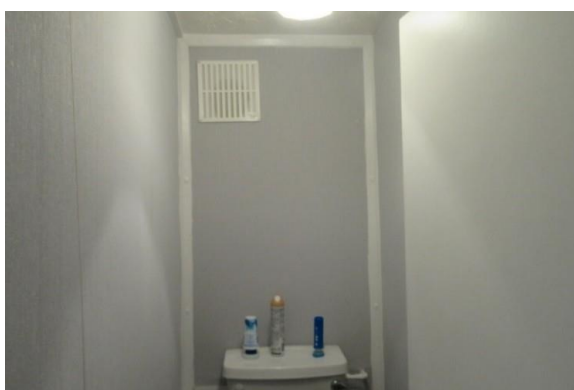
**Example of existing panelling**

The survey has identified a number of issues that we are already addressing through a planned programme of work. This includes upgrading wooden framed removable service riser panels in bathrooms and replacing them with metal framed fixed panelling.

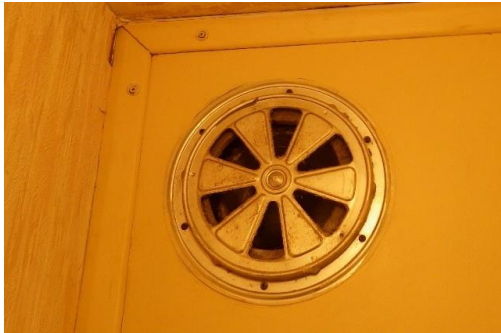
**Ventilation duct with no intumescent liner**

Fitting intumescent strips to air transfer grills. The cover grilles to these openings can be replaced with a new cover which includes an intumescent liner.

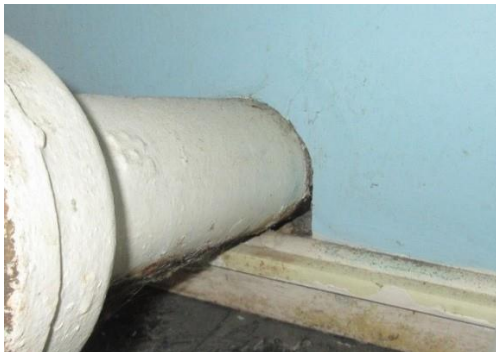
**Waste pipe with no intumescent collar**

Work will also continue to upgrade waste pipes so they are fitted with an intumescent collar.

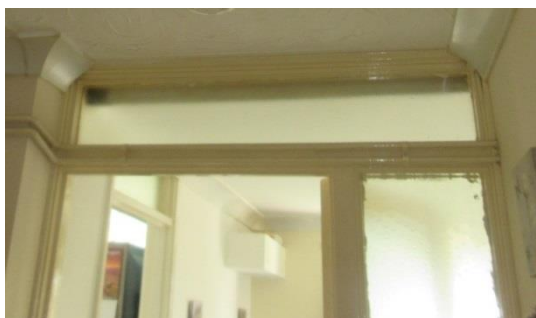
**Non fire-rated visual panels to door and side panel**

Carrying out this work will address 4 per cent of the issues identified and cost £103,500. This work will be carried out over the next 12 months.

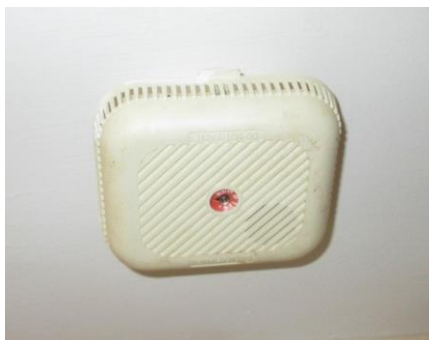
**Example of older battery style alarm (left) and new mains powered alarm (right)**

Carrying out this work will address 1 per cent of the issues identified and cost £53,500. It will be carried out over the next 12 months.

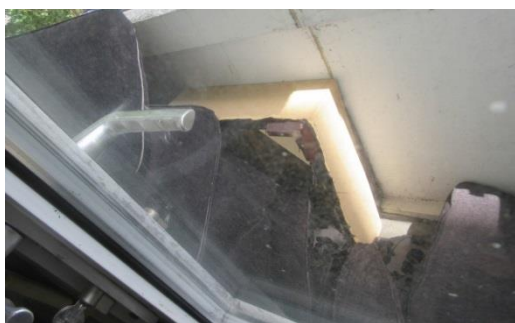
**Flammable items stored on balcony**

These include the need to remove flammable items stored on balconies and replacing decorative polystyrene ceiling tiles present in some flats.

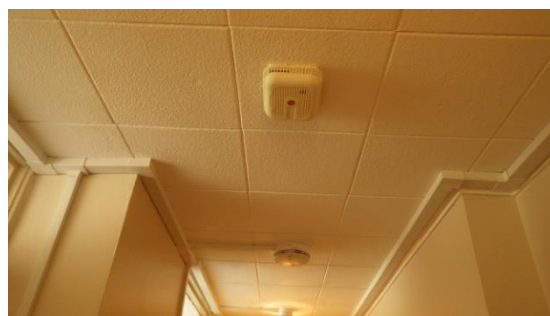
**Decorative polystyrene ceiling tiles**
