#### 1 Fire safety in the tower blocks Purpose: To report to cabinet the recommendations from the fire safety checks undertaken in the council's hi-rise tower blocks.

Cabinet
17 January 2018
Director of neighbourhoods
Fire safety in the council's hi-rise tower blocks

# **Tower block review**

January 2018 NPS Norwich Ltd Prepared for: Norwich City Council

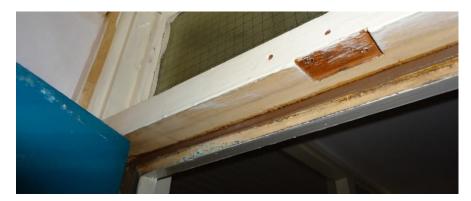
The survey has identified a number of repairs required to flat entrance and store doors. Many of these doors have been repaired by us in the past or have had alterations made to them by the residents over a number of years.

Example of letter flap with no intumescent liner

Additional door furniture added to front door

Door closer removed

Gap between door and frame exceeding 4 mm recommended tolerance

To replace 718 existing front doors and store doors with new fire doors.

To renovate and repair the existing doors would be time consuming, complex, disruptive for residents and not cost effective. It is therefore recommended that all of the entrance and store doors are replaced early in the New Year. There is budgetary provision available for this work in this financial year.

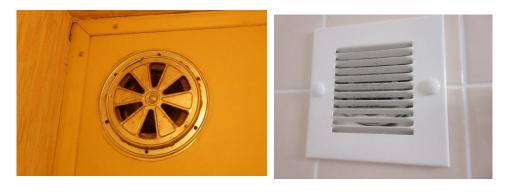
Variety of ventilation ducts with no intumescent liner

Example of new grille cover

Fitting intumescent strips to air transfer grills, waste pipes and other voids will also be carried out as necessary. Again, historic repairs by us or alterations made to them by the residents over a number of years, mean that replacing and standardising ventilation ducts and air transfer grilles will be less time consuming and more cost effective.

The cover grilles to these openings can be replaced with a new cover which includes an intumescent liner. These liners are designed to expand and fill the opening to prevent the spread of smoke and fire. A majority of the upgraded flats in Winchester and Normandie Tower have already been fitted with these types of grille.

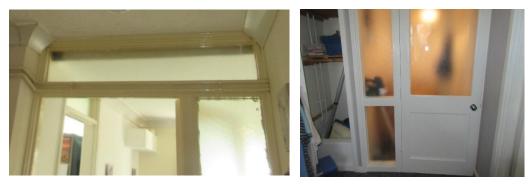
While not a fire door, the dividing door between the hall and lounge protects the means of escape from the bedroom, bathroom and WC from the most likely source of a fire (ie the lounge or kitchen).

Two examples of non-fire rated visual panels to door and side panel.

#### Recommendation 3 – replace lounge/hall vision panels with safety glass

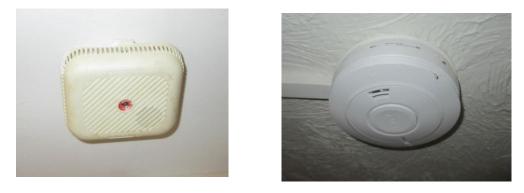
Example of older battery style alarms (left) and newer mains powered alarms (right)

The council already has a programme to install hardwired smoke alarms throughout every flat and is currently half way through the work. The remainder of the programme to install 192 smoke alarms will be accelerated.

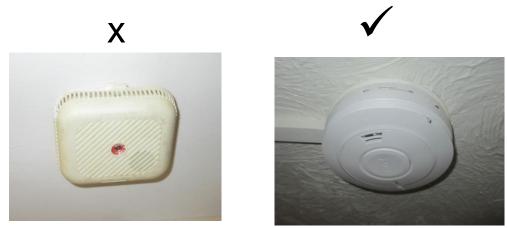
Example of older battery style alarm (left) and new mains powered alarm (right)

The council already has a programme to install hardwired smoke alarms throughout every flat and is currently half way through the work. The remainder of the programme to install 192 smoke alarms will be accelerated.
