The Halls – Works Required Revision B

The Halls, St Andrews Plain, Norwich NR3 1AU

22.67 REV B

Building Survey / Feasibility

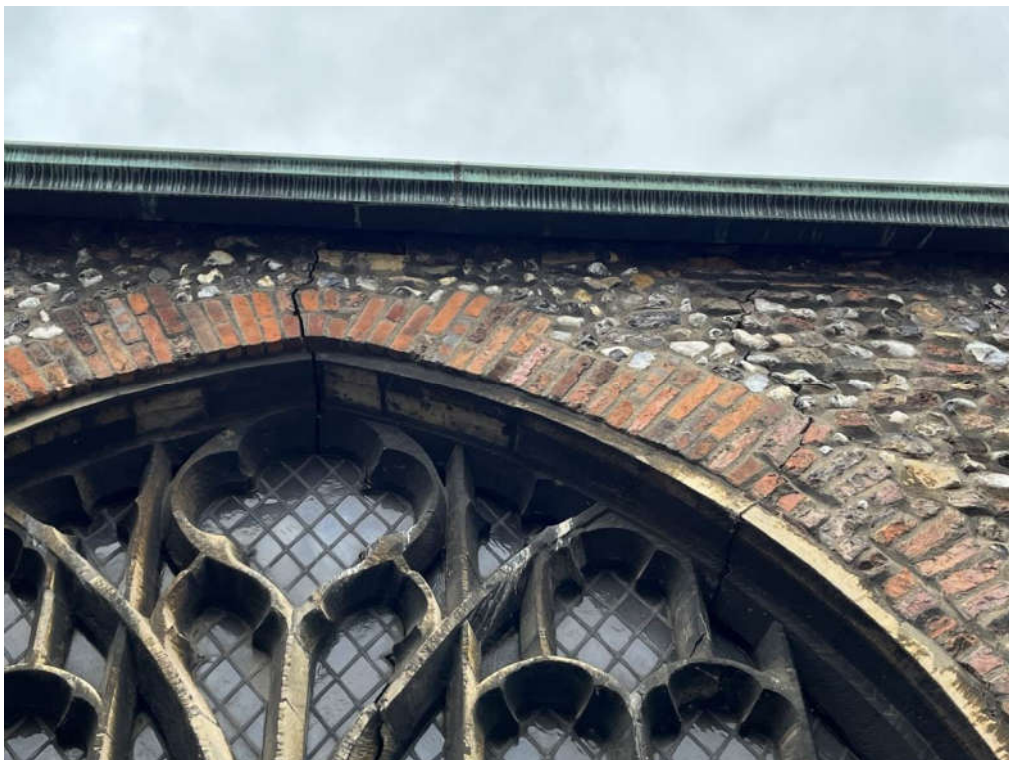
Photograph 8 – Cracking over window arch (western window on North Elevation)

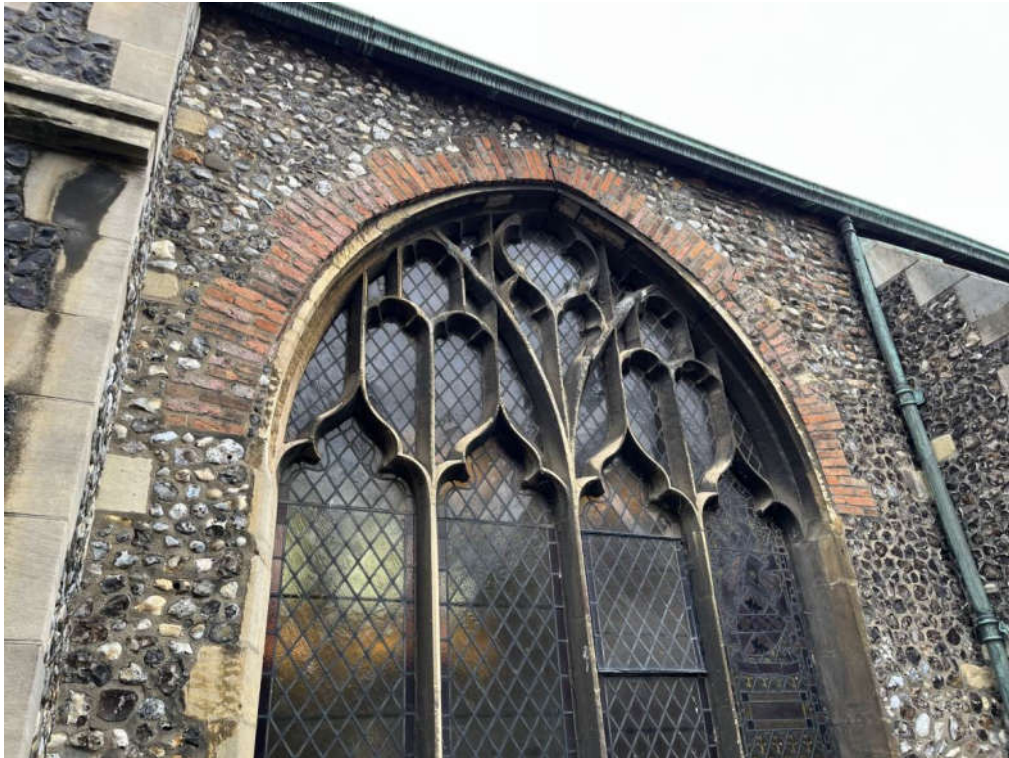
Photograph 9 – Brickwork exposed around North Elevation arches

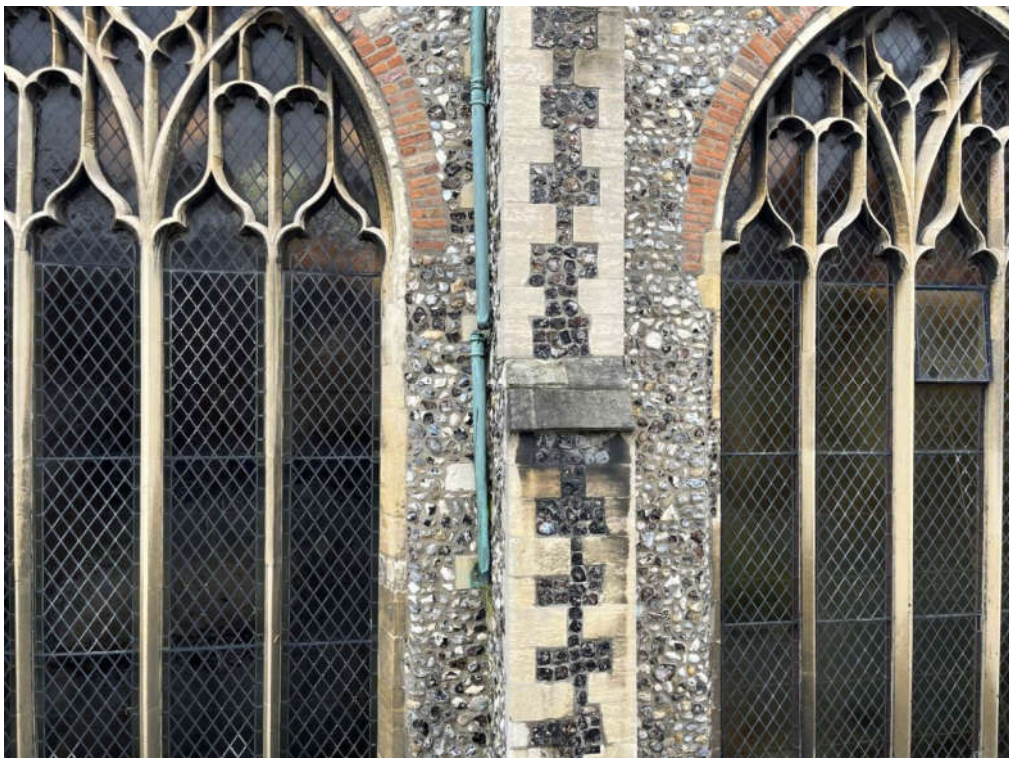
Photograph 10 – Downpipe broken and missing

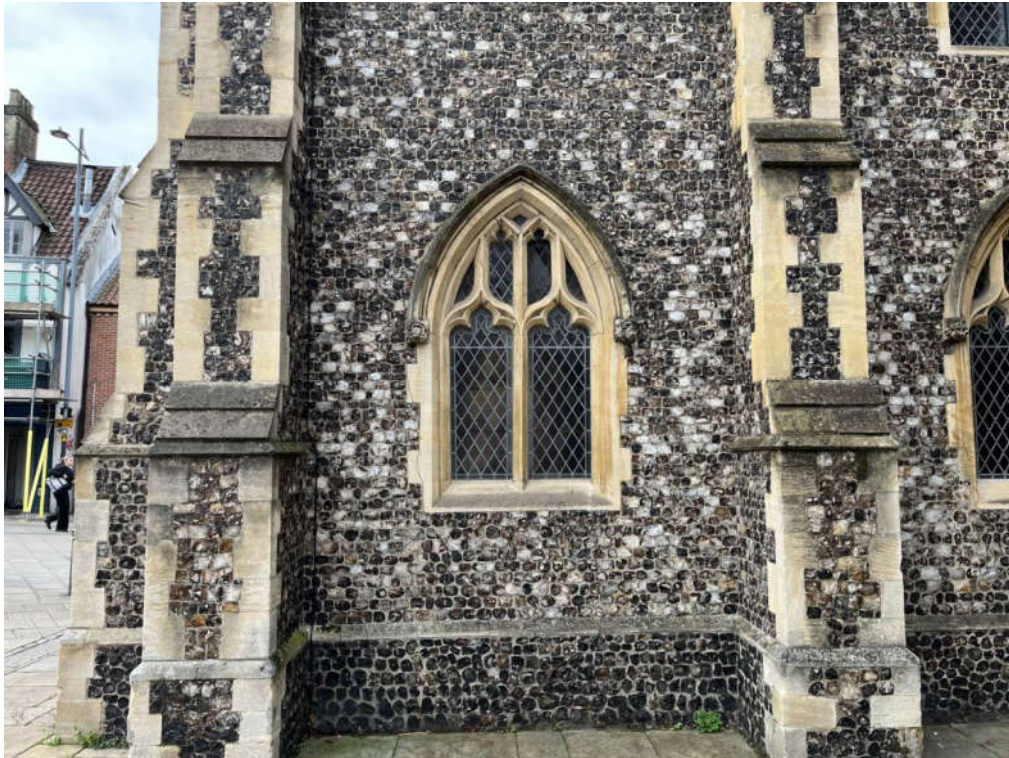
Photograph 11 – Vertical crack below and above South porch window

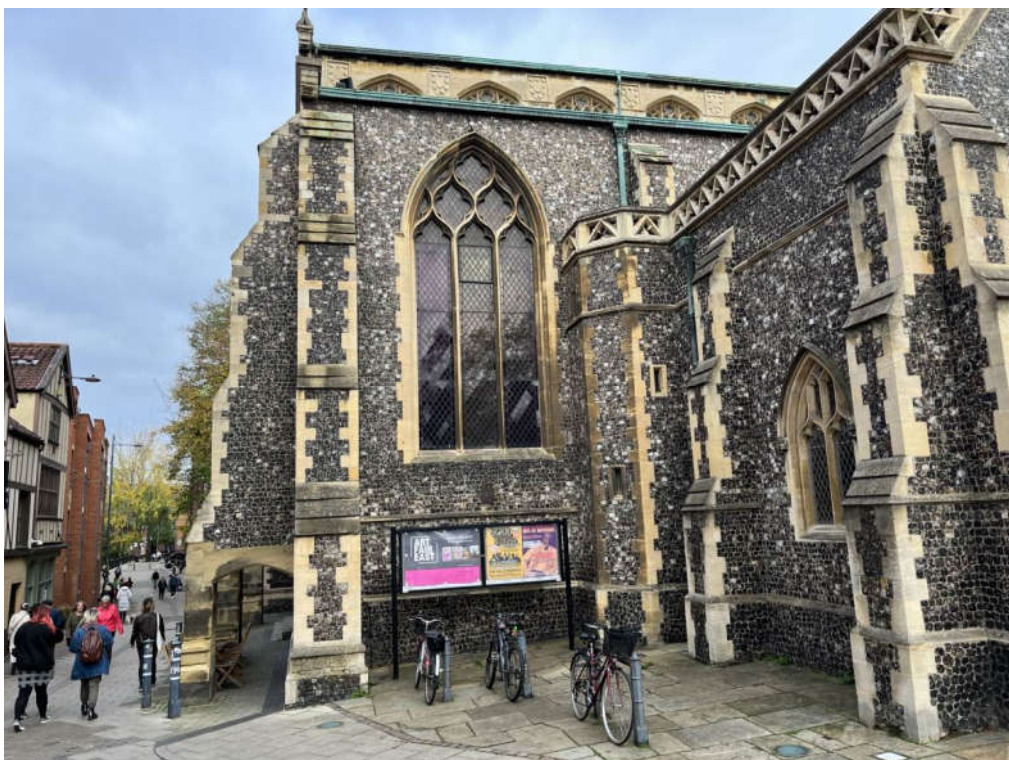
Photograph 12 – Vertical crack below and above western most South Aisle window

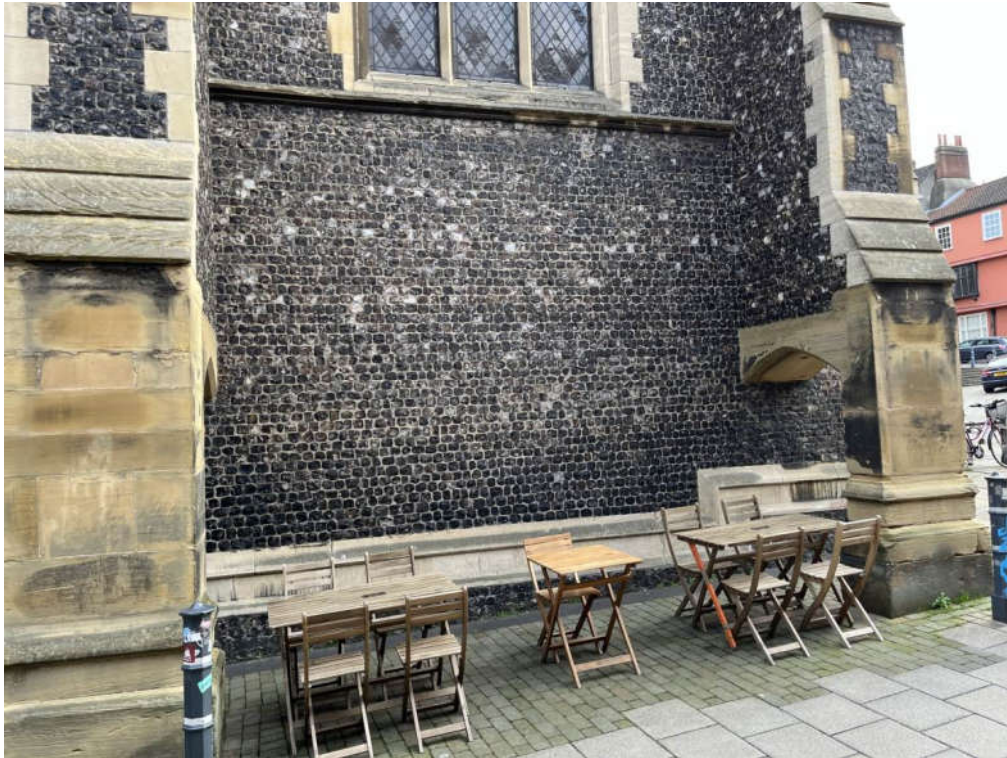
Photograph 13 – Vertical crack below southern West gable window

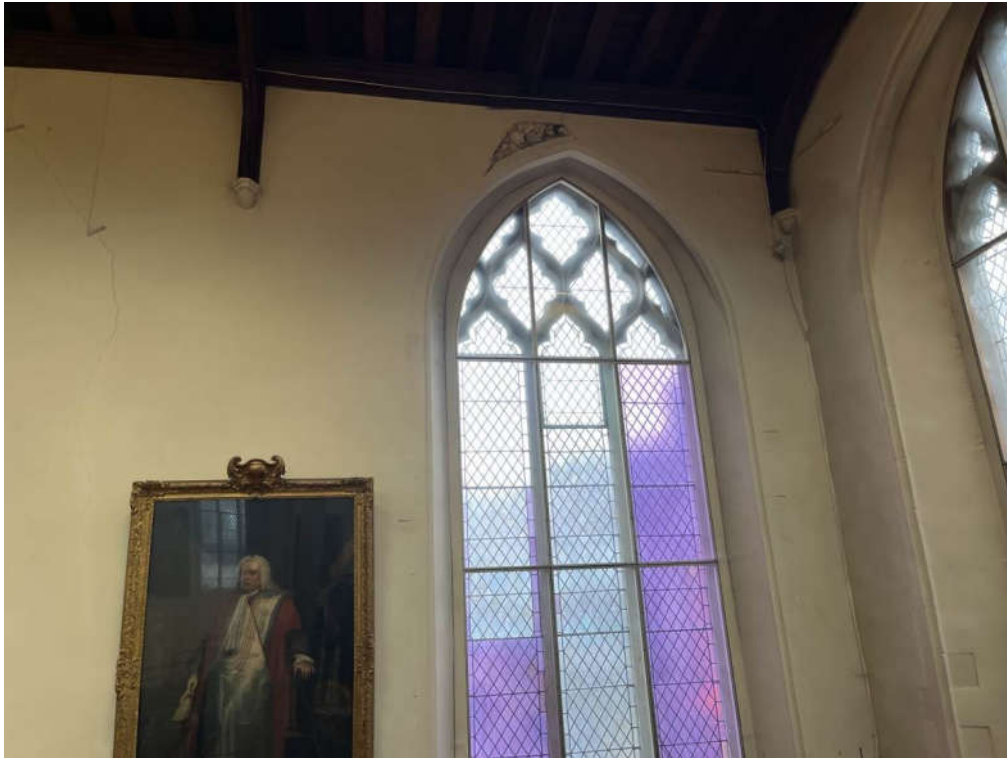
Photograph 25 – Cracking to West end of South aisle's South wall

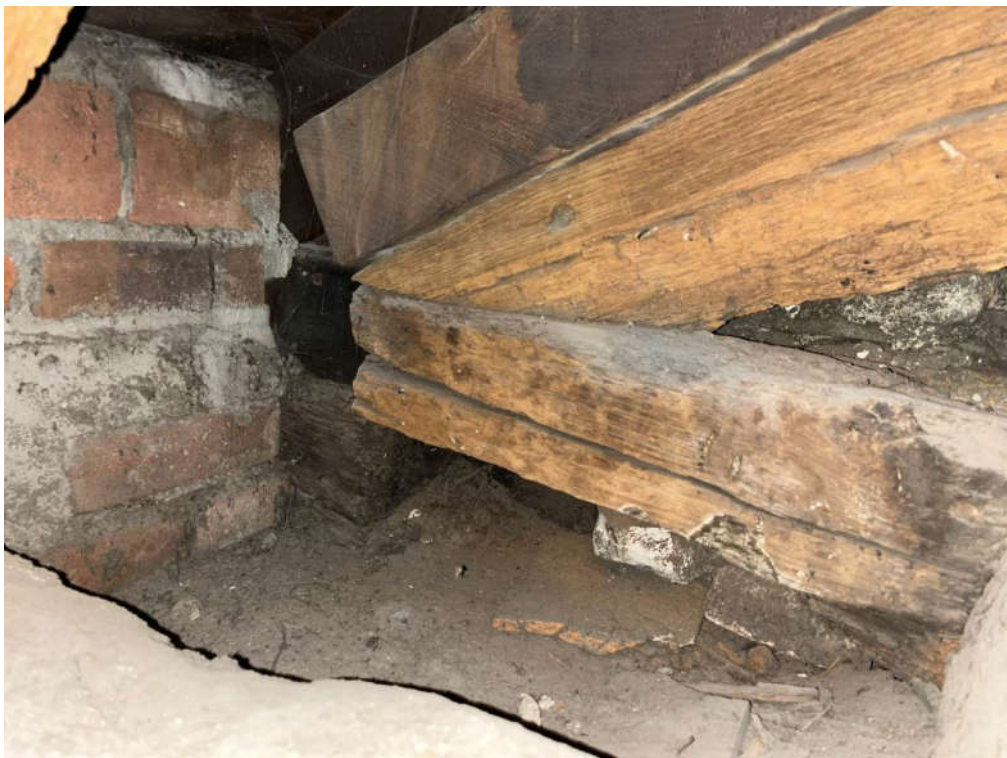
Photograph 28 – Signs of decayed timber at eaves level (common rafter end and plate)

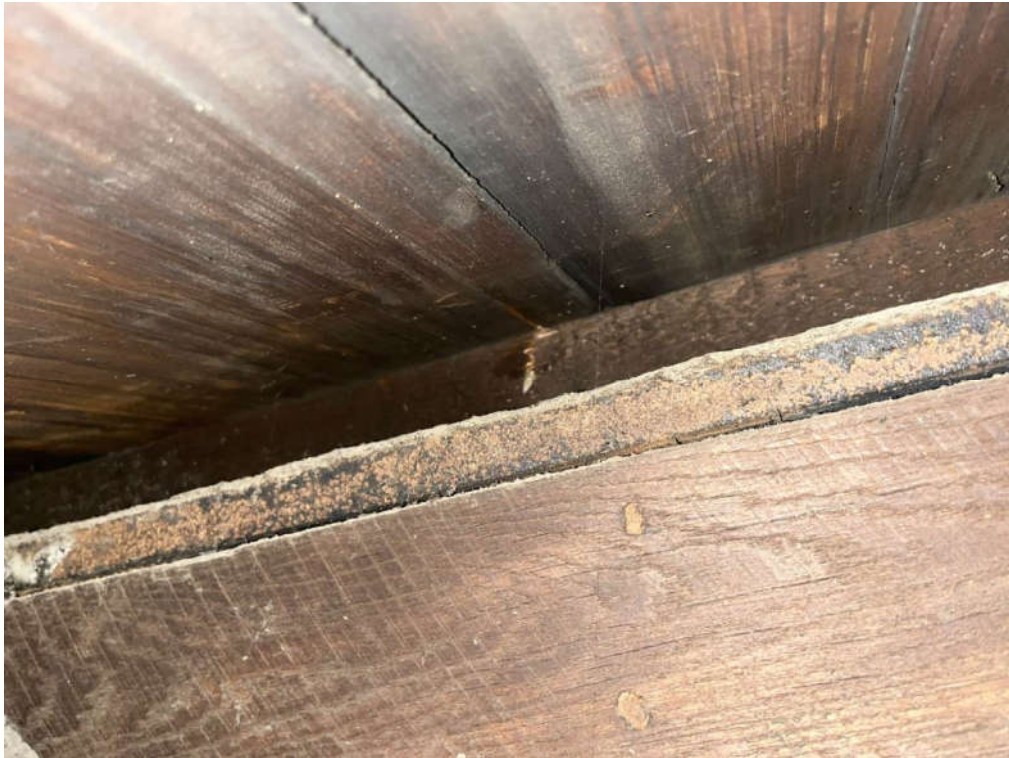
Photograph 43 – Top flange of steel rafter showing signs of rust

The steel members within the roof structure are suffering from corrosion, while this is not currently causing an issue it is recommended that the steel is exposed and treated in the medium term to prevent further corrosion causing structural issues.

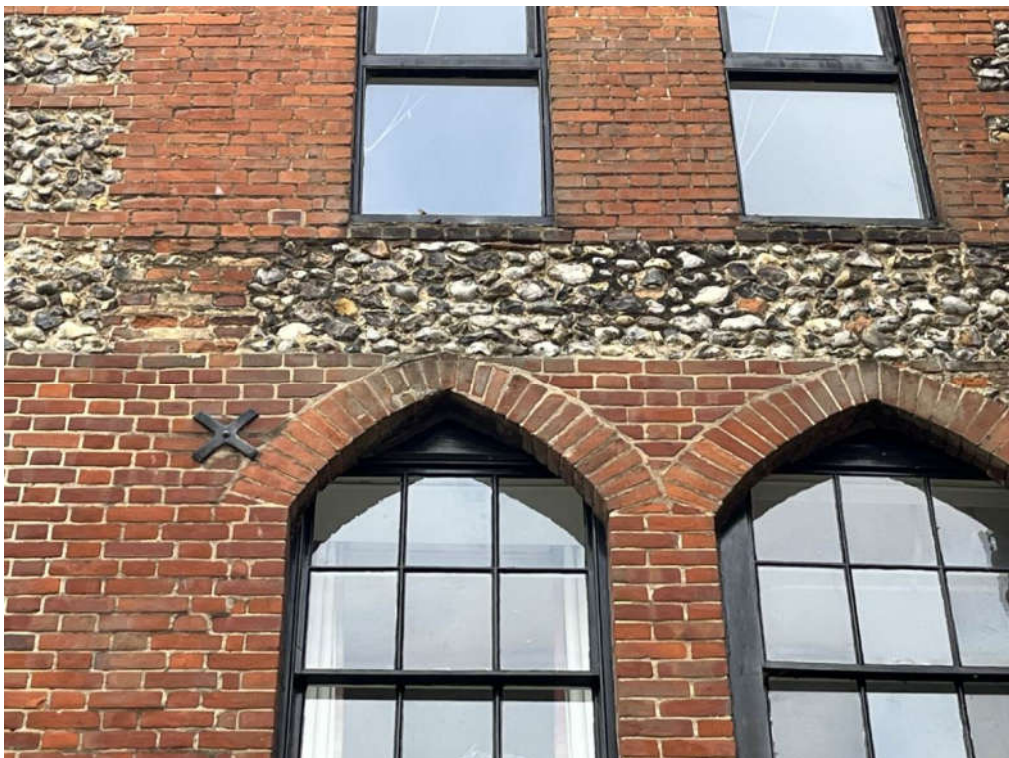
Photograph 53 – Brick window arch bowing out

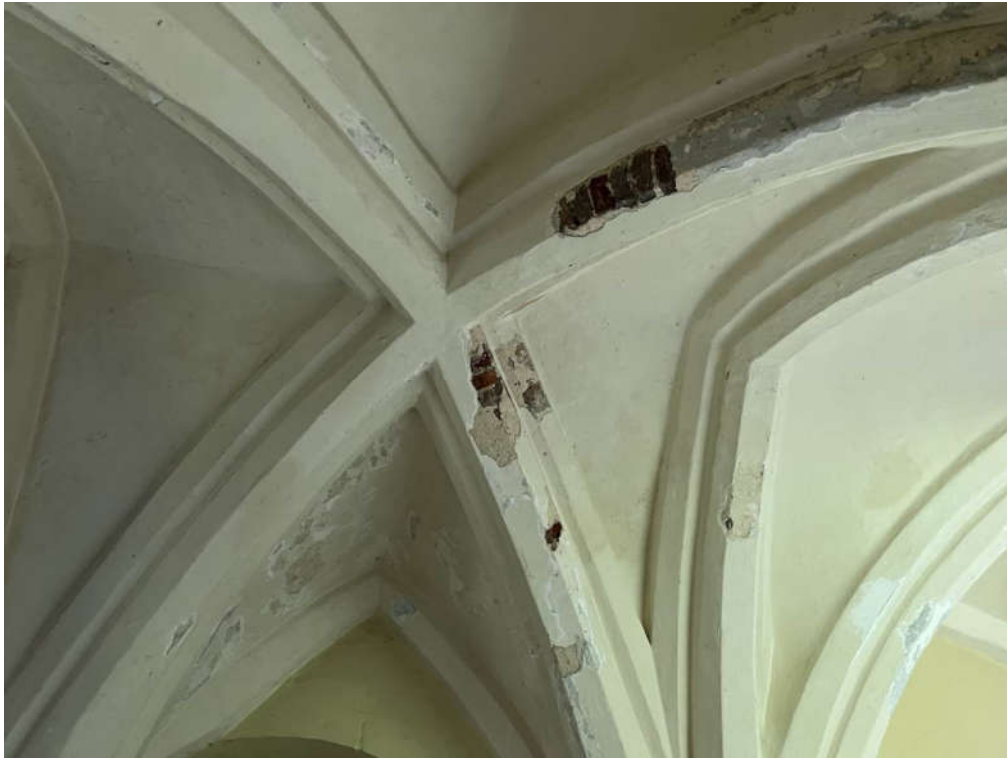
Photograph 61 – Brickwork deteriorated where plaster has fallen away

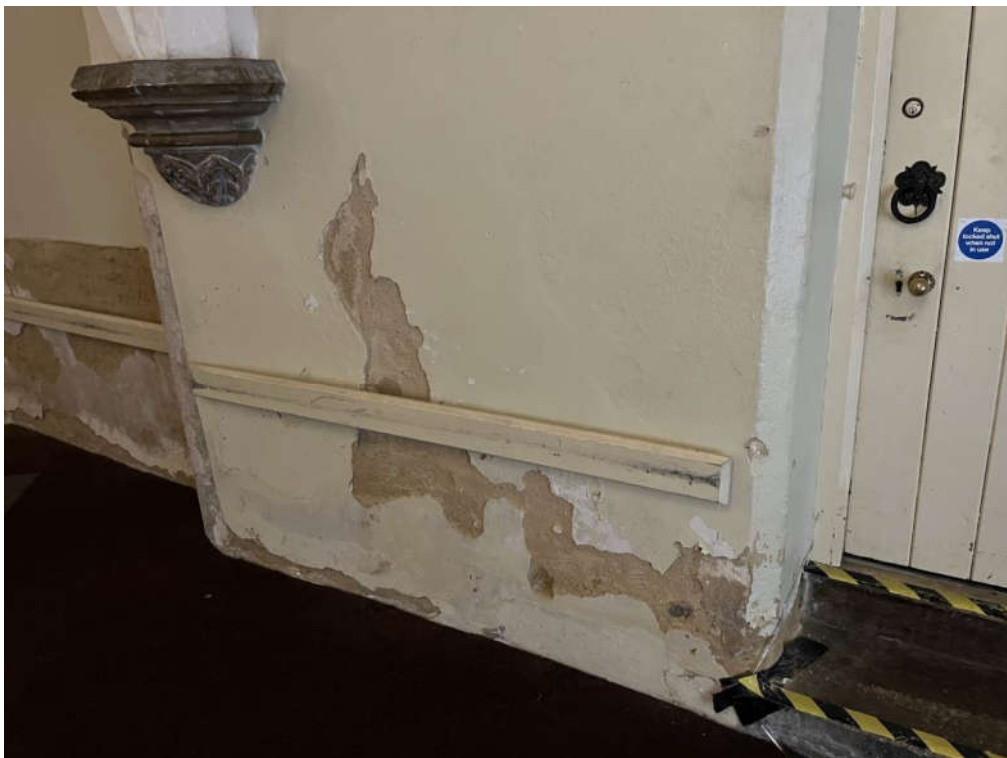
Photograph 62 – Signs of damp in Ground Floor walls

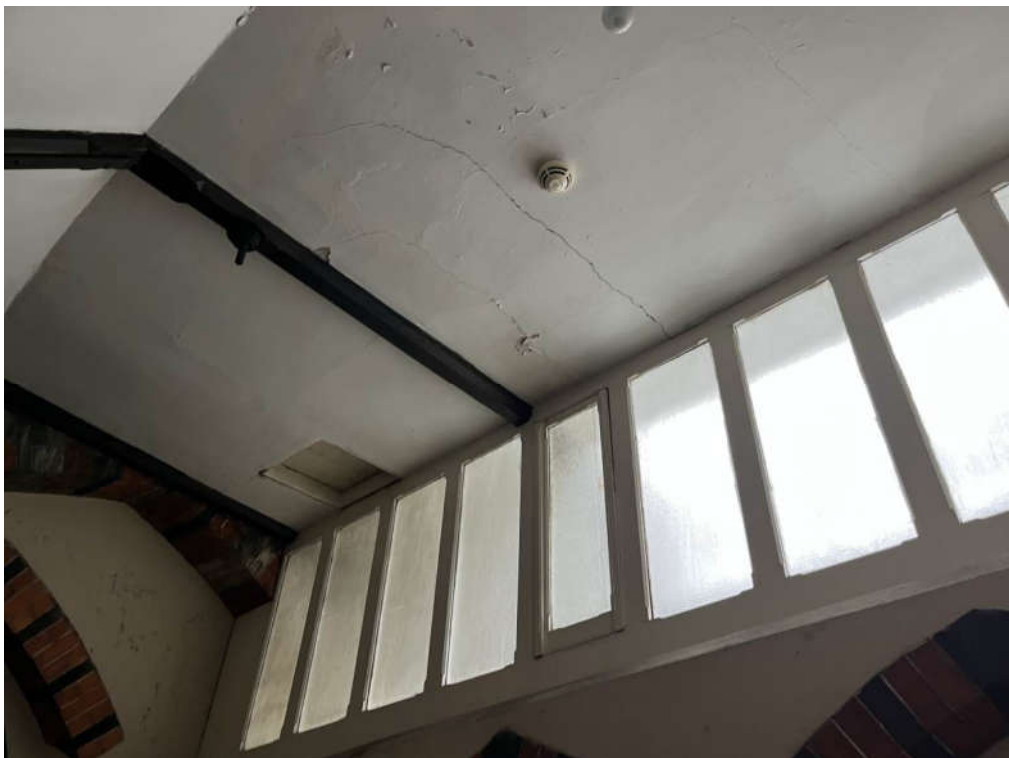
Photograph 75 – Extensive water ingress through roof structure over staircase

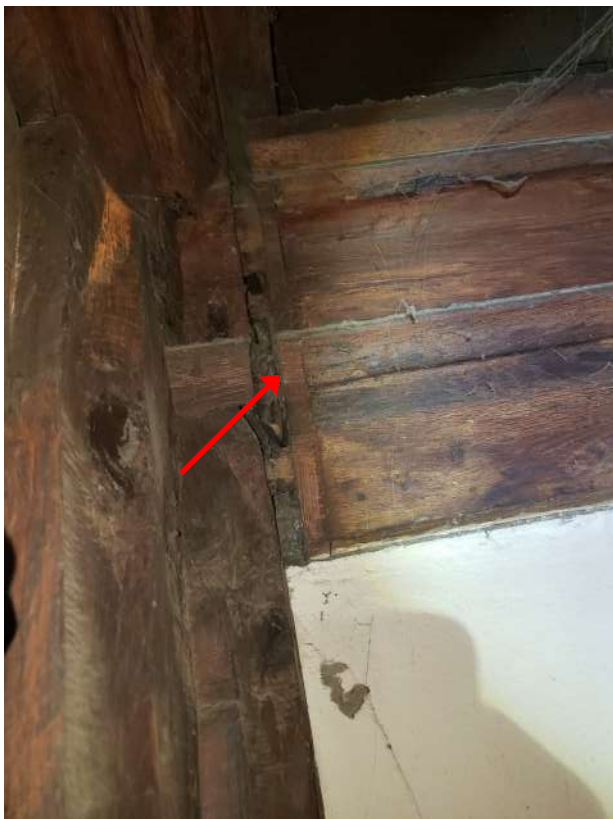
Fig 12:

St Andrew's Hall, internal; showing a gap at the joint between a truss post and moulded cornice. Note the presence previous patch repairs, suggesting the joint had possibly moved since their installation

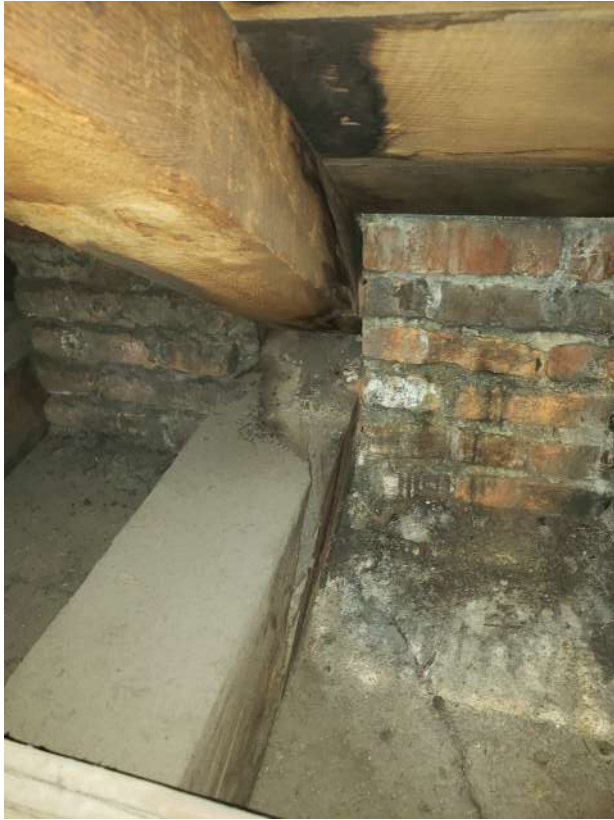
Fig 23:

St Andrew's Hall, Nave; showing significant localised moisture staining to the structural timber elements, as well as the internal face of the brickwork, on the north side of bay 3. Note this had likely been caused by a failure to previous roofing materials allowing moisture ingress. Moisture readings were below the threshold for the onset and growth of biological decay organisms

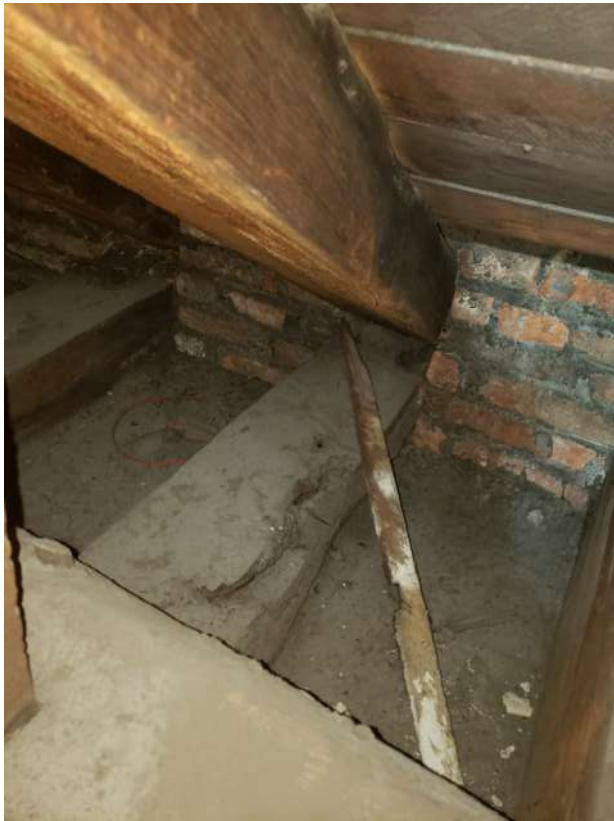
Fig 29:

St Andrew's Hall, Nave; showing a sole plate on the south side of bay 6 that was identified as having a decayed partially embedded end and further decay to the centre for ~300/350mm

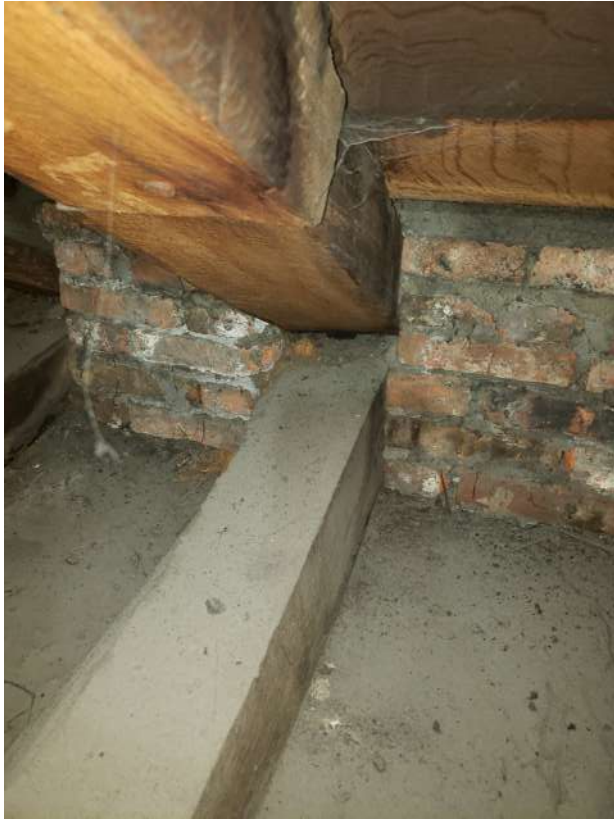
Fig 33:

St Andrew's Hall, Nave; showing the partially embedded end of a sole plate on the south side of bay 5, that had been partially decayed on the left hand side, in close proximity to the joint interface with the common rafter

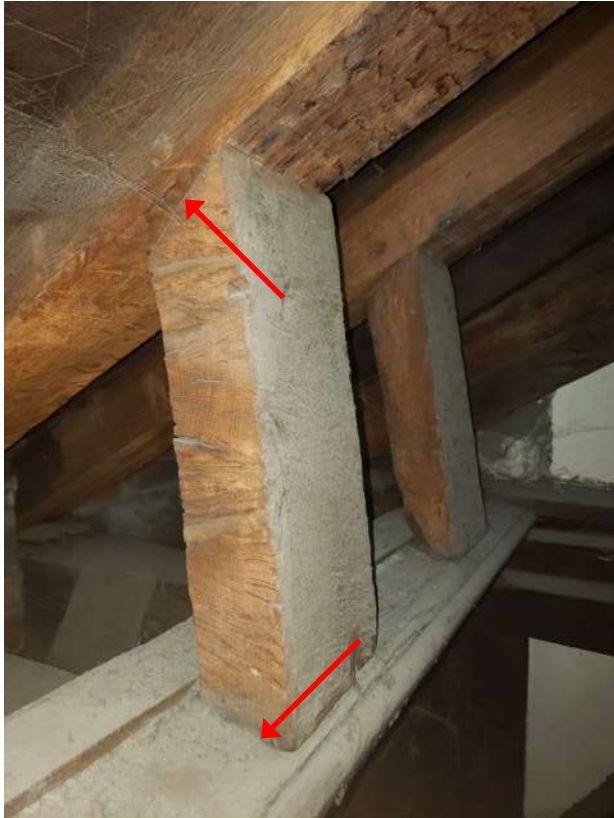
Fig 39:

St Andrew's Hall, Nave; showing movement to the ashlars on the south side of bay 1, resulting in partial separation of both upper and lower joints

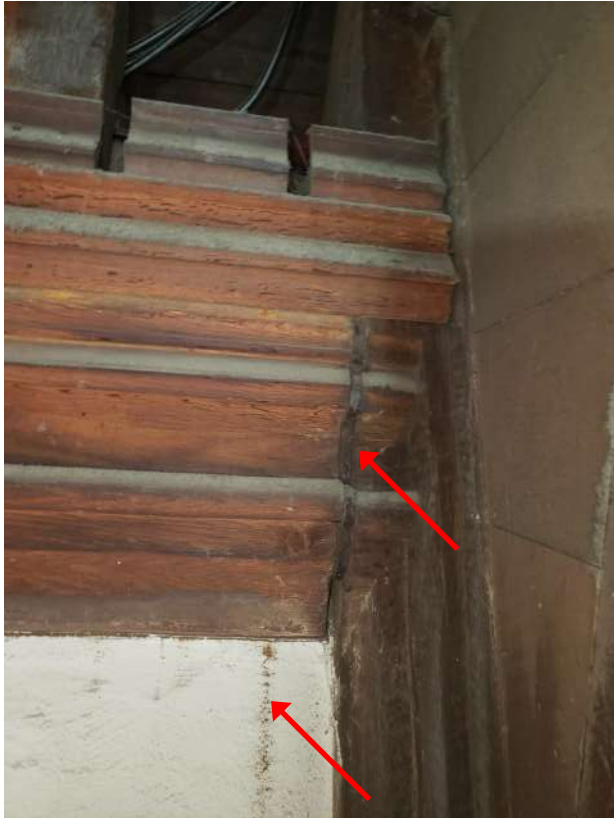
Fig 59:

Blackfriars', bay 3; showing partial separation of the moulded cornice/inner plate on the north side. This was not deemed to be critical. Also note the presence of frass beneath the joint, moisture readings taken at the time of survey indicated levels were below the threshold for the onset and growth of biological decay organisms

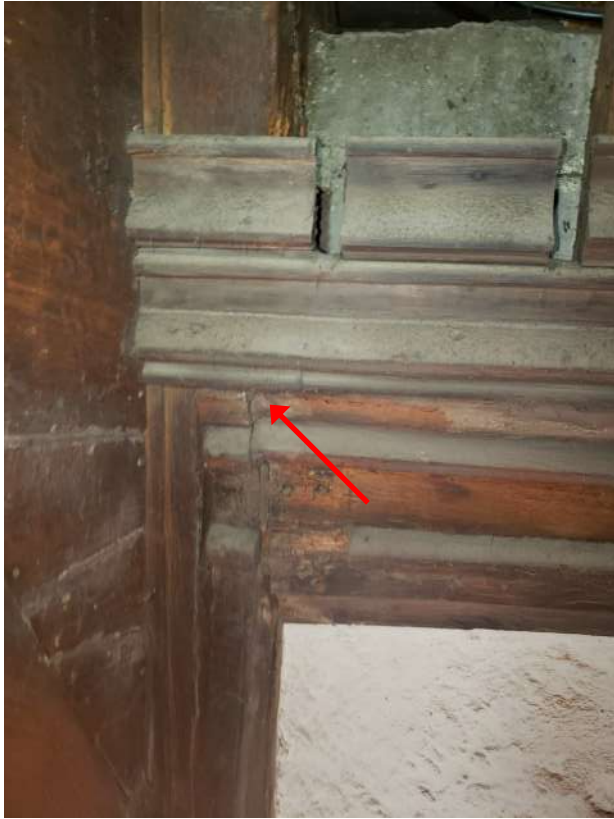
Fig 69:

Blackfriars', bay 9; showing the west end of the moulded cornice/inner plate that had been historically affected by both 'wet' rot decay and wood boring beetle, on the north side. The element was deemed to possibly be at risk of failure due to its contact with a decayed truss post

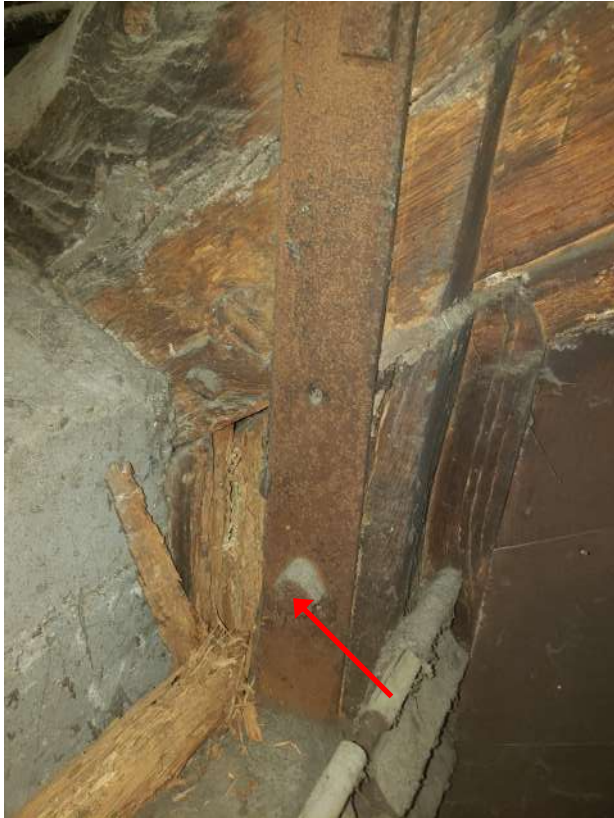
Fig 71:

Blackfriars', bay 9; showing the top of the north truss post of truss no. 10. The post had been structurally decayed by 'wet' rot that continued down its length for ~1m. This decay was likely affecting the integrity of the metal strapping and mechanical fixings

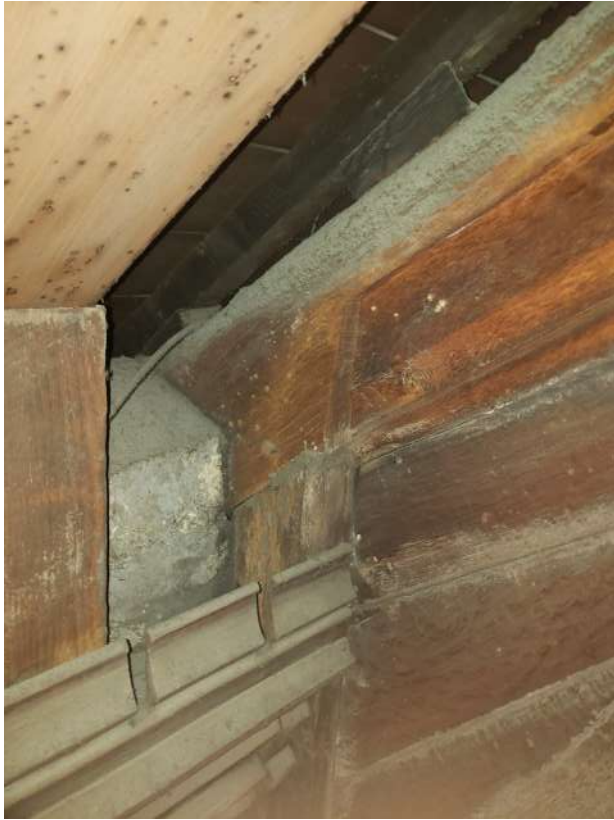
Fig 73:

Blackfriars', bay 9; showing the continued, excessive use of cementitious material atop the wall head on the south side of the bay, as well a significant build-up of dust at eaves level and on structural elements. This could present a health hazard to occupants of the hall
