**Report to** Cabinet  
17 January 2018  
**Report of** Director of neighbourhoods  
**Subject** Fire safety in the council's hi-rise tower blocks

# Tower block review

**January 2018**

**NPS Norwich Ltd**

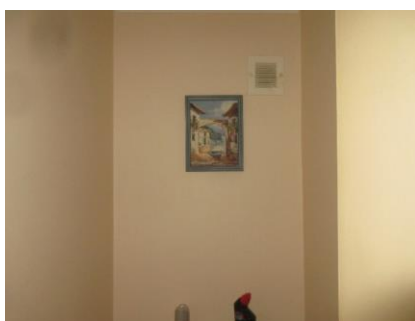
Example of existing panelling

Example of new panelling

Fitting intumescent strips to air transfer grills, waste pipes and other voids will also be carried out as necessary. Again, historic repairs by us or alterations made to them by the residents over a number of years, mean that replacing and standardising ventilation ducts and air transfer grilles will be less time consuming and more cost effective.

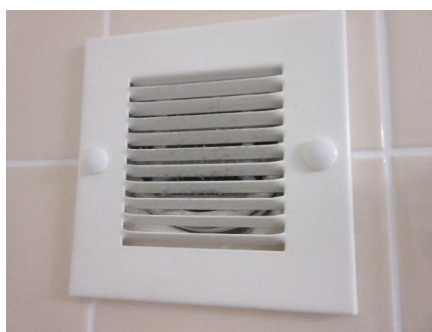
Variety of ventilation ducts with no intumescent liner

Example of new grille cover

The cover grilles to these openings can be replaced with a new cover which includes an intumescent liner. These liners are designed to expand and fill the opening to prevent the spread of smoke and fire. A majority of the upgraded flats in Winchester and Normandie Tower have already been fitted with these types of grille.

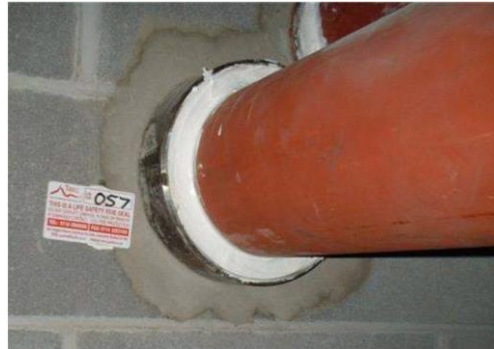
**Waste pipe from WC penetrating compartment panel**

**New pipework fitted with intumescent collar**

Work will also continue to upgrade waste pipes so they are fitted with an intumescent collar.

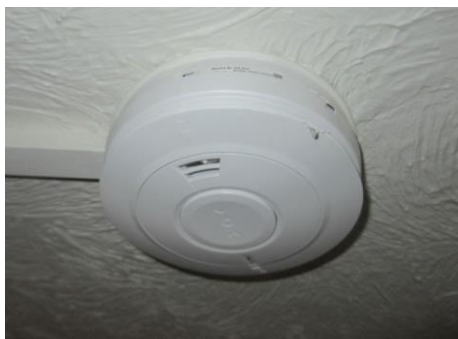
The presence of effective smoke alarms is essential for early warning and life safety in tower blocks. They must be present at the least in the means of escape of any flat. Smoke alarms varied in number and quality, some being older battery style ones and some flats having mains powered alarms fitted with a test switch panel mounted in the wall. All flats had the smoke alarm tested as part of the survey.

Example of older battery style alarms (left) and newer mains powered alarms (right)

The council already has a programme to install hardwired smoke alarms throughout every flat and is currently half way through the work. The remainder of the programme to install 192 smoke alarms will be accelerated.

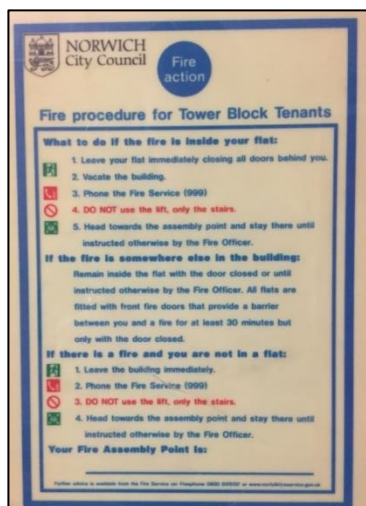
Current fire safety notice

We have identified a number of things that could be improved in terms of the quality and timeliness information relating to fire safety.

Working with the fire service and residents, it is proposed to develop an education and information programme which will look at, information on notice boards; additional information relating to stay put policy; fire doors; smoke alarms; product recalls; hazardous materials or substances and use of communal areas and resident activities (smoking, cooking and trailing leads etc).

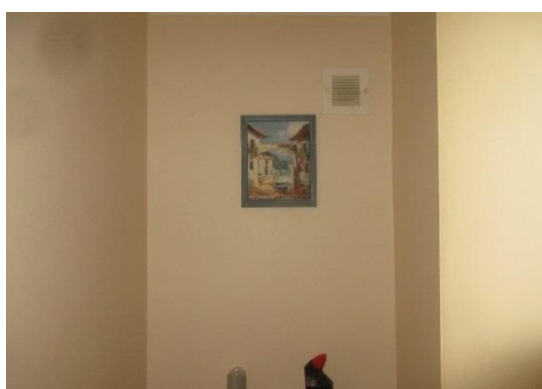
**Example of existing panelling**

**Example of new panelling**

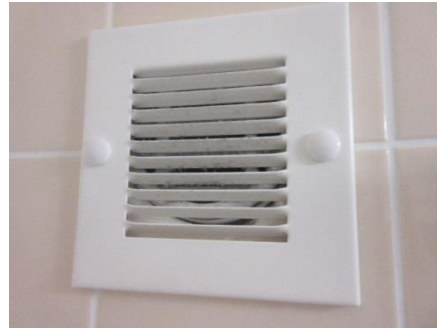
**Ventilation duct with no intumescent liner**

**Example of new grille cover**

Fitting intumescent strips to air transfer grills. The cover grilles to these openings can be replaced with a new cover which includes an intumescent liner.

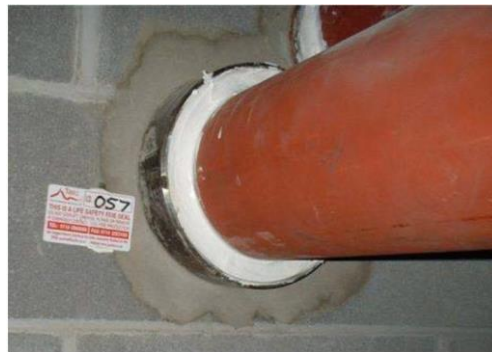
**Waste pipe with no intumescent collar**

**New pipe fitted with intumescent collar**

Work will also continue to upgrade waste pipes so they are fitted with an intumescent collar.

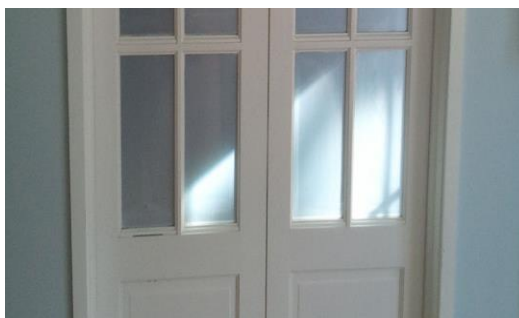
**Non fire-rated visual panels to door and side panel**

**Example picture of safety glass**

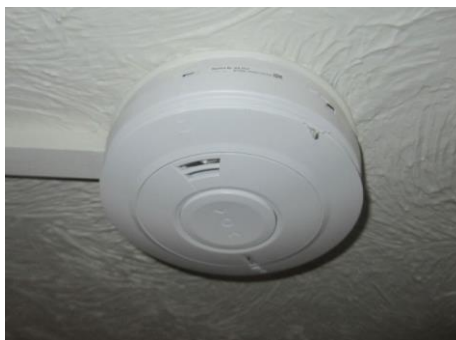
**Example of older battery style alarm (left) and new mains powered alarm (right)**

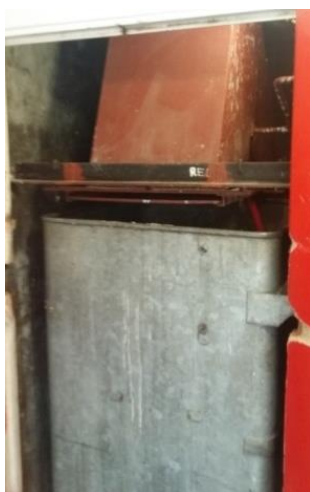
**Tower bin store and refuse chute**

However, it is felt these systems would benefit from being upgraded to a more up-to-date automatic chemical based suppression system and retrofit these systems to waste stores in all the towers.
