The Halls – Works Required Revision B

The Halls, St Andrews Plain, Norwich NR3 1AU

22.67 REV B

Building Survey / Feasibility

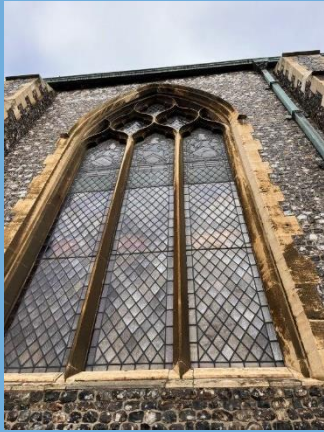
West Elevation Stain Glass Window

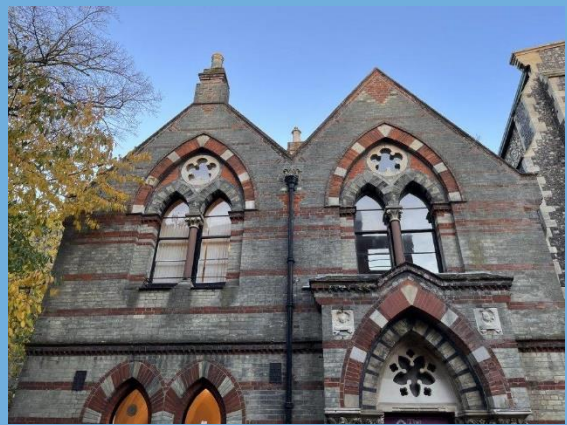
Front Elevation - Cloisters

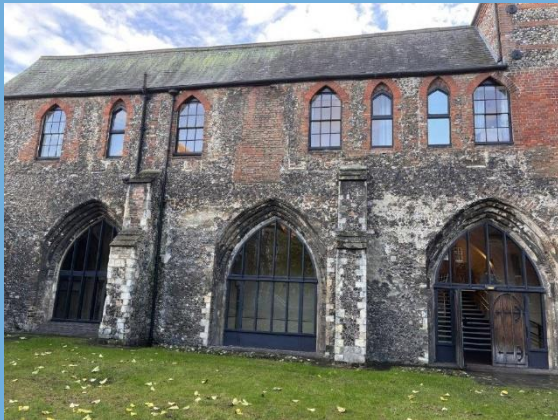
North Elevation - Cloisters

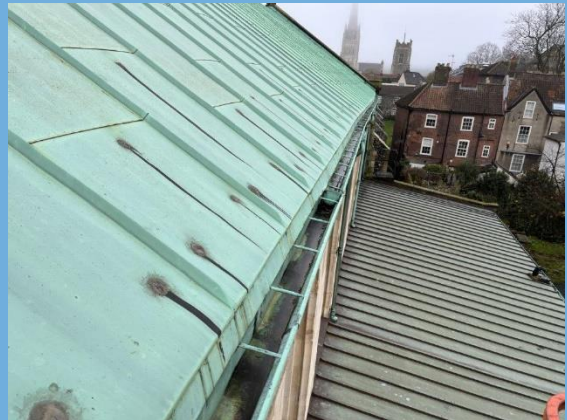
Nave roof – north pitch

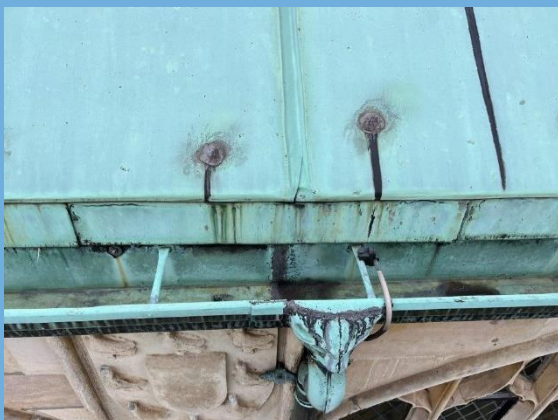
Poor lead fixings to centre of copper sheet

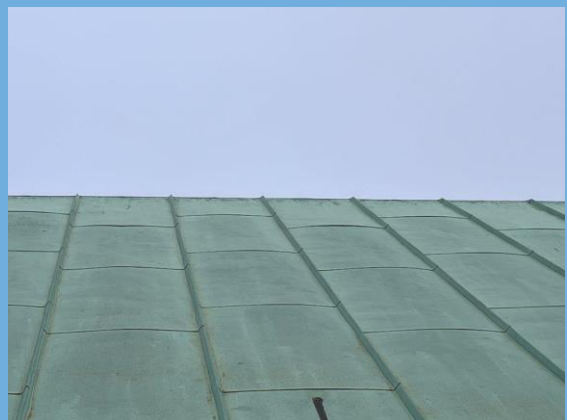
Copper sheets 'dishing'

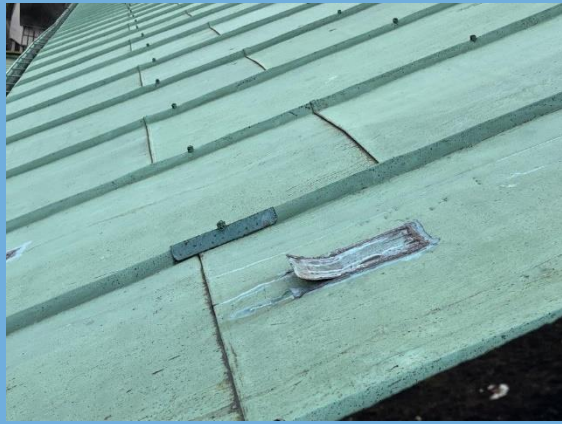
Failed patch repair to copper

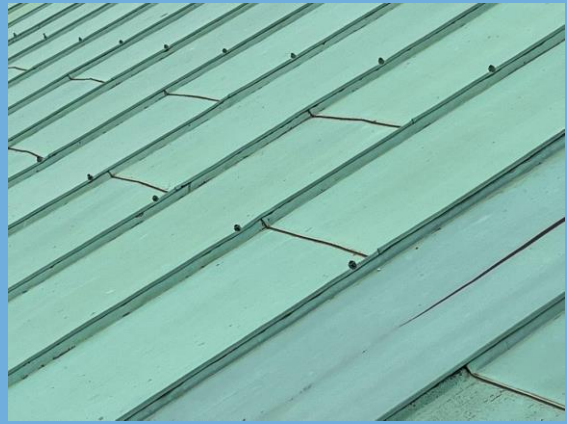
Fixings to copper sheet seams

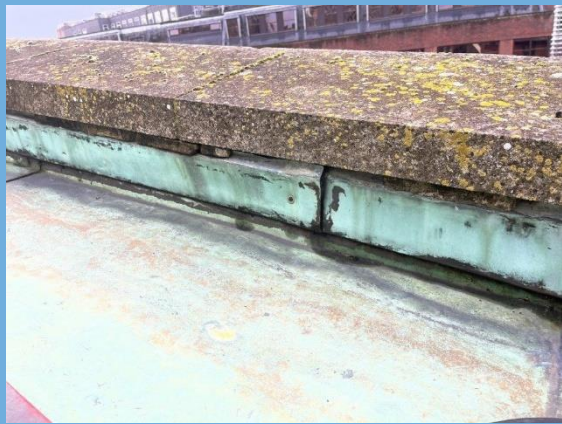
Copper abutments in poor condition

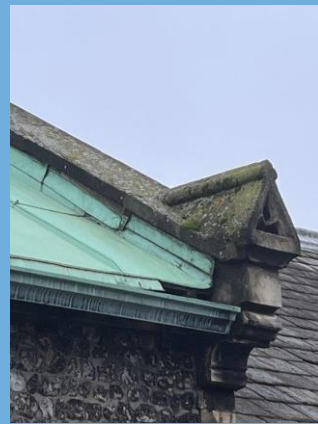
Failed copper flashing to gable

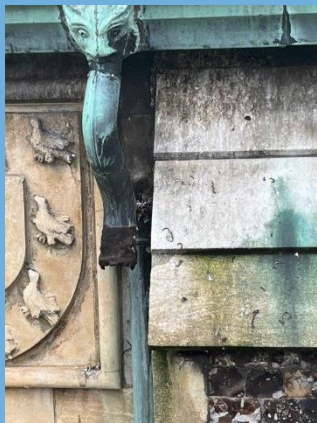
Disconnected swan neck to gable

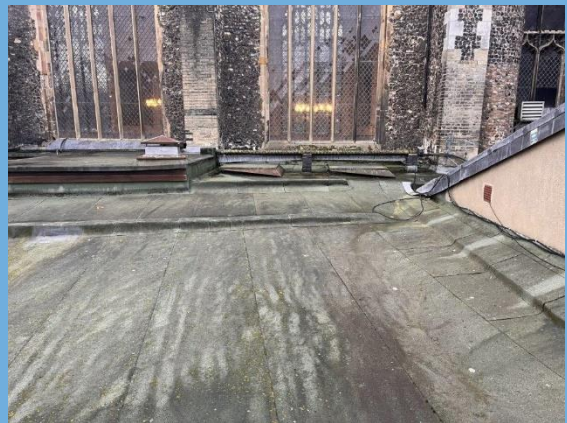
The felt roof over the Crypt is at end of life and should be renewed, we recommend an alternative product is used and the drainage of the roof is changed to reduce the risk of future leaks.

Felt roof in poor condition

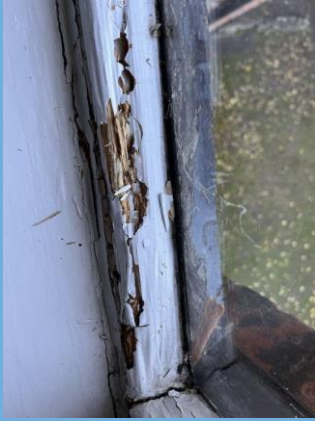
There is one window to the second floor which is suffering from significant timber decay and should be renewed immediately prior to the glazing becoming a hazard.

Cloister window at end of life

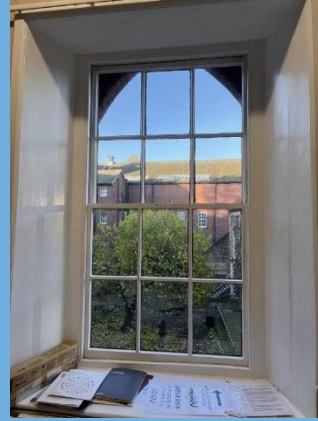
Typical Cloister window internally

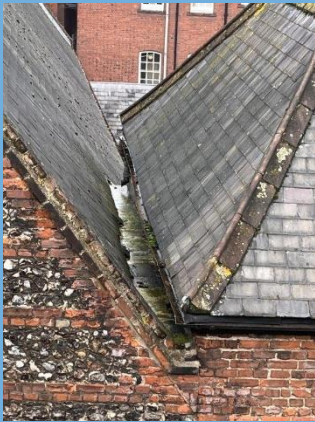
Cloister valley gutter

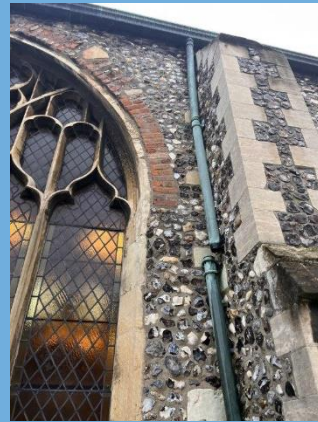
Copper RWG in poor condition

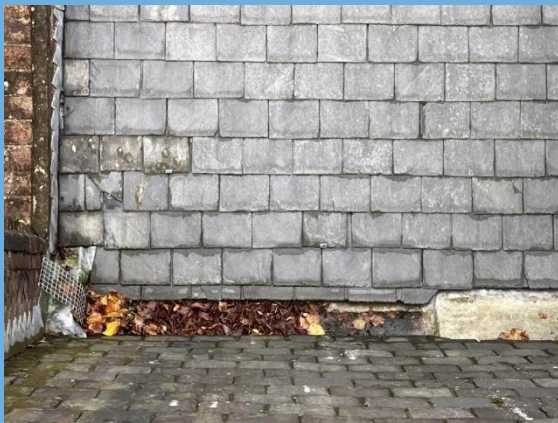
Leaf debris to Cloister valley gutter

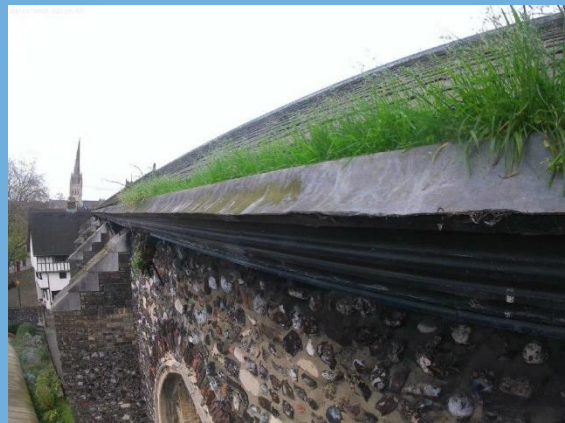
The rainwater goods to Blackfriars should be cleaned and some immediate patch repairs carried out, further maintenance should follow when access is provided.

Blackfriars gutter in disrepair

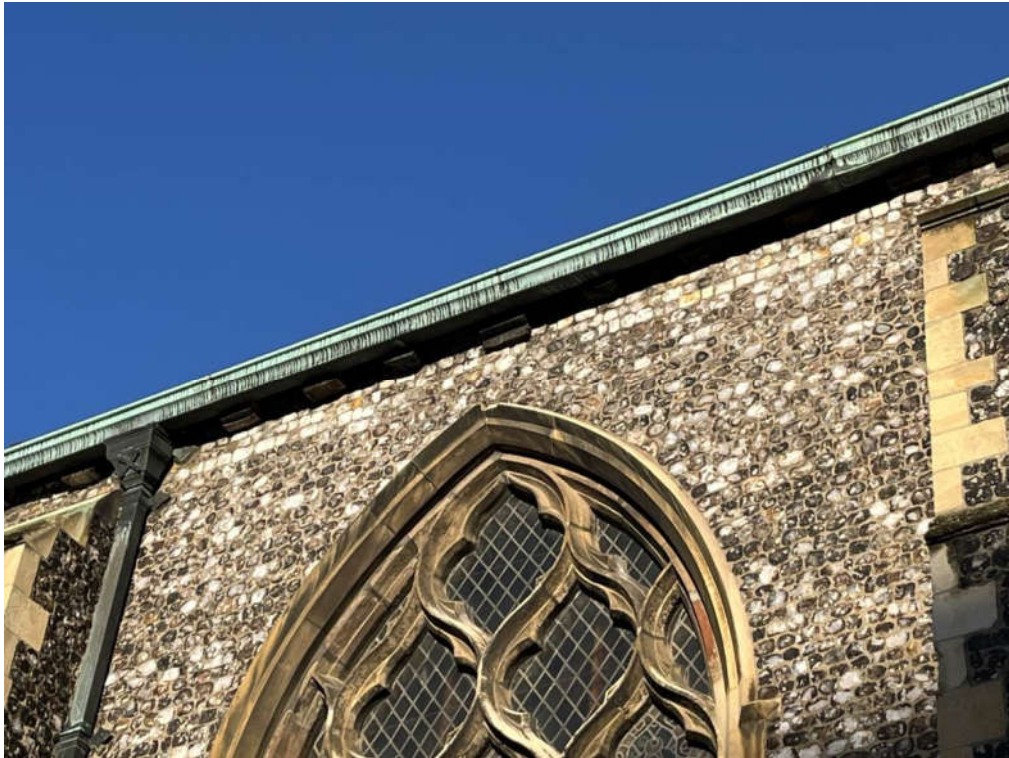
Photograph 7 – Roof structure visible at eaves externally

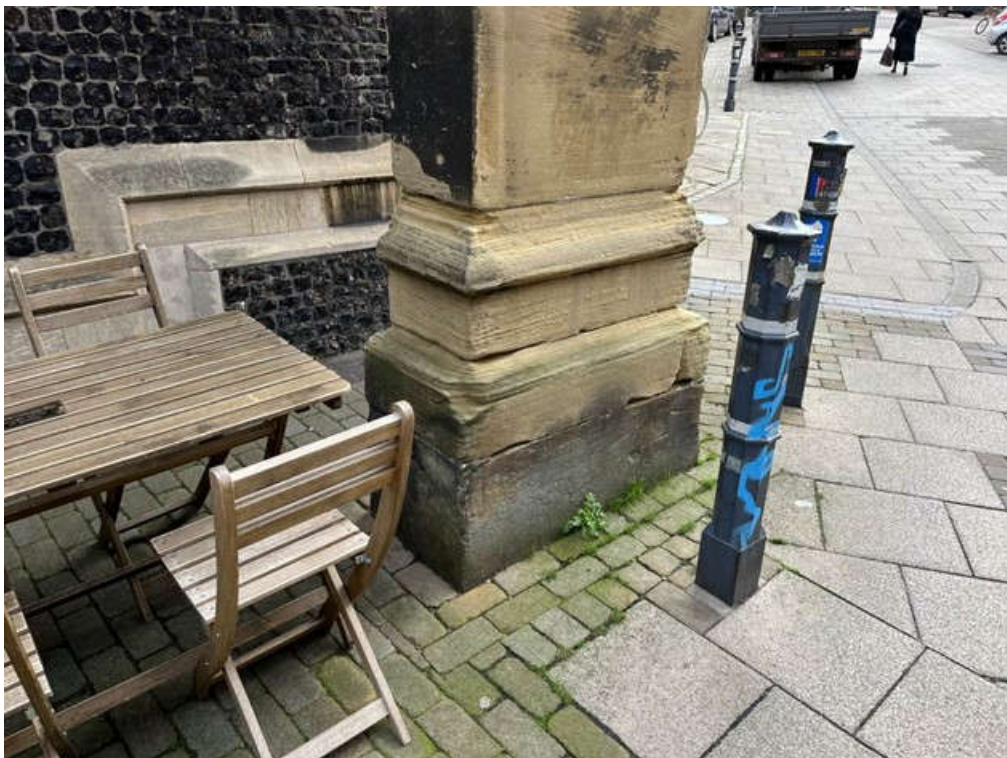
Photograph 14 – Eroded stonework to base of West gable buttresses

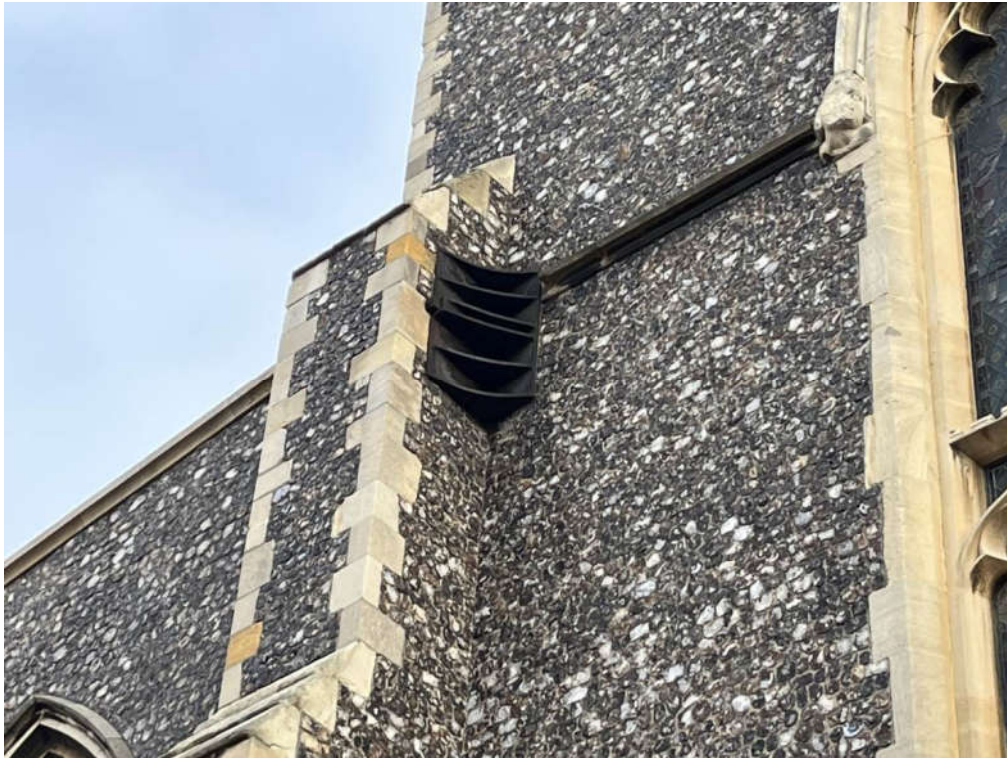
Photograph 15 – Large metal bracket tying West gable construction to end buttresses

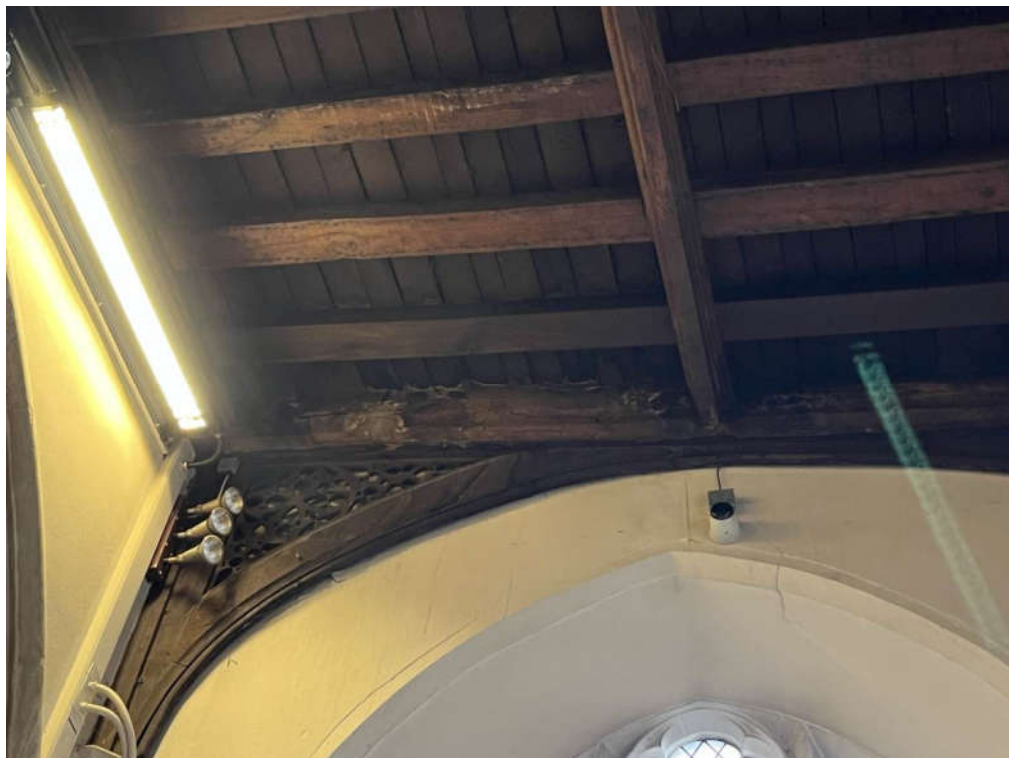
Photograph 24 – Signs of historic damp to East end of South aisle roof structure

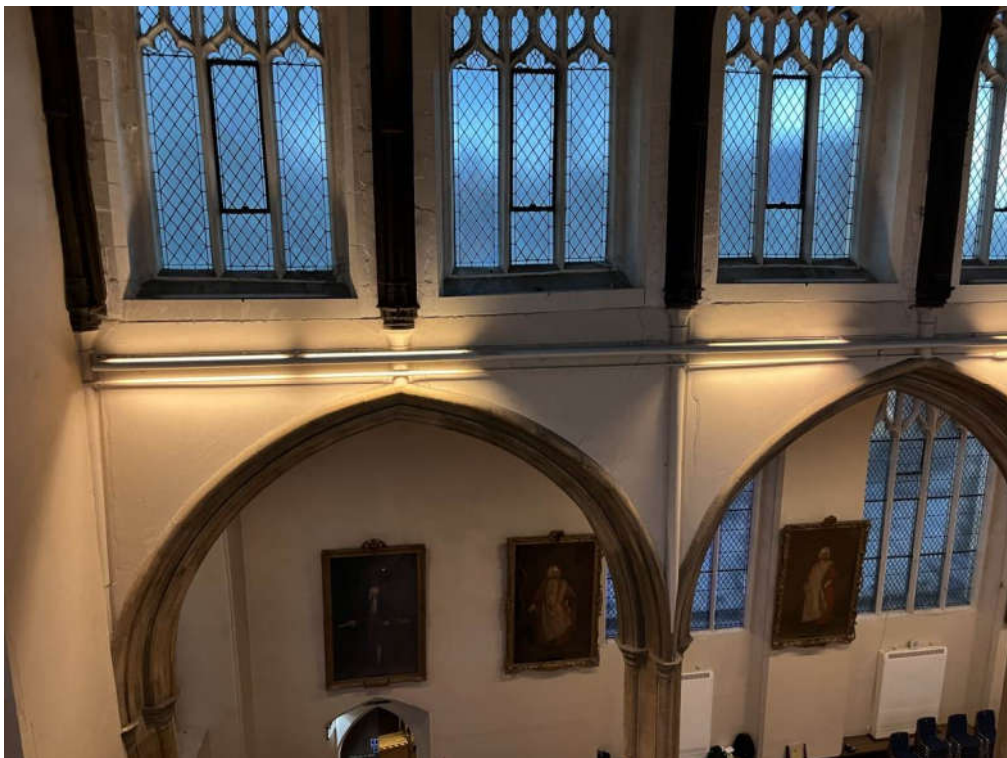
Photograph 26 – Signs of historic movement to West end of nave at aisle roof level (window sills sloping/dropped)

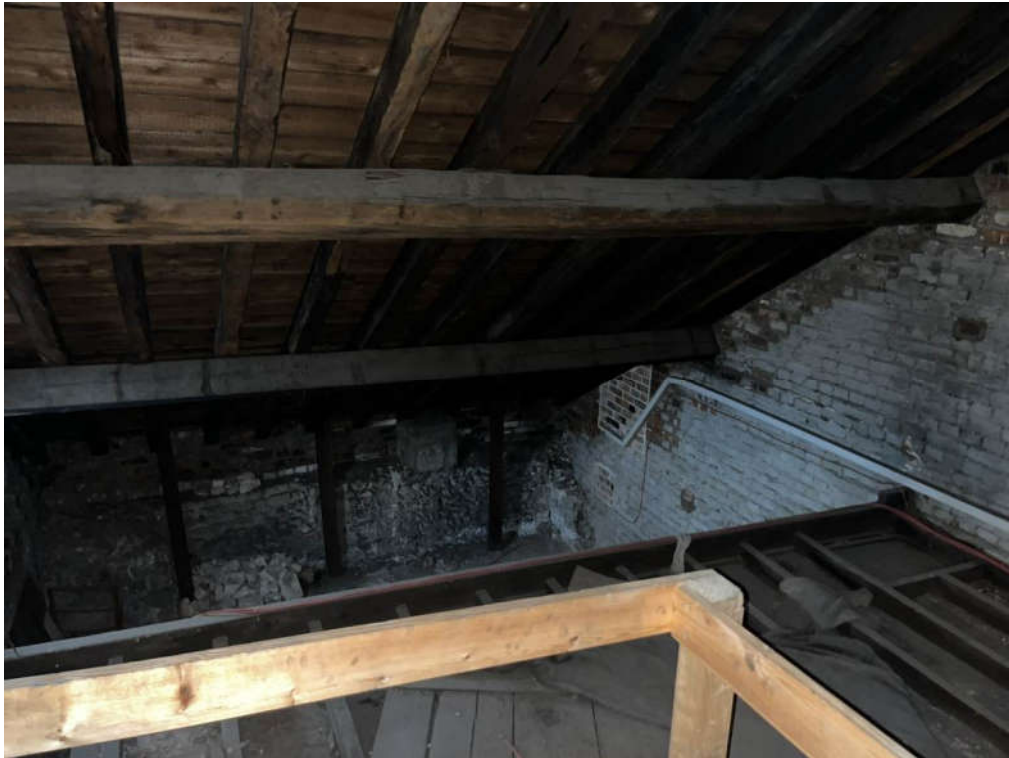
Photograph 29 – 'Modern' roof structure over organ

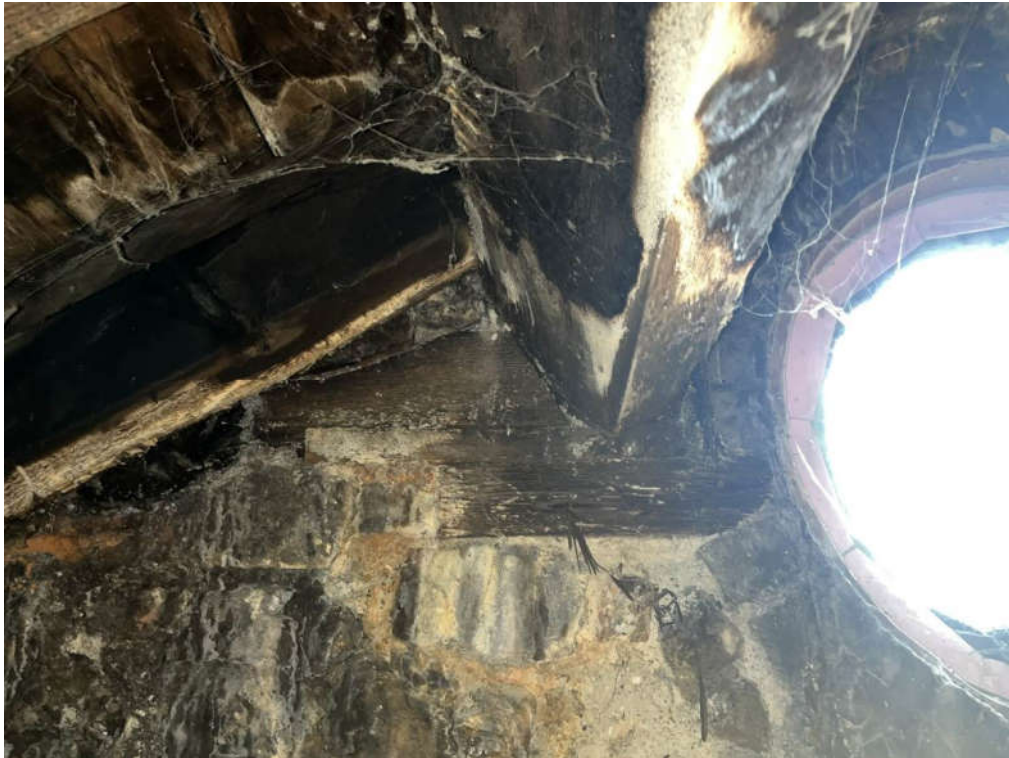
Photograph 31 – Damp timber elements where North purlin extends into East wall (organ loft)

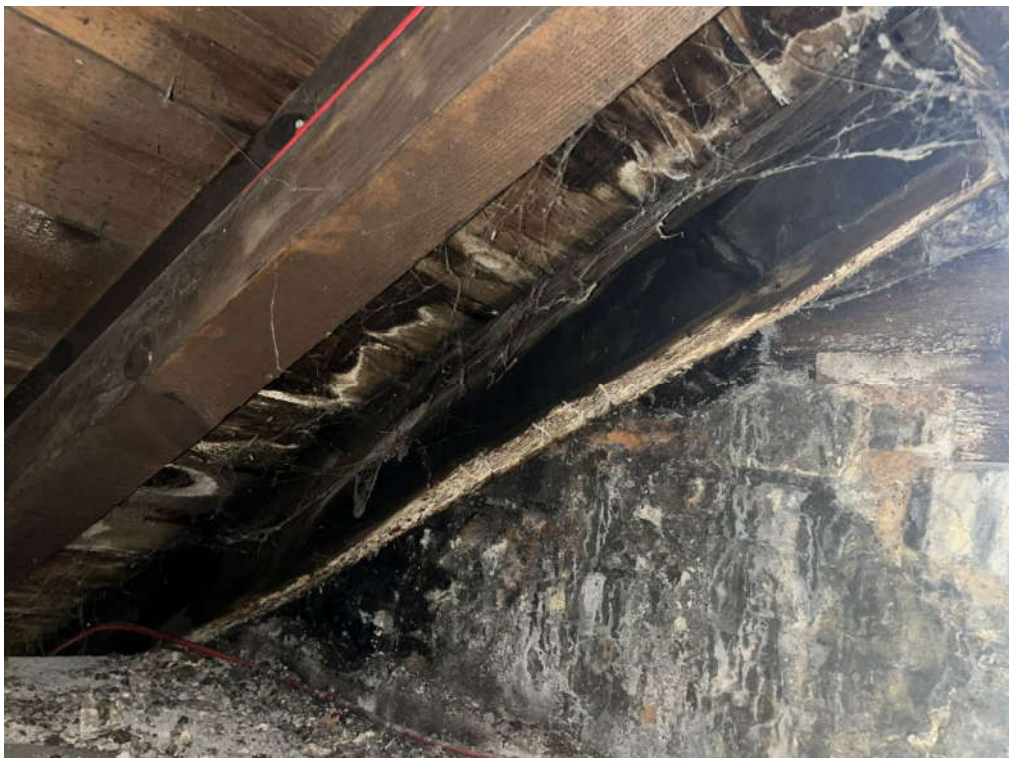
Photograph 32 – Damp common rafter against North Wall in organ loft

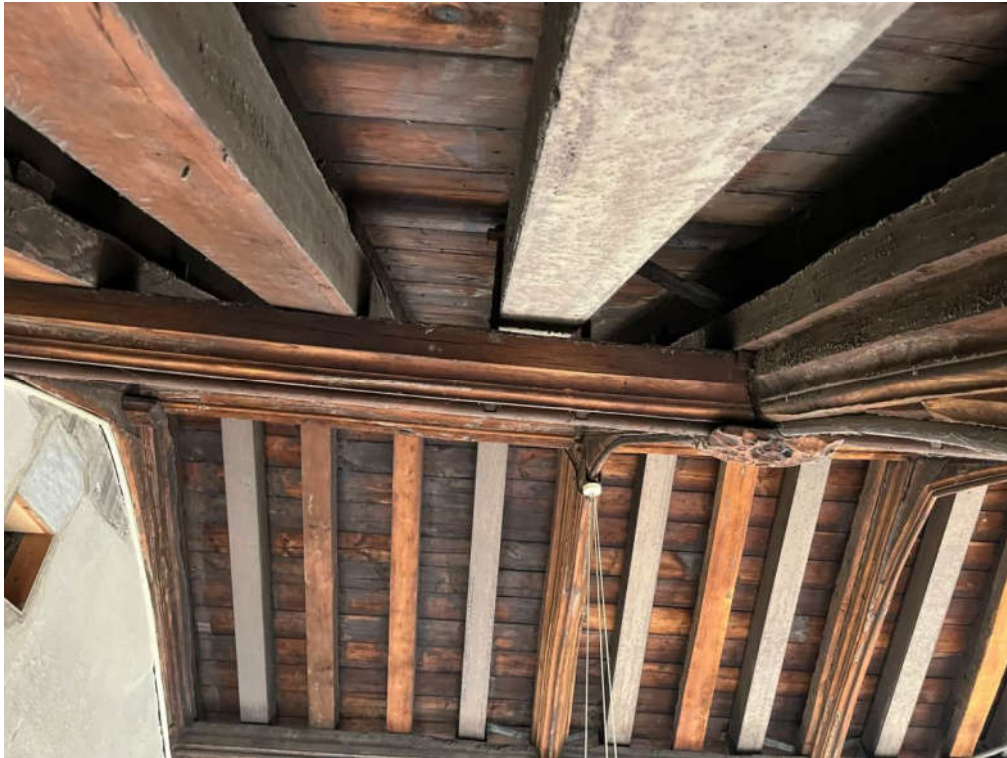
Photograph 41 – Bracket behind rafters assumed to support historic timber truss from new steel trusses either side

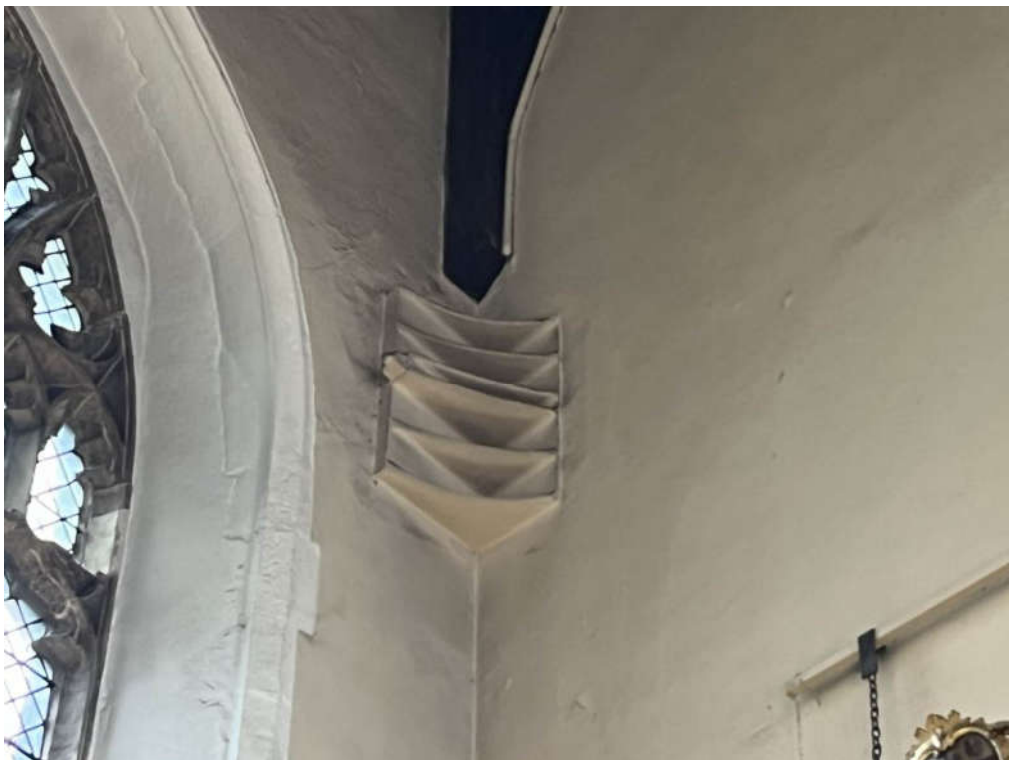
Photograph 44 – Metal restraint brackets present on West wall mimicking brackets on West elevation of St Andrew's Hall

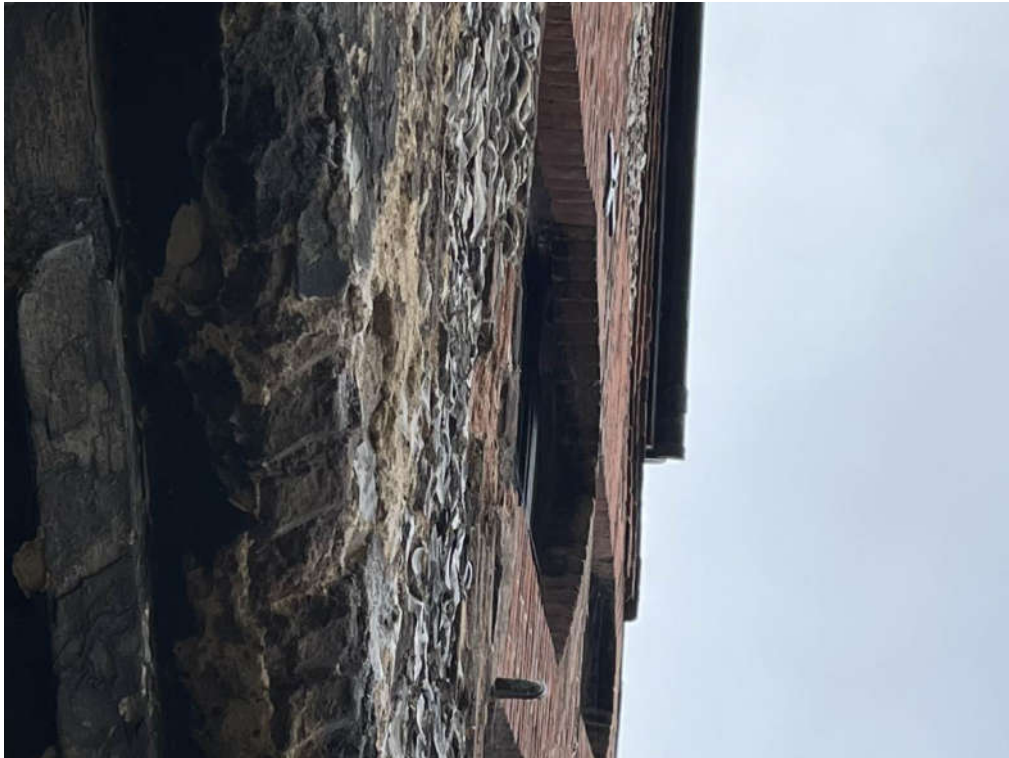
Photograph 53 – Brick window arch bowing out

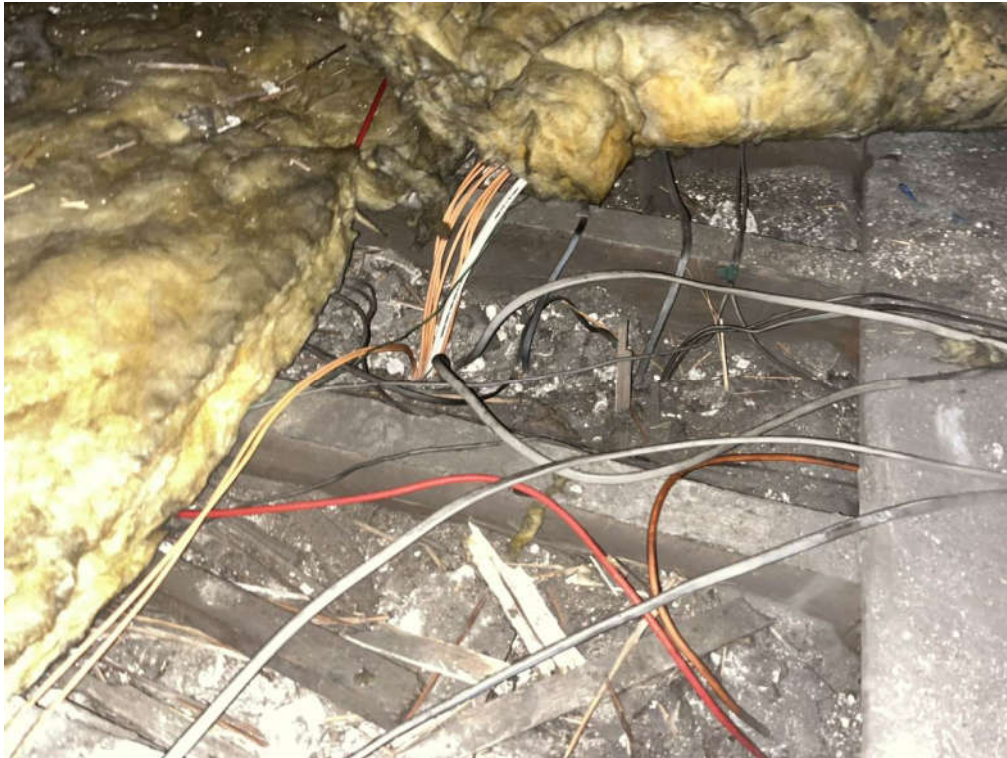
Photograph 69 – Debris in ceiling void

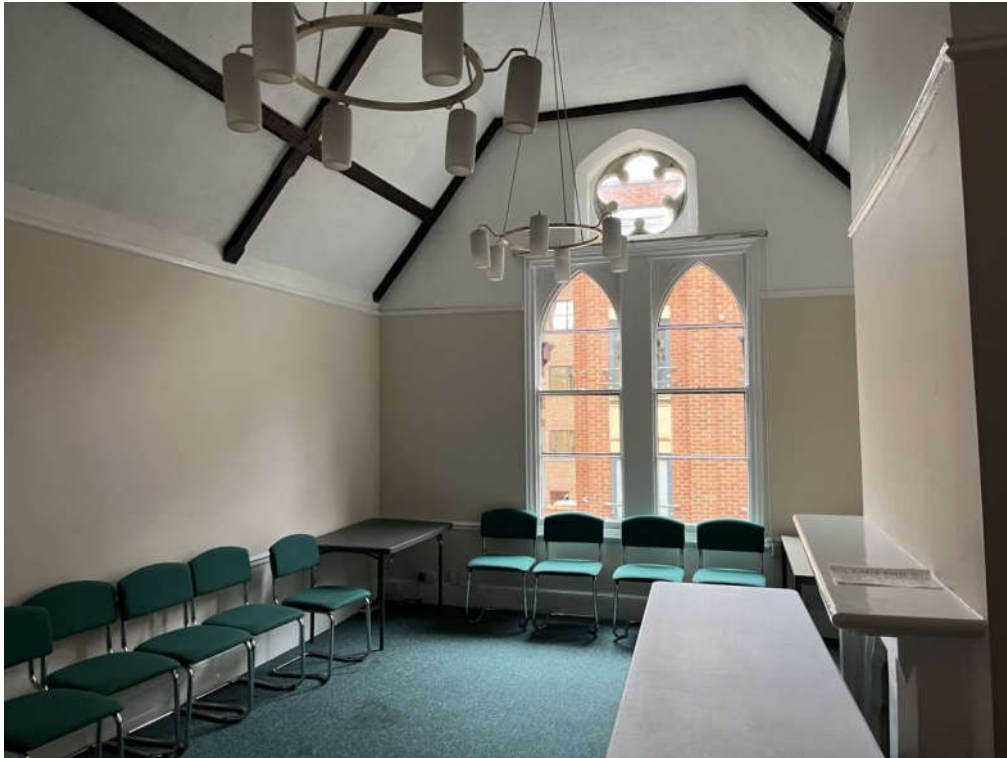
Photograph 71 – Meeting rooms in West end of First Floor

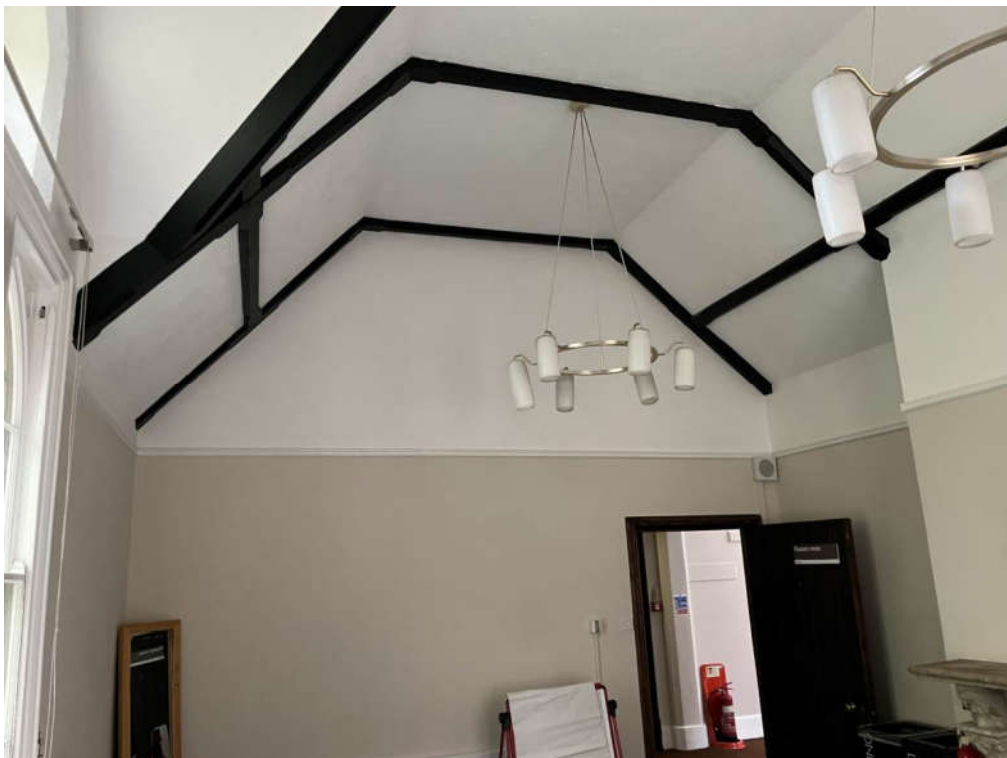
Photograph 72 – Meeting rooms in West end of First Floor

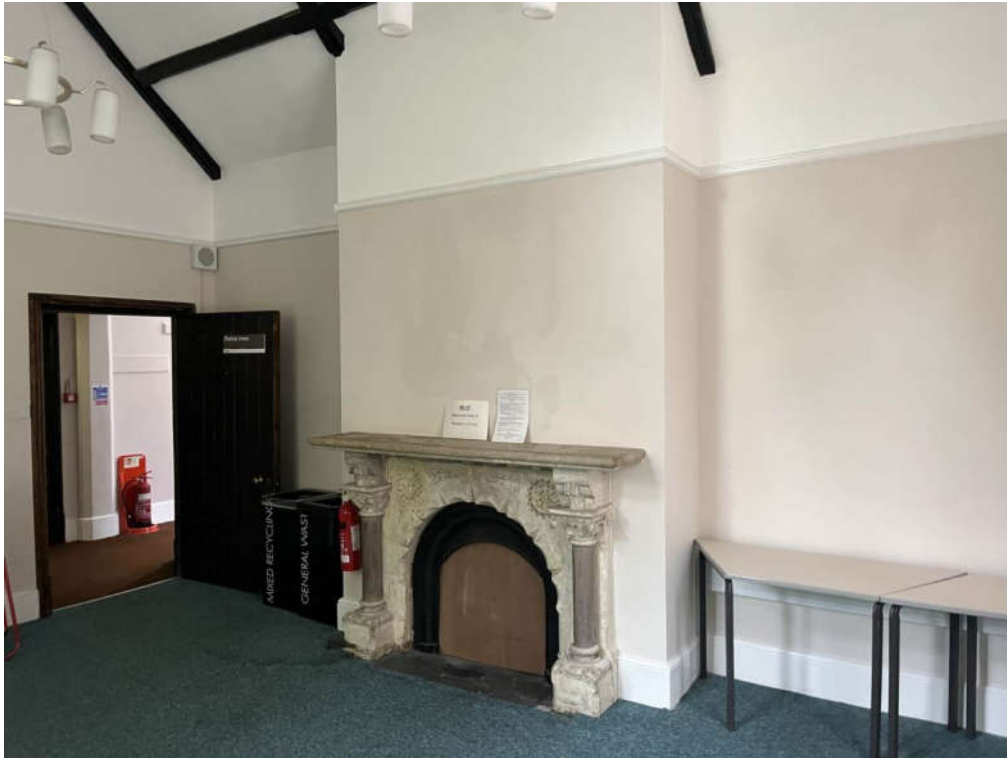
Photograph 73 – Fireplace blocked and signs of damp on chimney breast

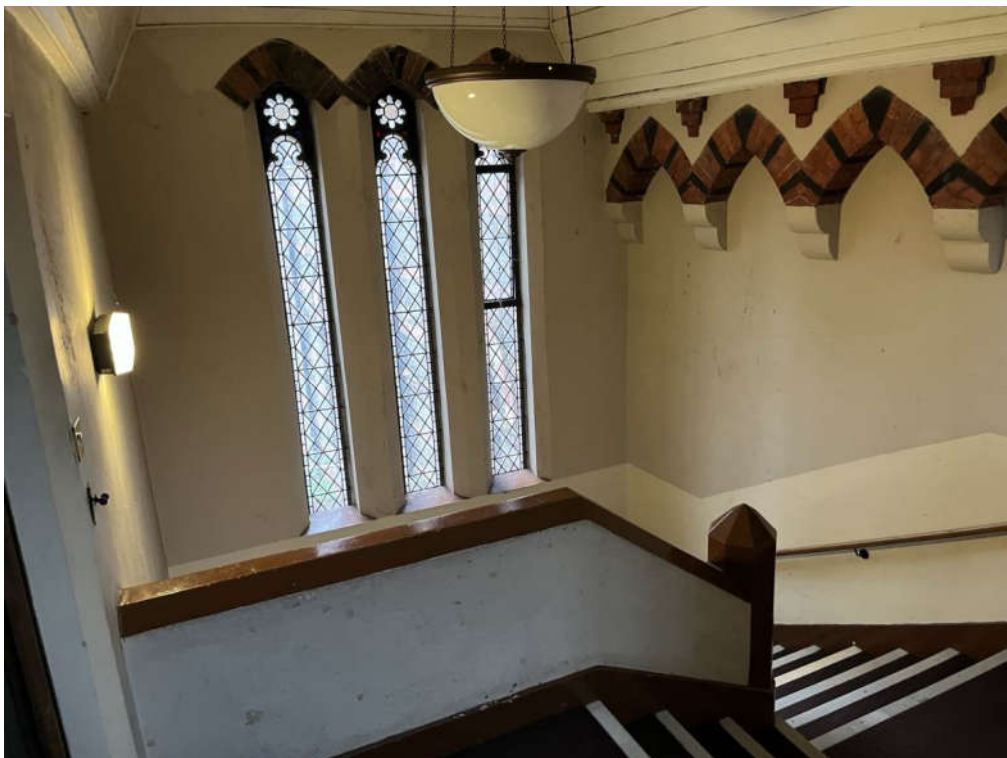
Photograph 74 – Staircase within West end of Cloisters

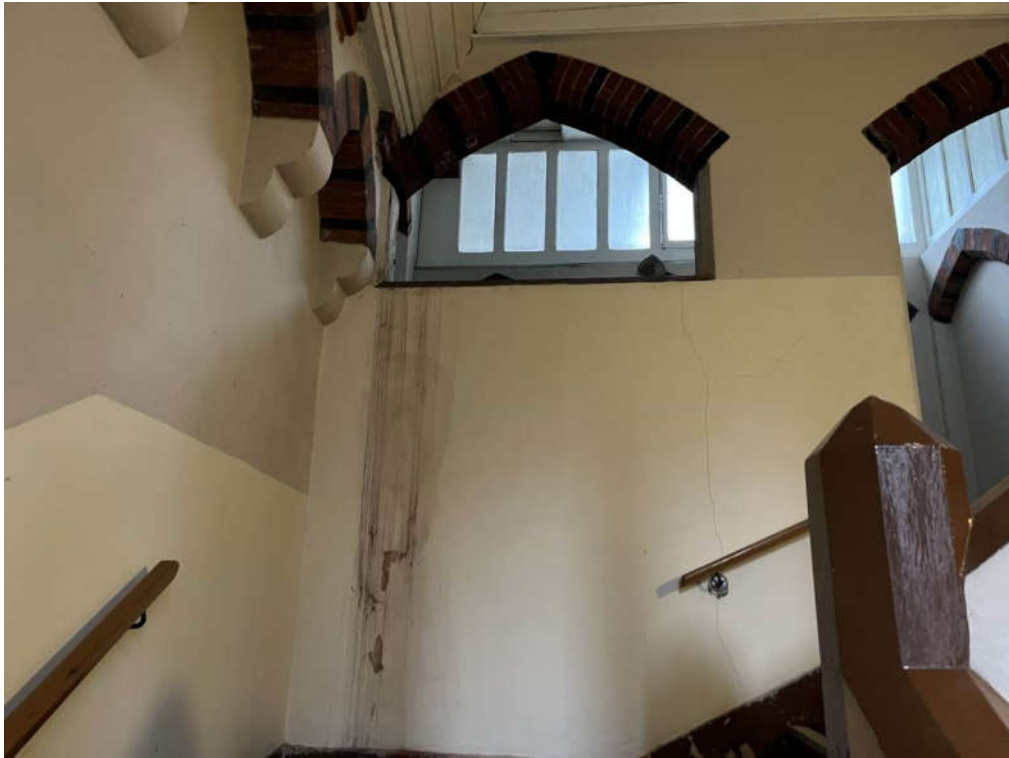
Photograph 75 – Extensive water ingress through roof structure over staircase

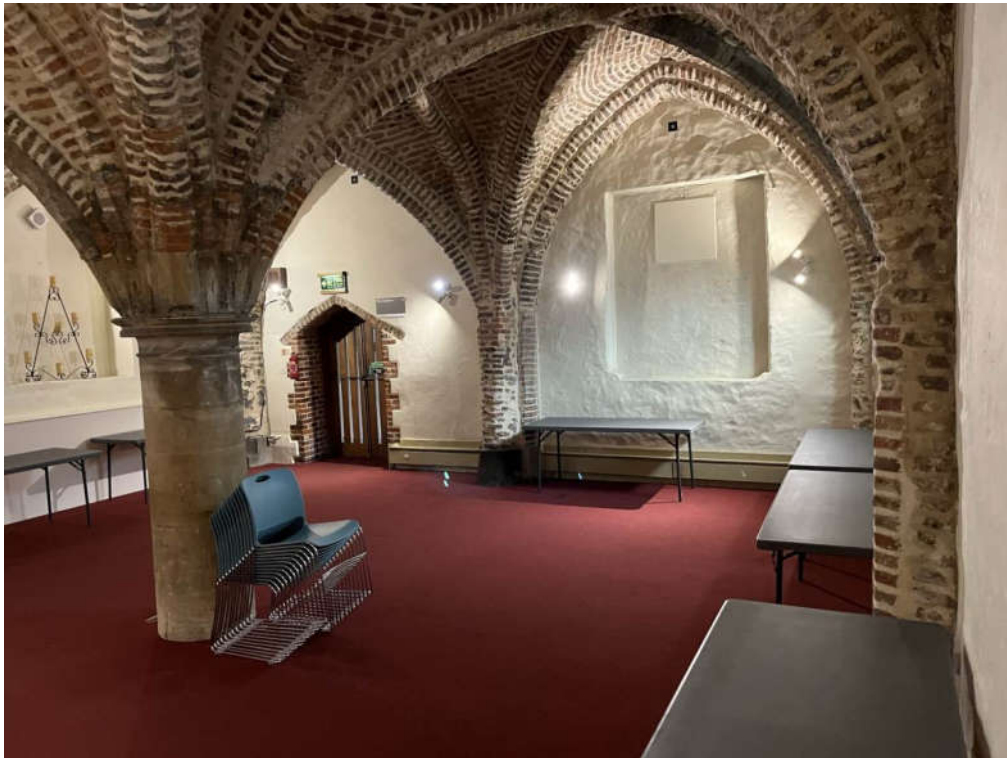
Photograph 77 – Crypt looking West

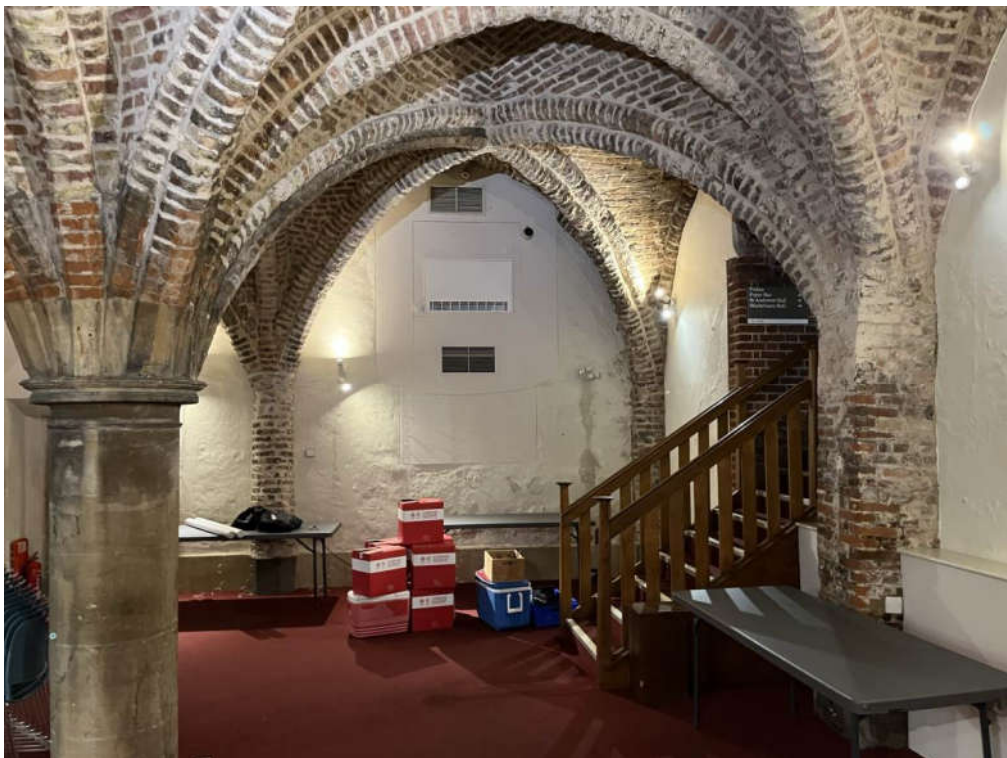
Photograph 78 – Crypt looking East

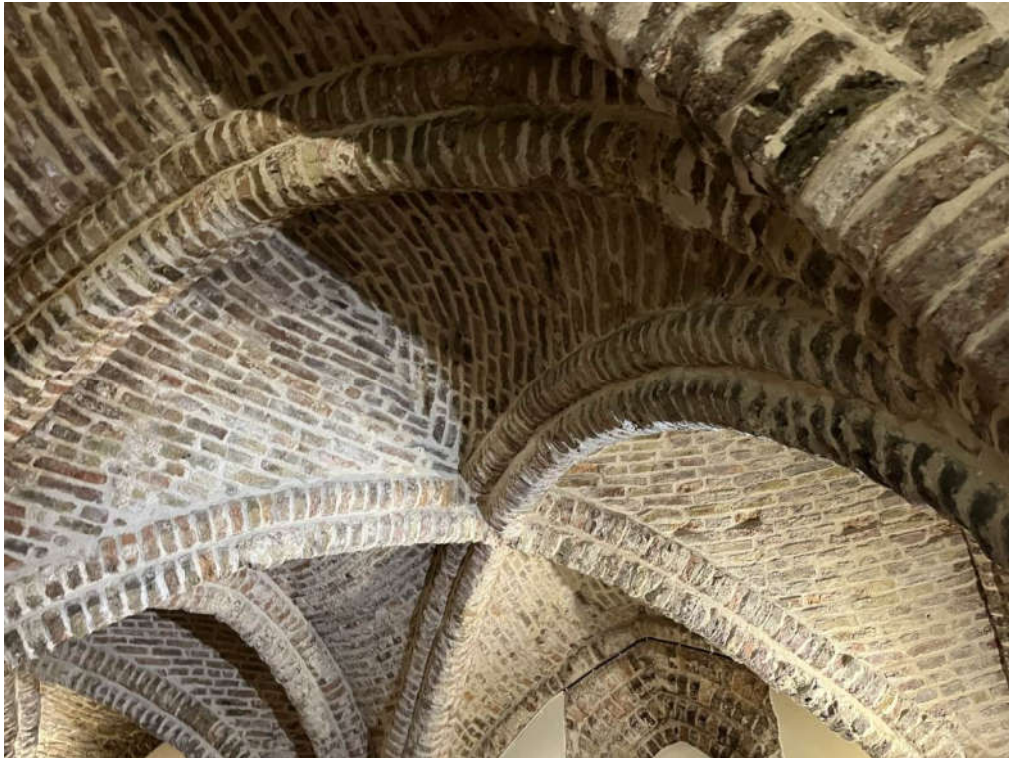
Photograph 79 – Masonry arches repointed in the last century

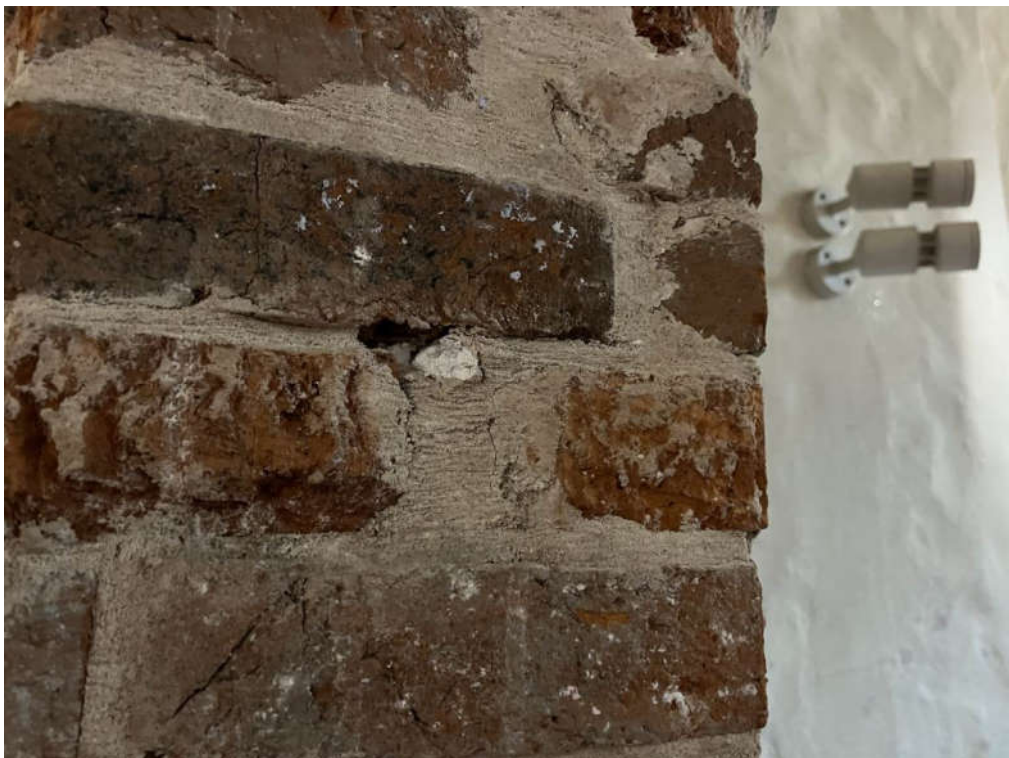
Photograph 80 – Masonry repointed with a hard mortar

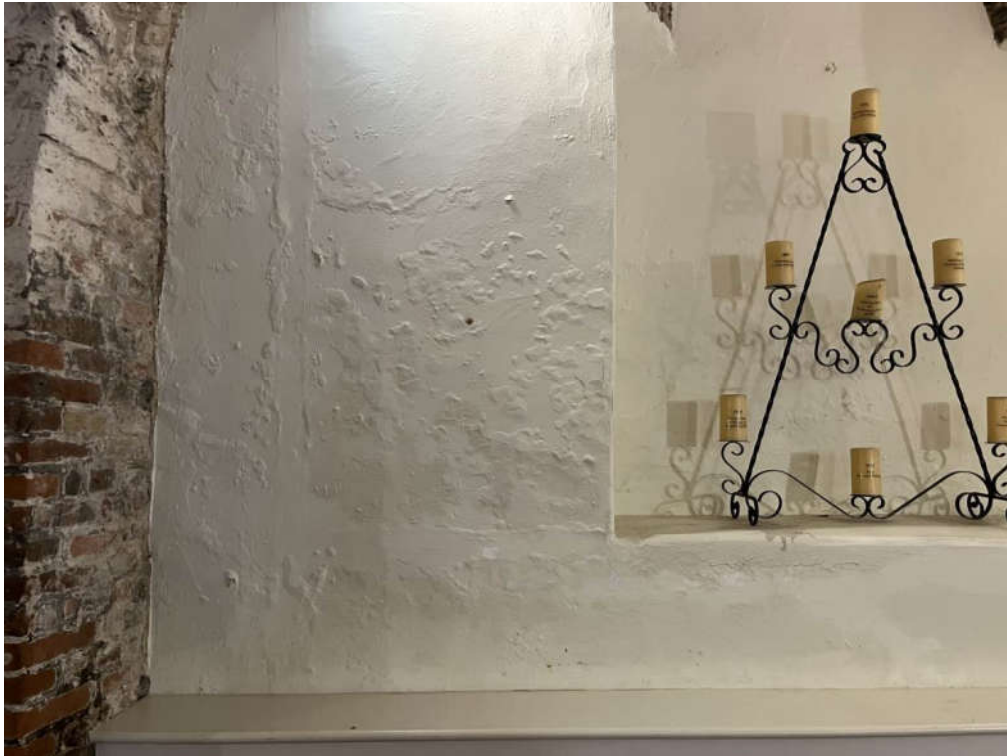
Photograph 81 – Signs of damp in walls

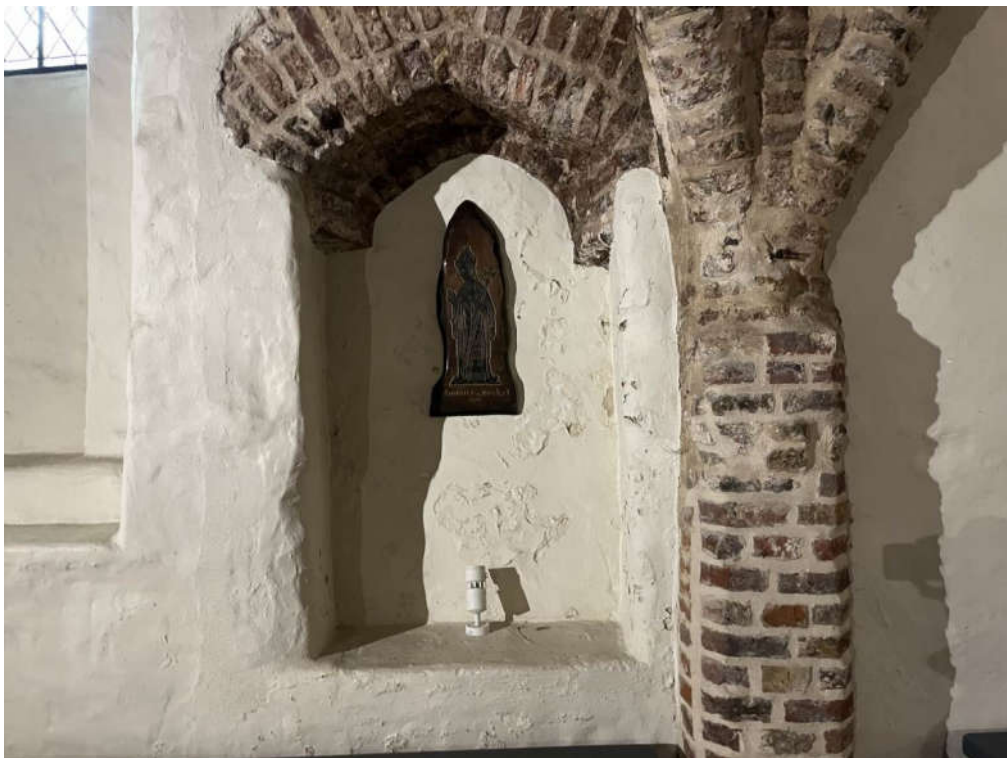
Photograph 82 – Signs of damp in walls

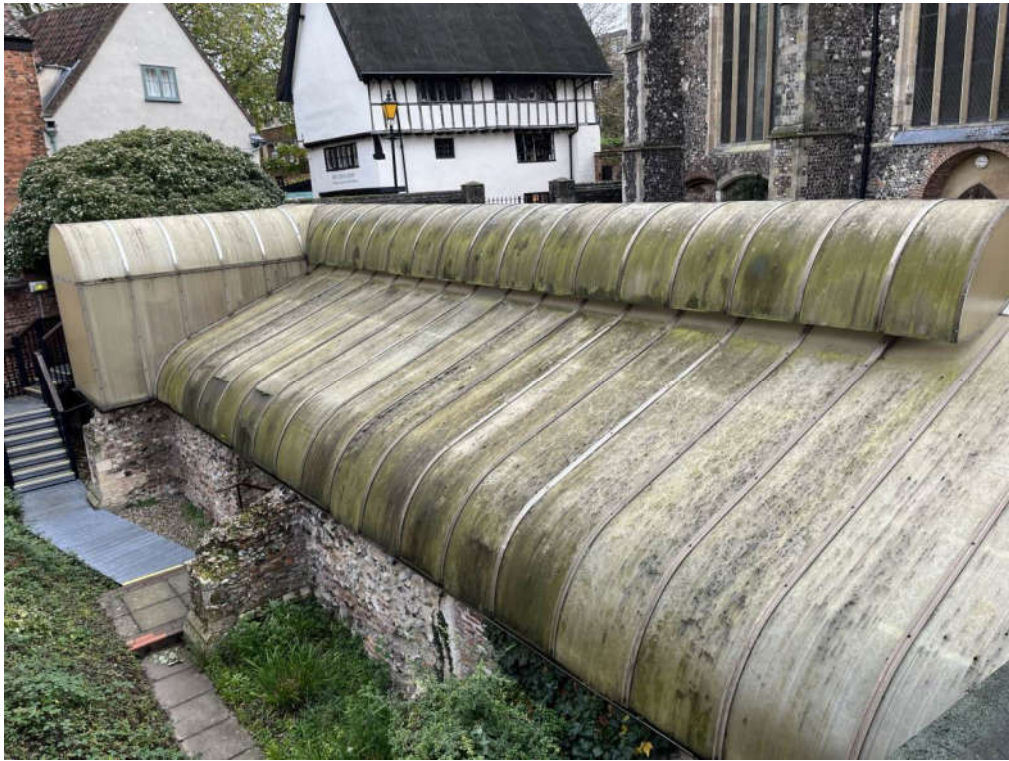
Photograph 83 – North Elevation
