The Halls – Works Required Revision B

The Halls, St Andrews Plain, Norwich NR3 1AU

22.67 REV B

Building Survey / Feasibility

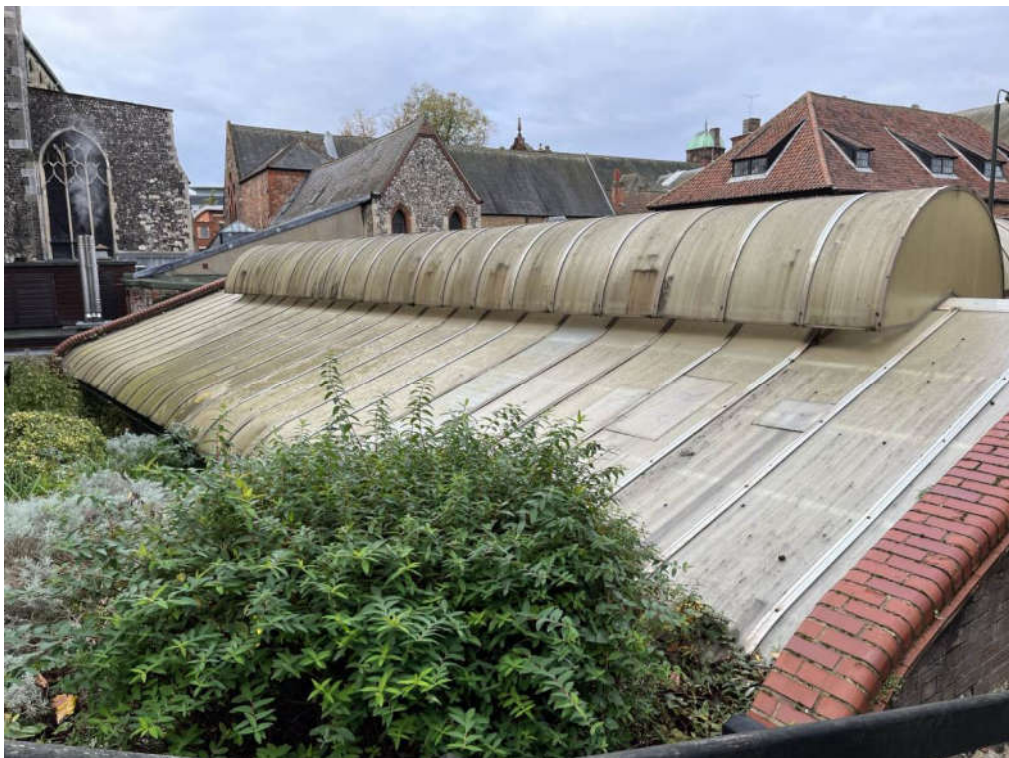
Photograph 84 – South Elevation

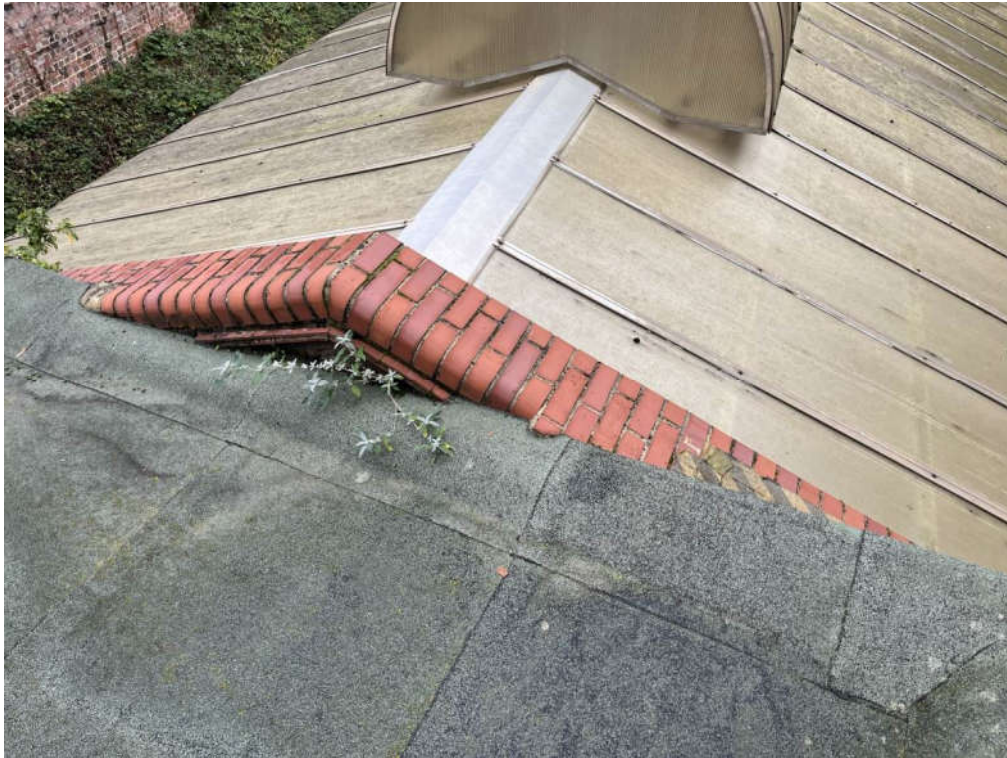
Photograph 85 – No flashing where West gable meets adjacent roof

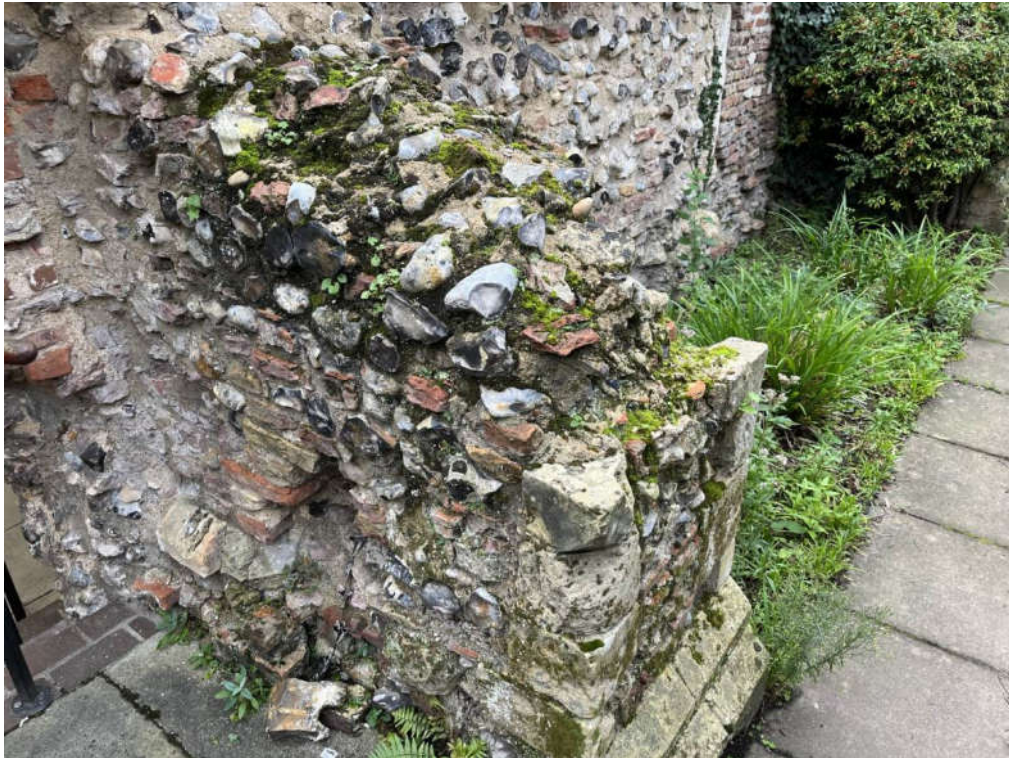
Photograph 87– Exposed remains of flint wall

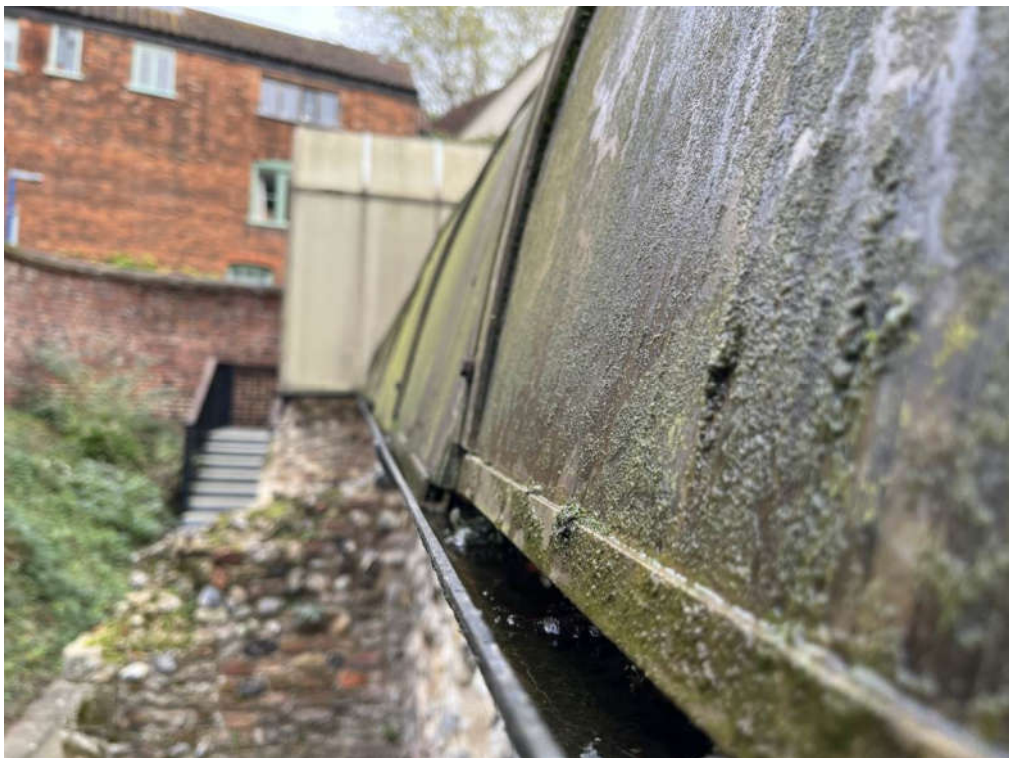
Photograph 88 – Dropped roof sheet and blocked gutters

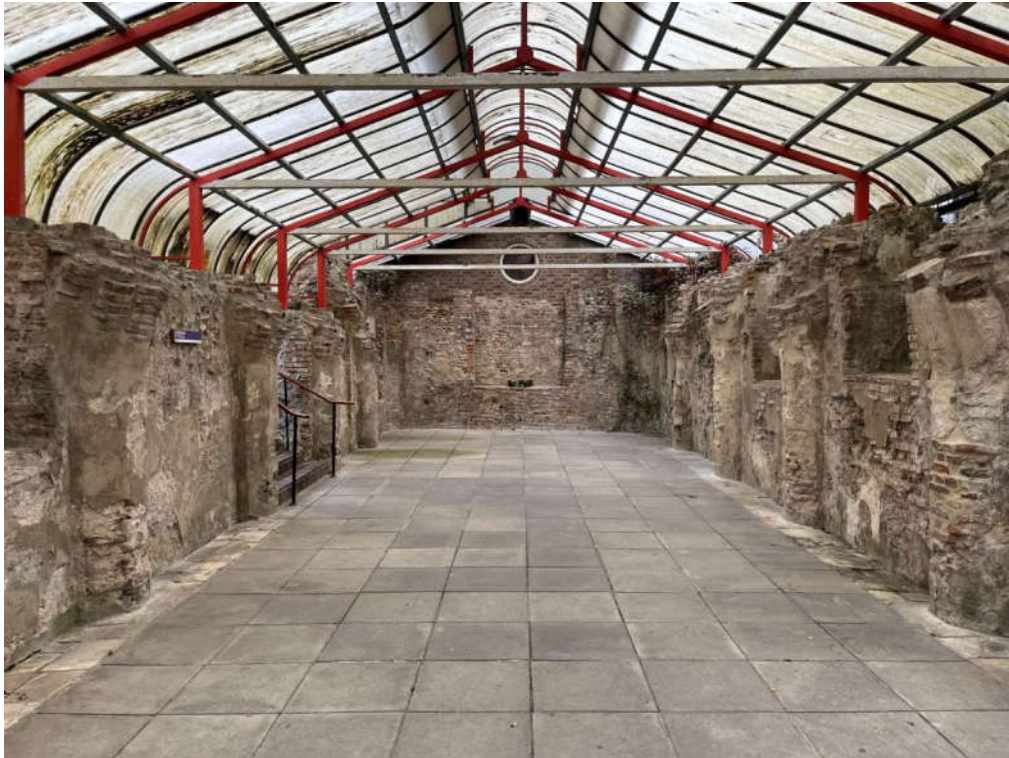
Photograph 89 – Internal looking East

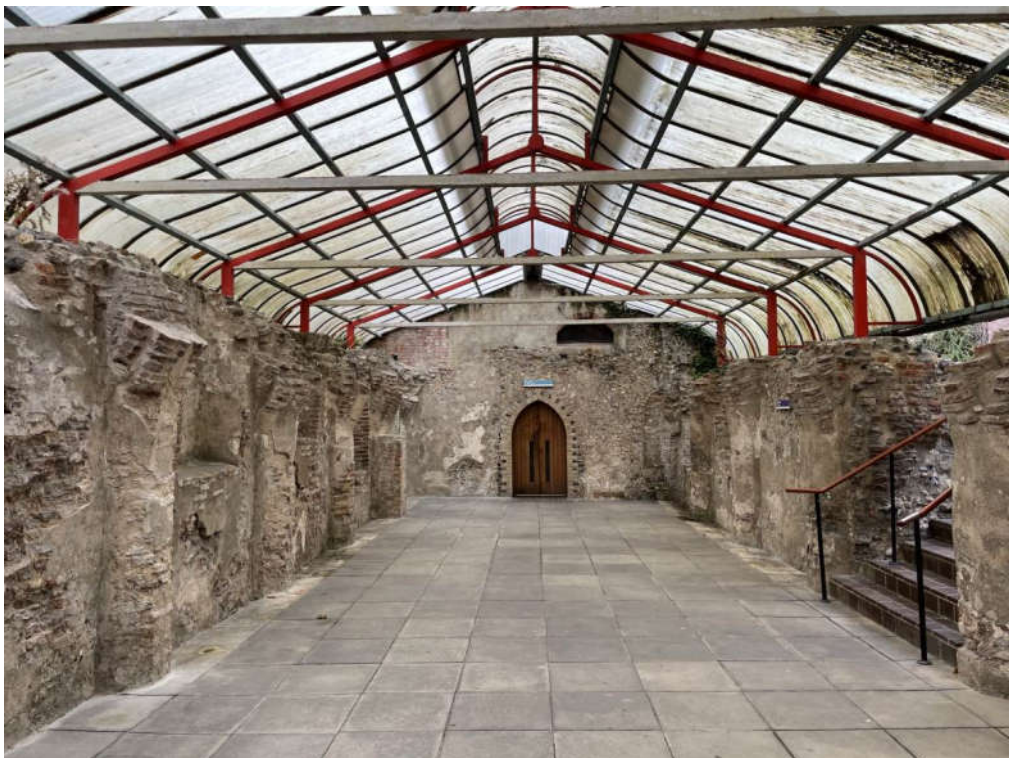
Photograph 90 – Internal looking West

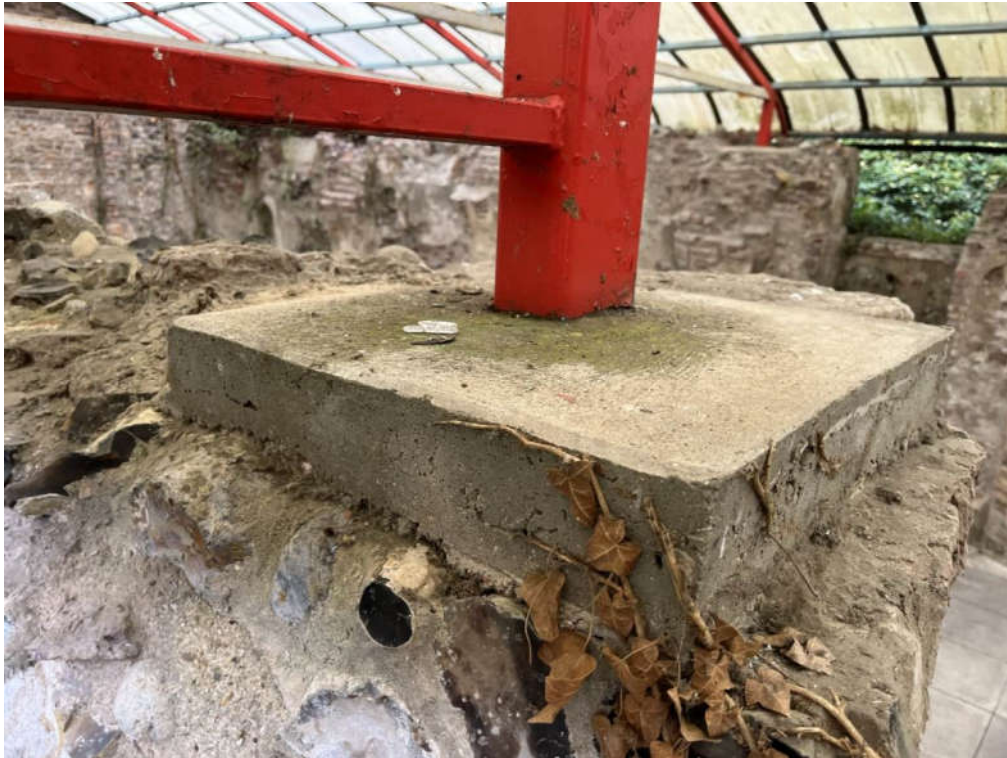
Photograph 91 – Steelwork embedded in concrete pad cast onto wall

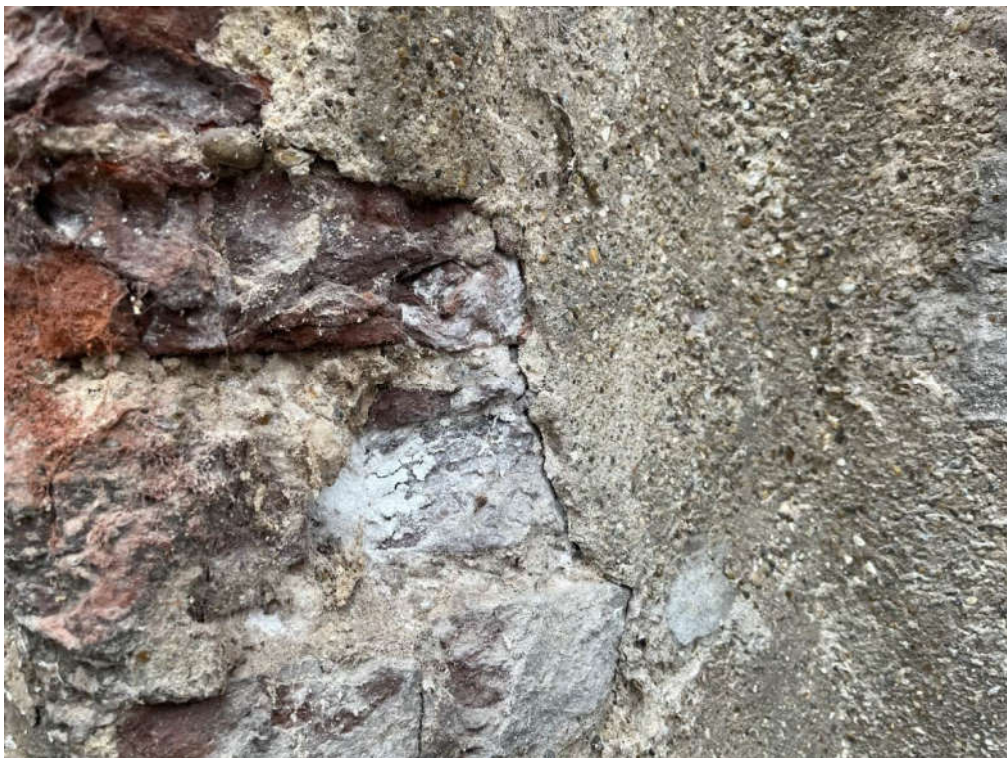
Photograph 92 – Cementitious render on walls

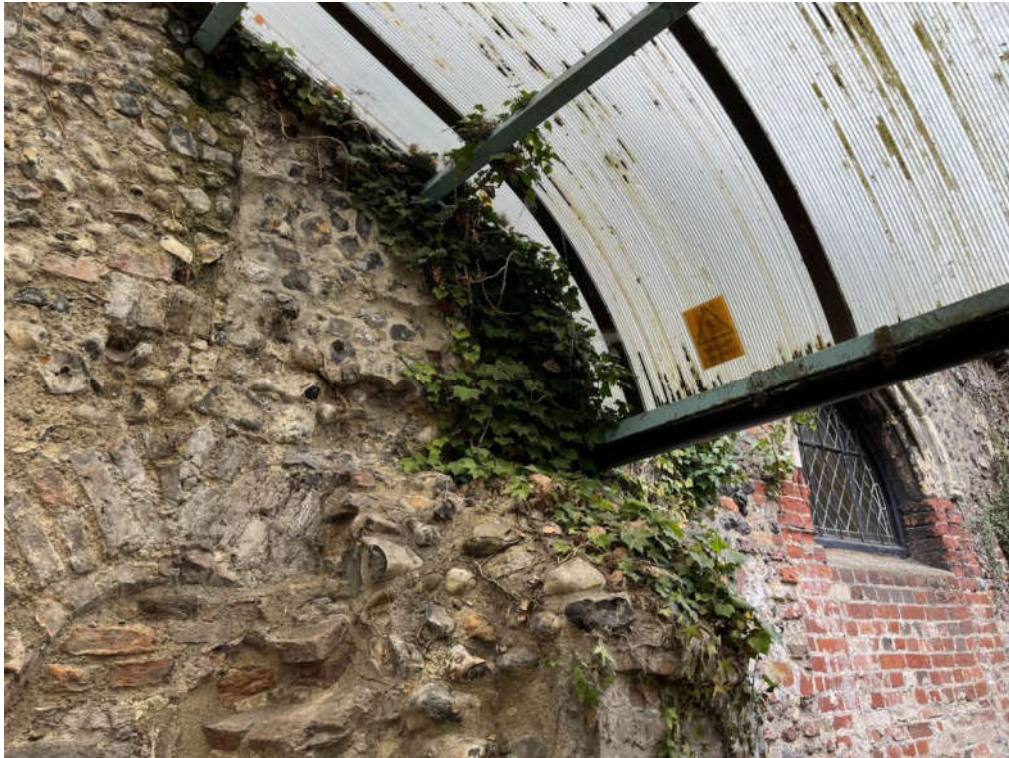
Photograph 93 – Vegetation growing into building

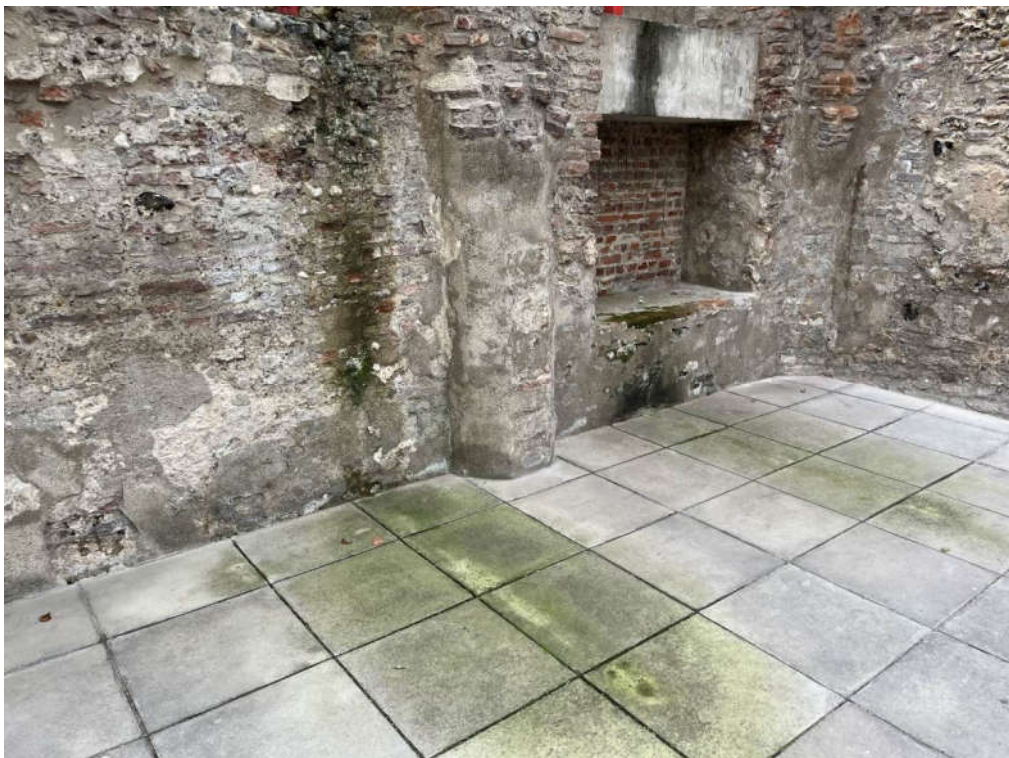
Photograph 94 – Signs of water ingress

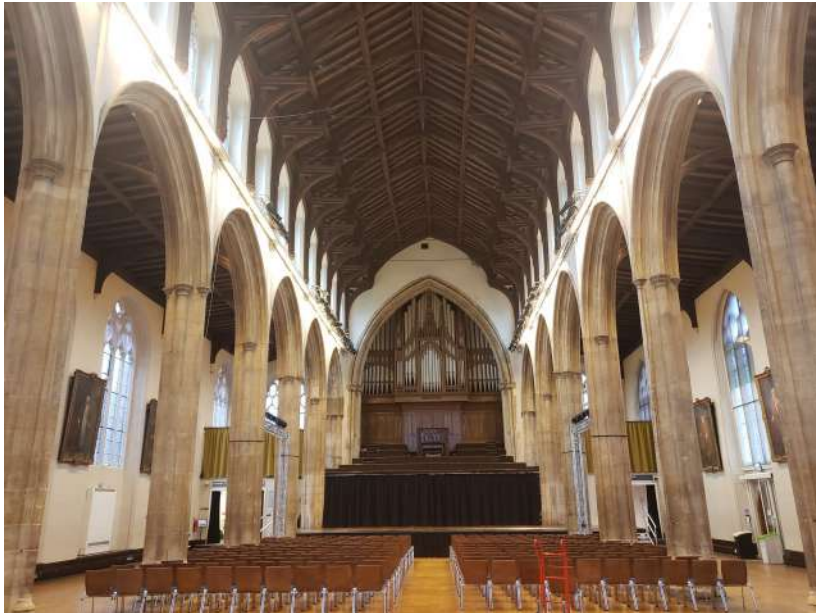
Fig 1:

St Andrew's Hall, internal; showing a general view looking east of the structural arrangement of the timber roof and that of the overall building. Note the presence of aisles along the north and south sides, these were served by separate, lower roof structures than the Nave

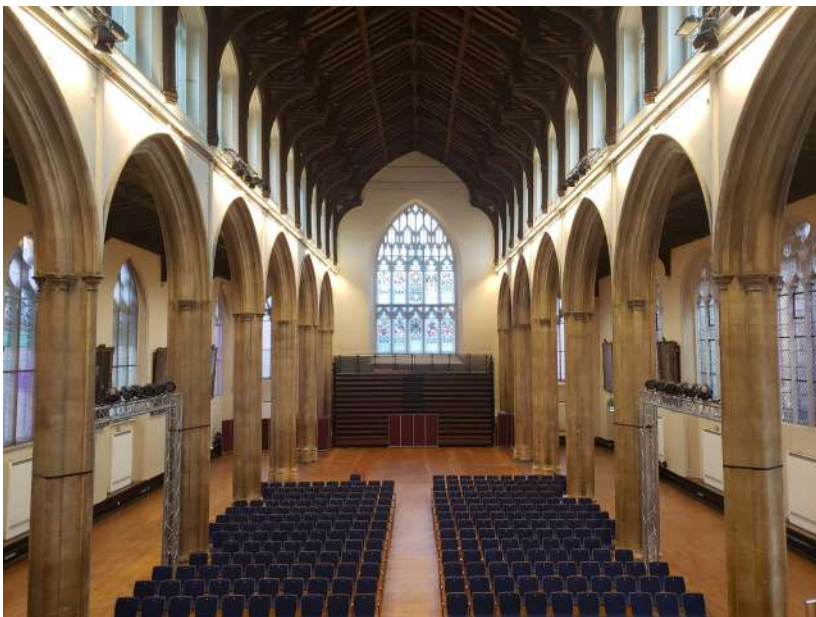
Fig 2:

St Andrew's Hall, internal; showing a general view looking west of the structural arrangement of the timber roof and that of the overall building

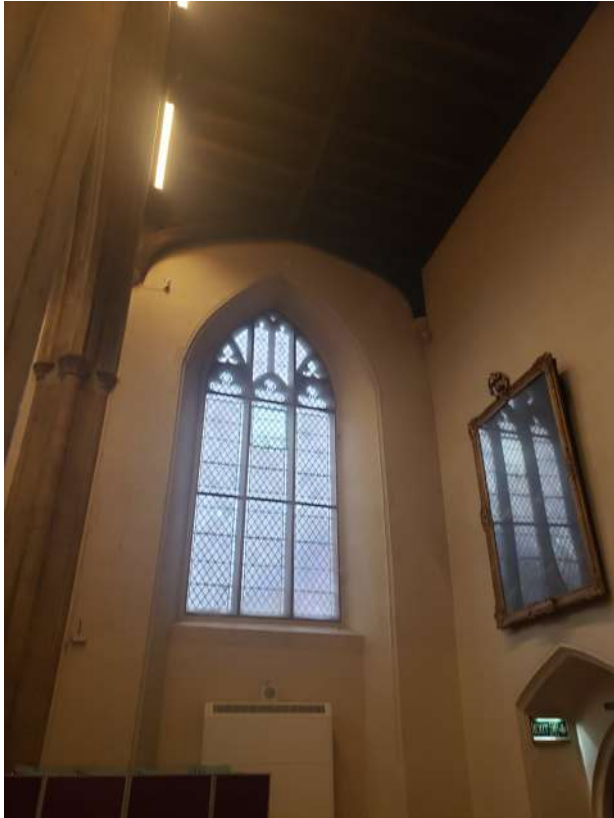
Fig 3:

St Andrew's Hall, internal; showing a general view of the masonry gable wall at the west of the north aisle. This was reported to have possibly been rebuilt during the 19th century

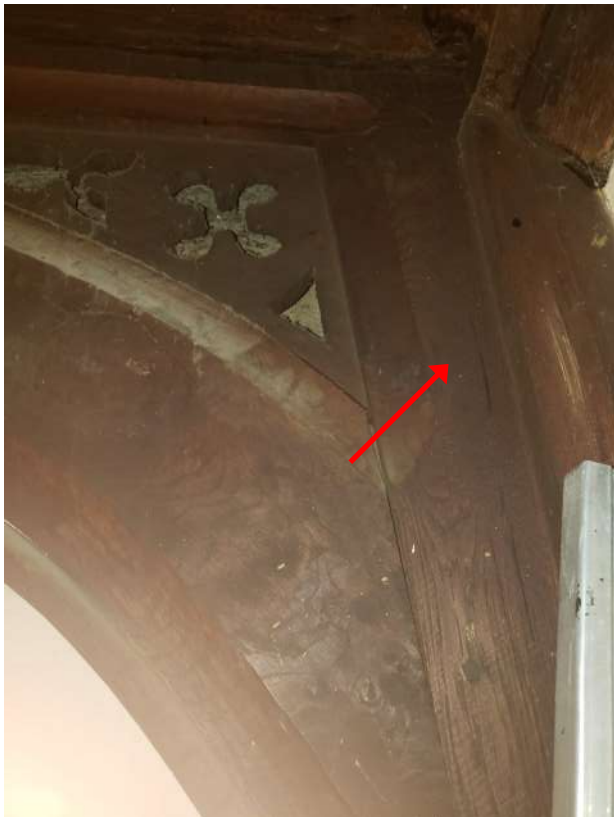
Fig 4:

St Andrew's Hall, internal; showing a focused view of timber truss elements forming the north side of the first truss adjacent to the internal face of the masonry gable wall at the west of the north aisle. Several elements displayed conversion marks indicating they were of contemporary origin

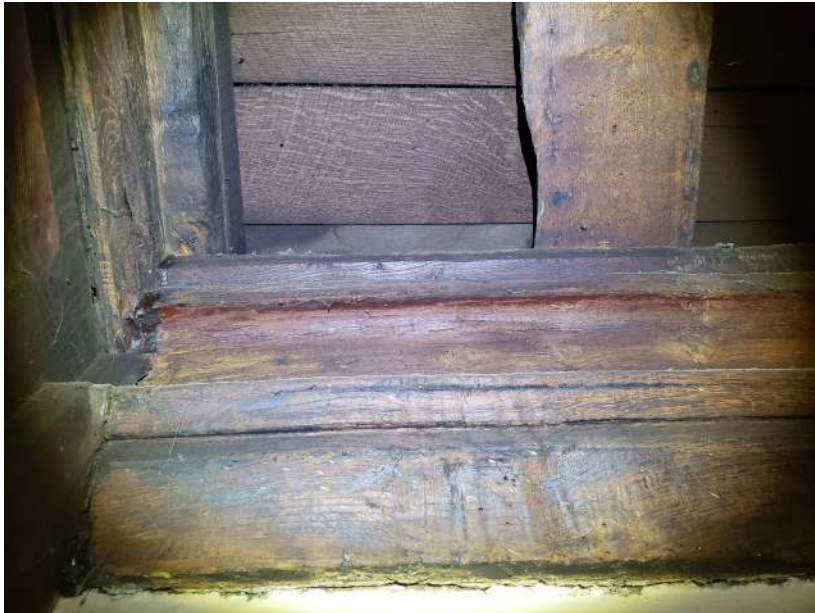
Fig 5:

St Andrew's Hall, internal; showing a focused view of timber components forming the roof structure at eaves level of the north aisle. Note the presence of mechanised conversion marks on the sarking board, indicating the sarking had been relatively recently replaced

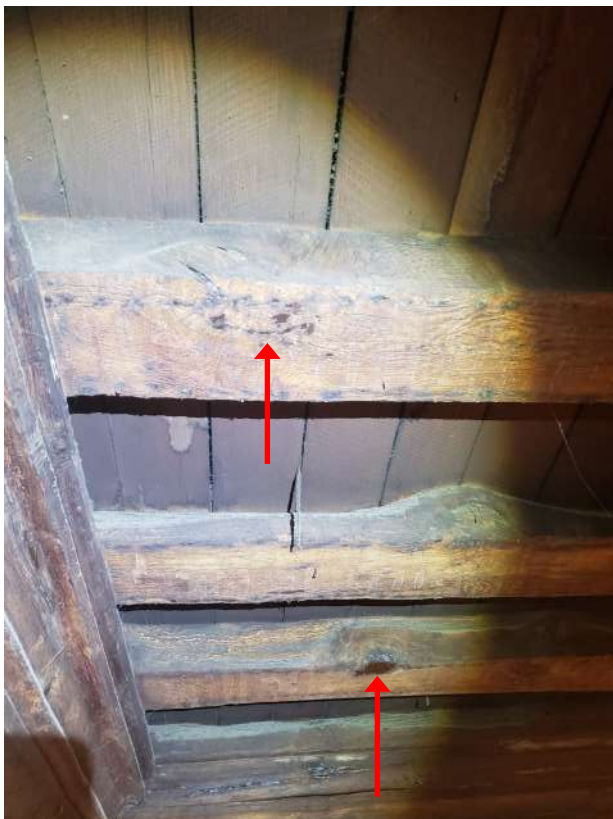
Fig 6:

St Andrew's Hall, internal; showing a focused view of historic common rafters forming the roof structure over the north aisle. Note the use of modern resin 'filler' materials. The use of this was identified throughout the entire roof structure

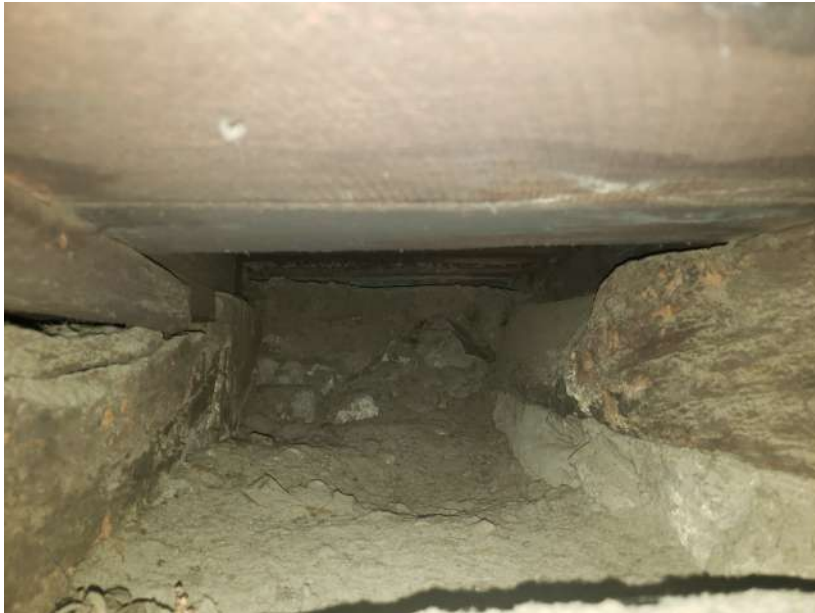
Fig 7:

St Andrew's Hall, internal; showing the condition of the north wall head and eaves of the roof structure over the north aisle. Note masonry had been positioned over and between each pair of rafters likely to provide lateral rigidity, as well as further strength the embedded ends. This prevented access to the feet of the rafters as well as any additional timber elements

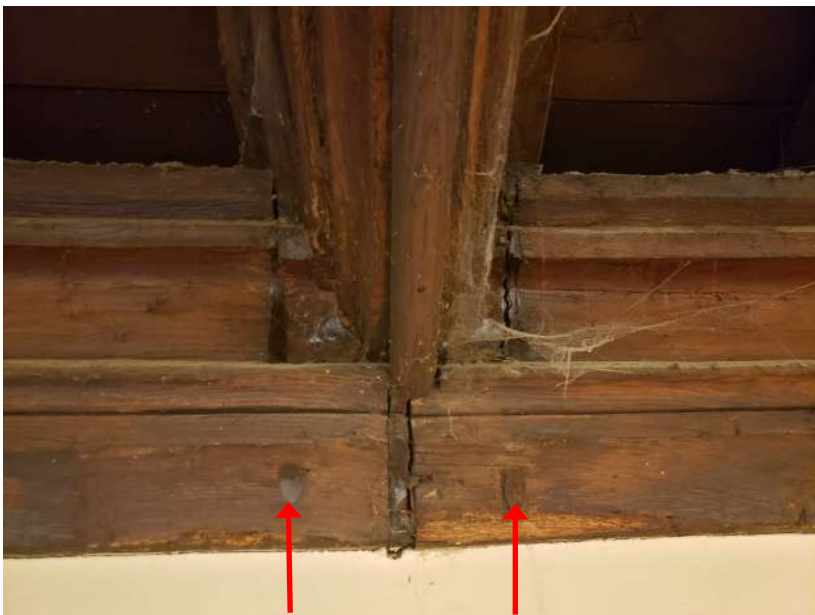
Fig 8:

St Andrew's Hall, internal; showing the typical jointing arrangement of the moulded cornices along the north side of the north aisle. Note 2 no. locations where timber pegs had been used to provide further security to the joint

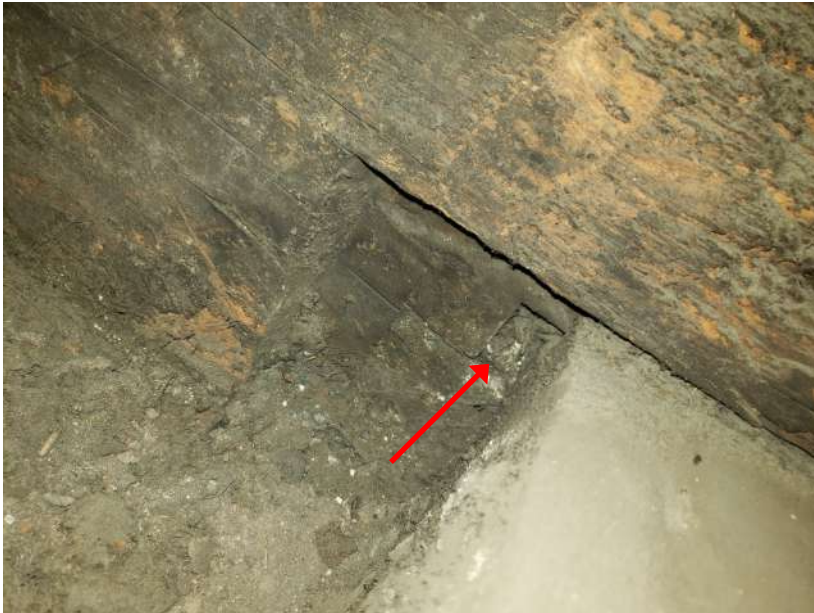
Fig 9:

St Andrew's Hall, internal; showing a focused view of the joint interface between a section of moulded cornice and a principal rafter on the north side of the north aisle. Note the joint type was a housed mortise and tenon

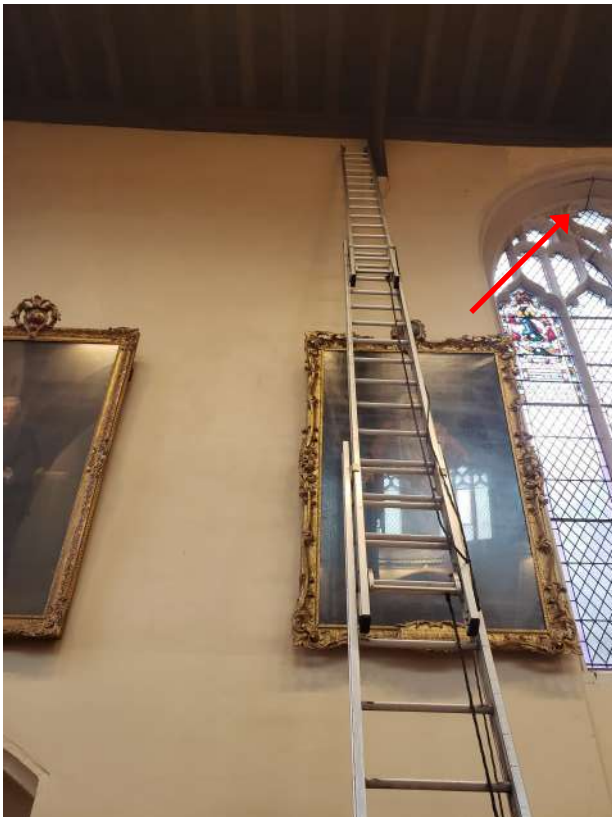
Fig 10:

St Andrew's Hall, internal; fracturing was identified to the centre of the masonry window arch and tracery beneath. This had not visibly affected the structural integrity of the roof at the time of survey

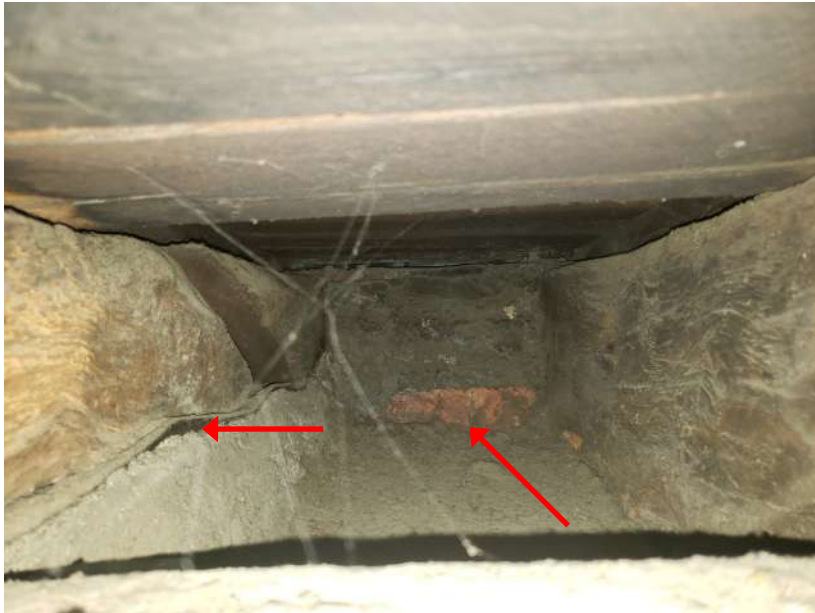
Fig 11:

St Andrew's Hall, internal; showing a build up of masonry atop the wall head on the north side of the north aisle. Note the presence of red brick and a likely cementitious render, indicating that this had been recently laid or added to. Also note the presence of a contemporary damp proof membrane beneath the common rafter, likely installed during previous widespread refurbishments

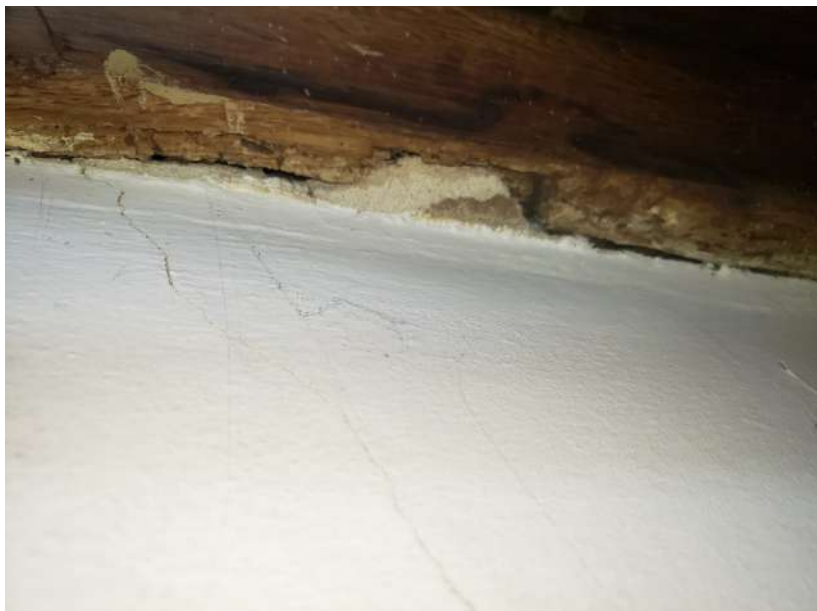
Fig 13:

St Andrew's Hall, internal; showing a section of moulded cornice that displayed evidence of decay by 'wet' rot and wood-boring beetle. Note that moisture levels at the time of survey were below the threshold required for the onset and growth of biological decay organisms, therefore the decay was deemed to be historic and no longer active

No chemical treatment required in relation to fungal decay organisms or wood-boring beetle infestation. Decayed timber should be cut back to sound material and repaired/replaced using timber to match existing. New timber should be fully isolated from damp or potentially damp masonry using a damp-proof material, through-ventilated air gap, or cut back and re-supported on hangers and brackets. All repairs should be directed by the Structural Engineer and in consultation with the Conservation Officer

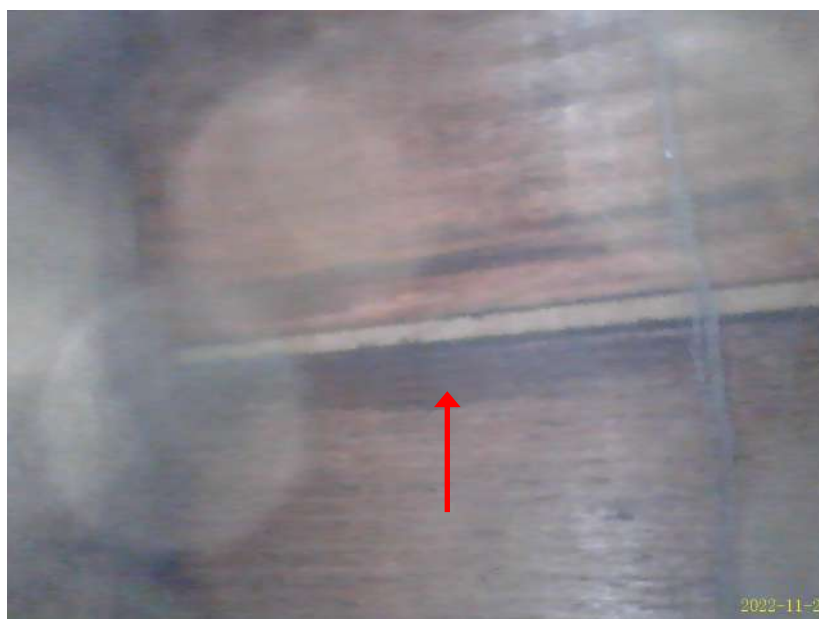
Fig 14:

St Andrew's Hall, internal; showing a videoscope of the type and condition of the materials used to form the subsequent roof layers above the internal hardwood sarking board. Note the sarking board within the void was visually identified as softwood. Also note the presence of localised moisture staining to the edges of the sarking board. This was likely due to a build up of humidity causing interstitial condensation within the roof void

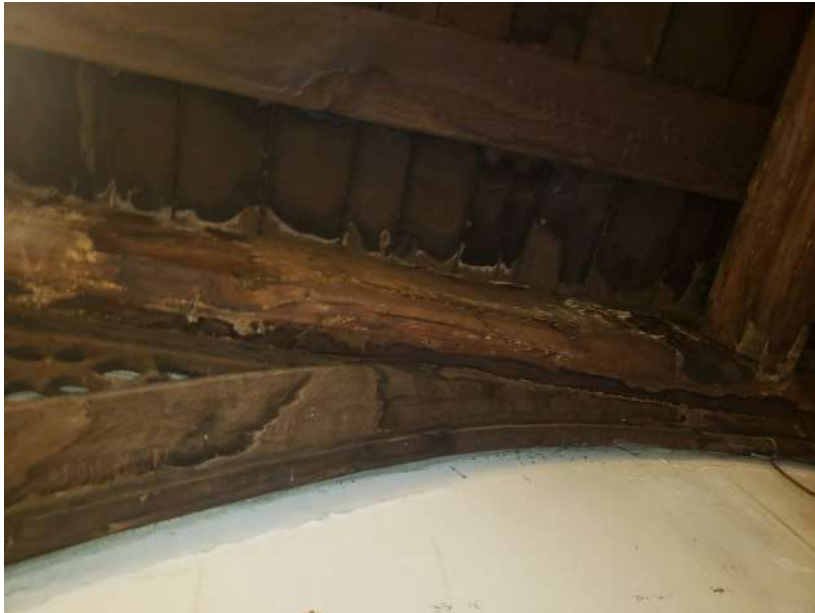
Fig 15:

St Andrew's Hall, internal; showing a principal rafter in close proximity to the masonry gable wall at the east end of the south aisle. Note widespread moisture staining to the timber elements, likely caused by excessive moisture ingress from external sources through the masonry

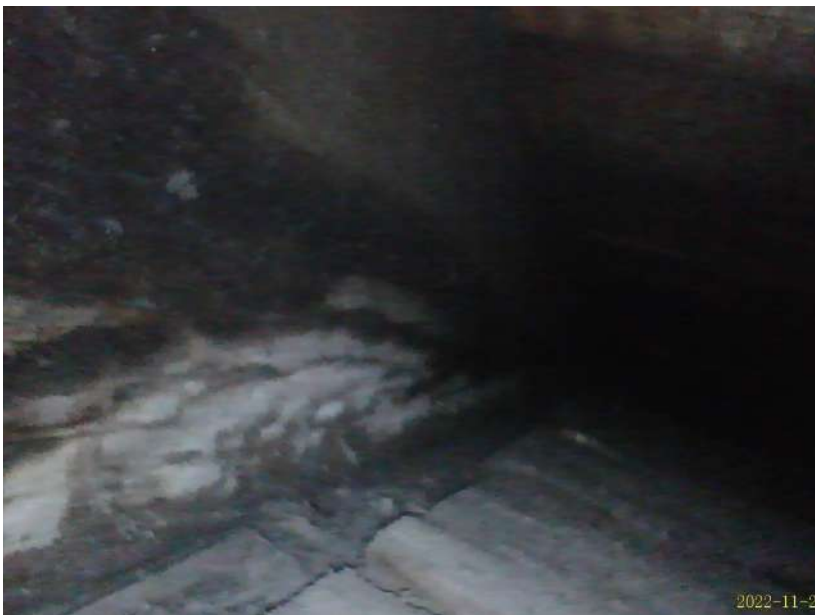
Fig 16:

St Andrew's Hall, south aisle; showing a videoscope image of the principal rafter forming the truss at the east end of the south aisle, pictured in fig. 15 above. Note the further extent of the moisture staining. No decay or mycelial growth was visibly identified at the time of survey

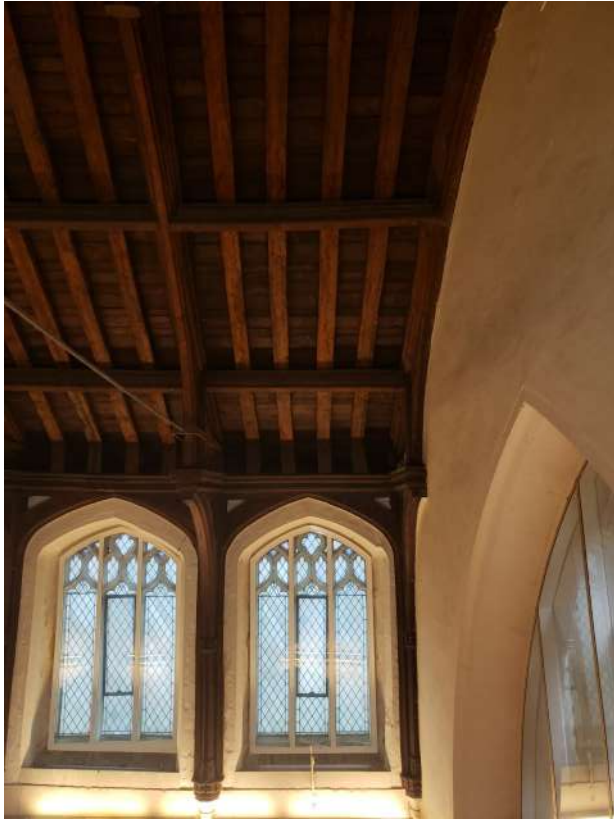
Fig 17:

- Bay 1, nave, north side – partial decay detected affecting the westernmost perpendicular timber sole plate at the bearing end. Localised wet rot and wood-boring beetle decay although moisture content readings too low for further decay to occur

St Andrew's Hall, Nave; showing the structural arrangement of a typical bay within the roof structure of bay 1, at the west end of the hall

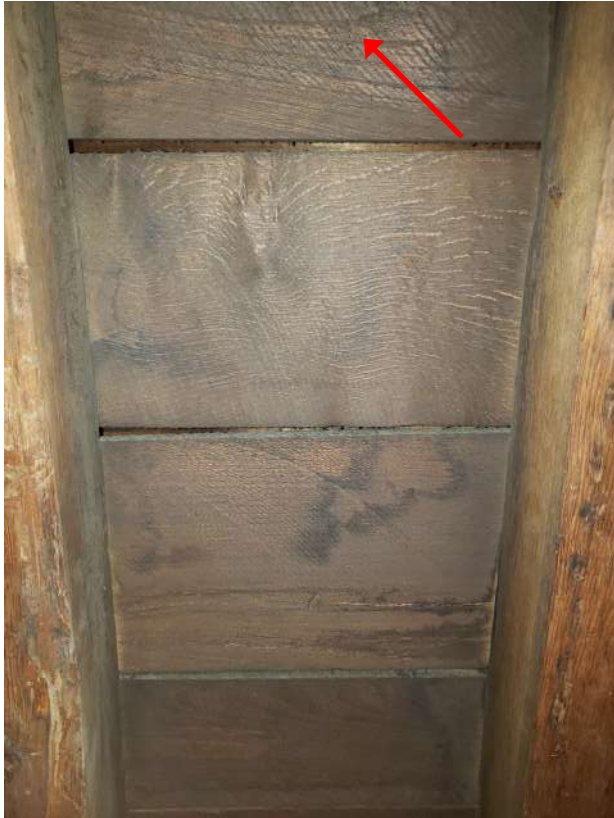
Fig 19:

St Andrew's Hall, Nave; showing a focused view of the hardwood sarking board used throughout the Nave. Note the visible mechanised conversion marks, indicating the sarking board was of contemporary origin

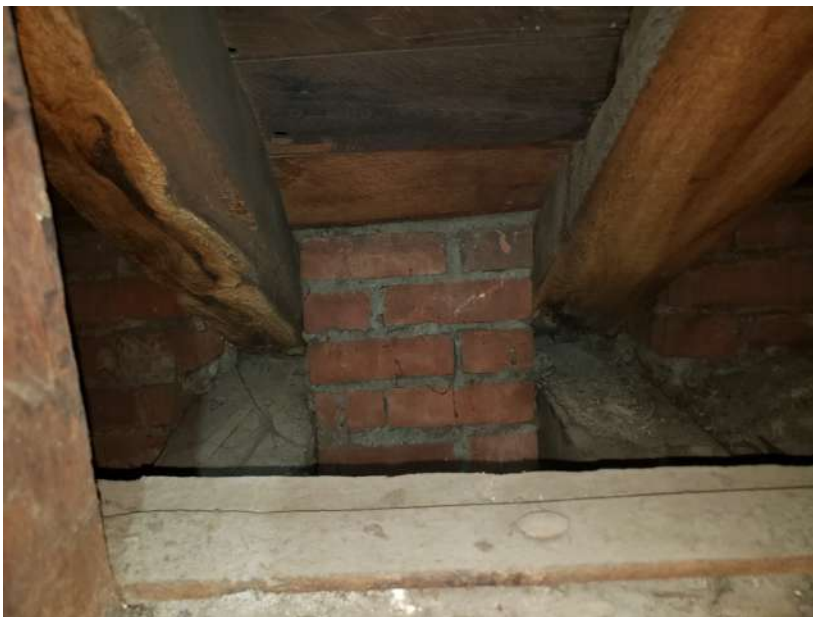
Fig 20:

St Andrew's Hall, Nave; showing the typical construction design of partially embedded bearing ends of common rafters and sole plates within the Nave. Note the use of red brick was considered to possibly be a later addition and the presence of likely cementitious render could prevent the evaporation of moisture trapped in close proximity or contact with the timber elements

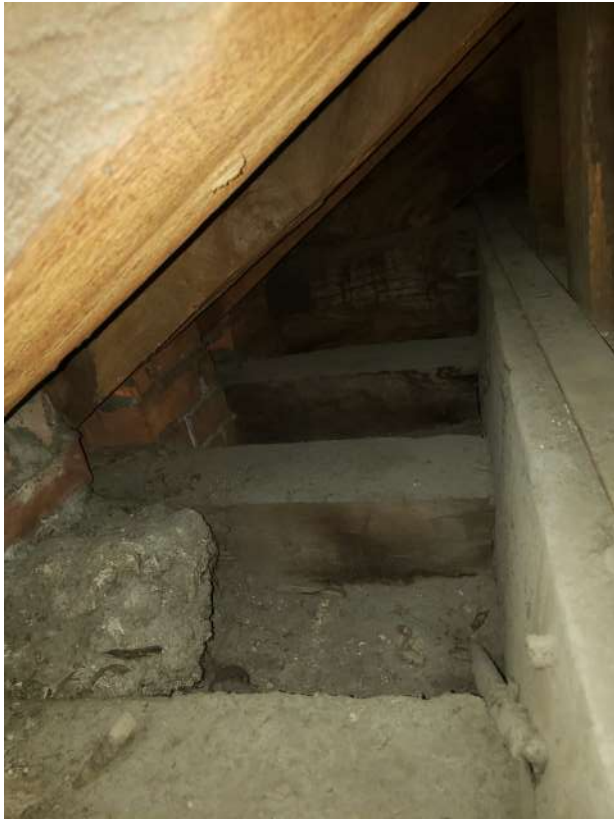
Fig 21:

St Andrew's Hall, Nave; showing a general view of the arrangement and condition of sole plates as well as their connections to the back side of the moulded inner plate within the north side of bay 1. Note the presence of high levels of dust and debris at eaves level, this could present a health hazard to occupants of the building, as well as construction and maintenance personnel carrying out works

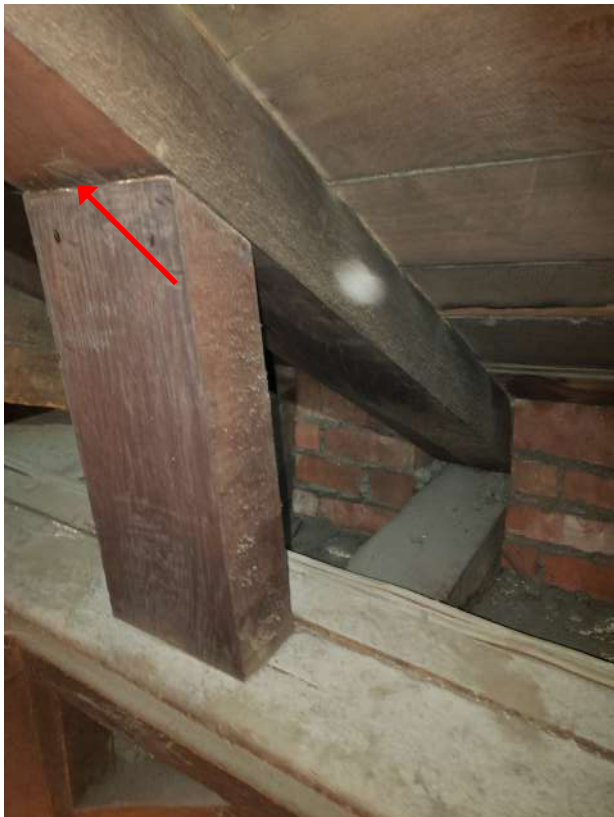
Fig 22:

St Andrew's Hall, Nave; showing the lower section of a common rafter, ashlar and sole plate within the north side of bay 3. Note the presence of an elongated mortise indicated alterations had previously taken place

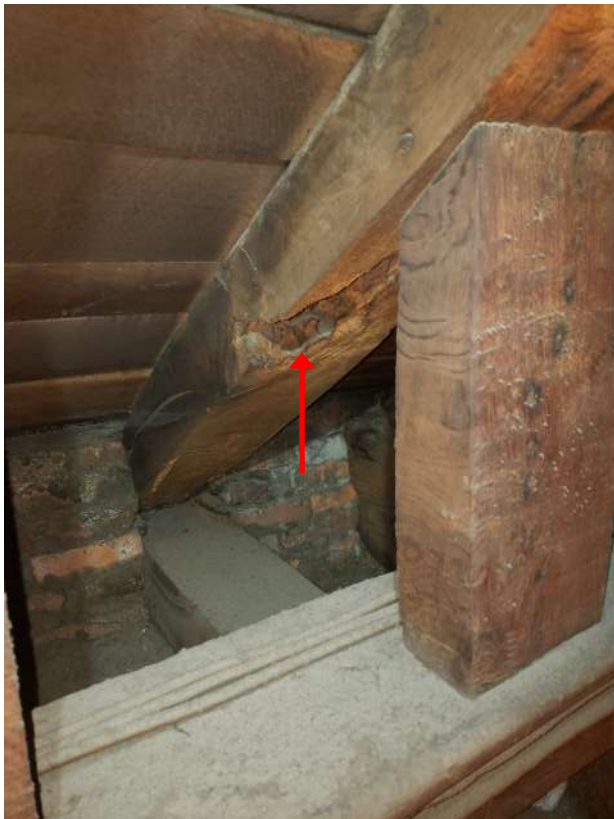
Fig 24:

St Andrew's Hall, Nave; showing a large dead knot located on the underside of the 4th common rafter on the north side of bay 6. Size and position of knot was deemed to likely be a strength reducing characteristic. Structural Engineer to comment

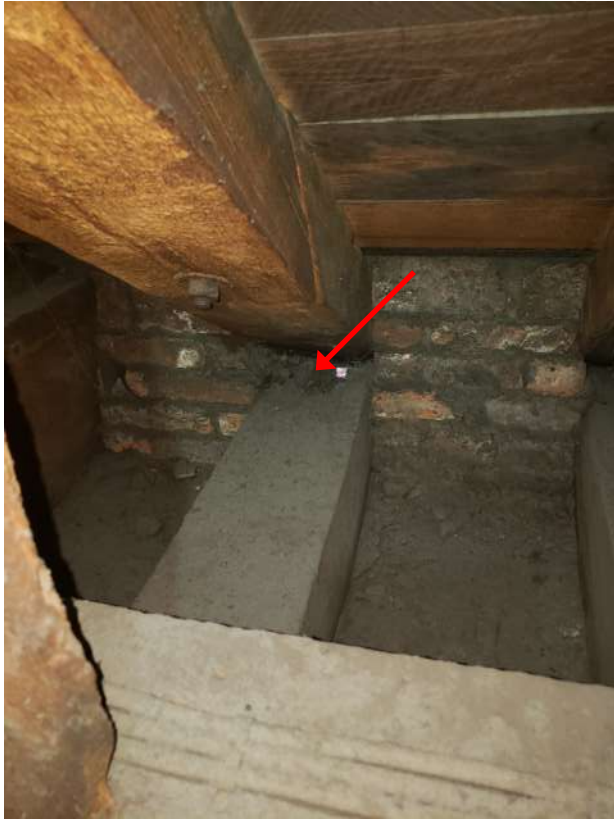
Fig 25:

St Andrew's Hall, Nave; showing a section of decay to the end of partially embedded sole plate on the north side of Bay 6. Moisture readings were below the threshold required for the onset and growth of biological decay organisms, indicating the instance of decay was historic

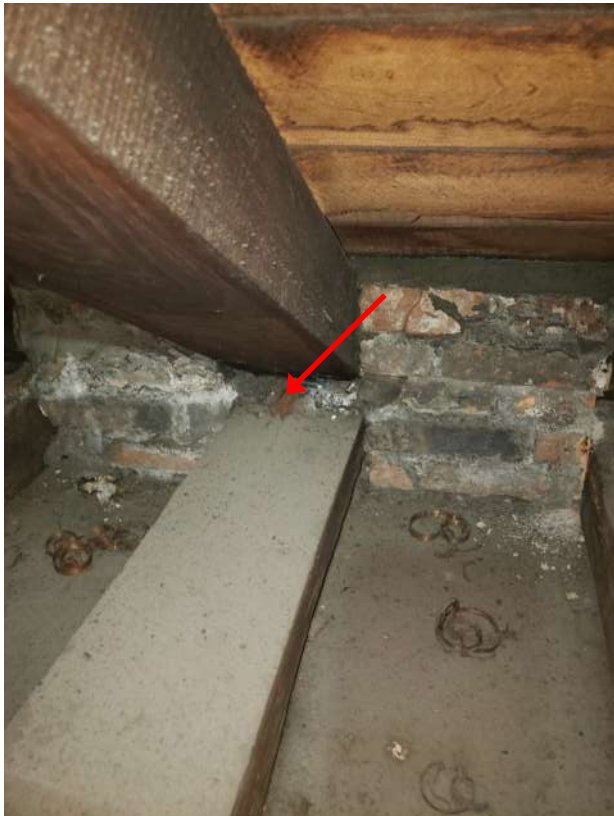
Fig 26:

St Andrew's Hall, Nave; showing a section of partial decay to the end of partially embedded sole plate on the north side of bay 9. Moisture readings were below the threshold required for the onset and growth of biological decay organisms, indicating the instance of decay was historic

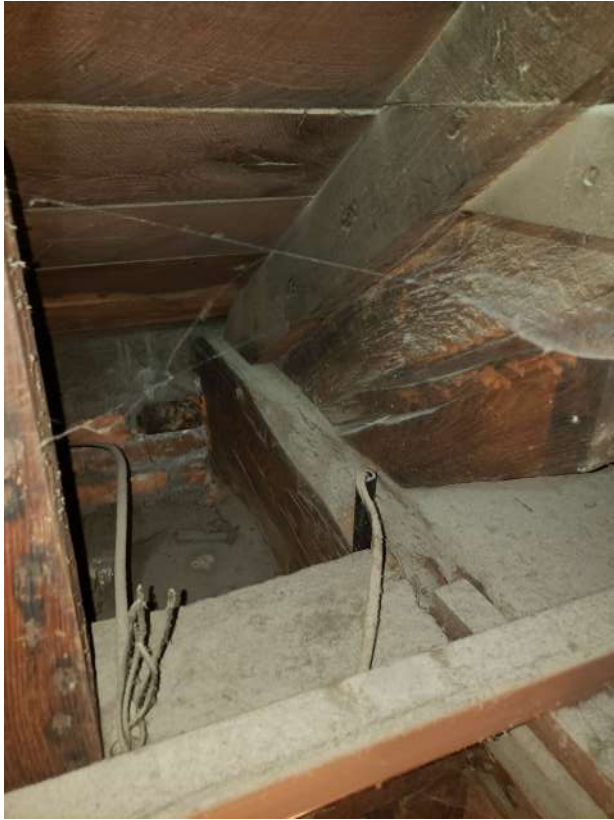
Fig 27:

St Andrew's Hall, Nave; showing the general condition and structural arrangement of timber elements on the south side of bay 9. Note the embedded end of the hammer beam underwent decay detection drilling. No decay was identified at the time of survey

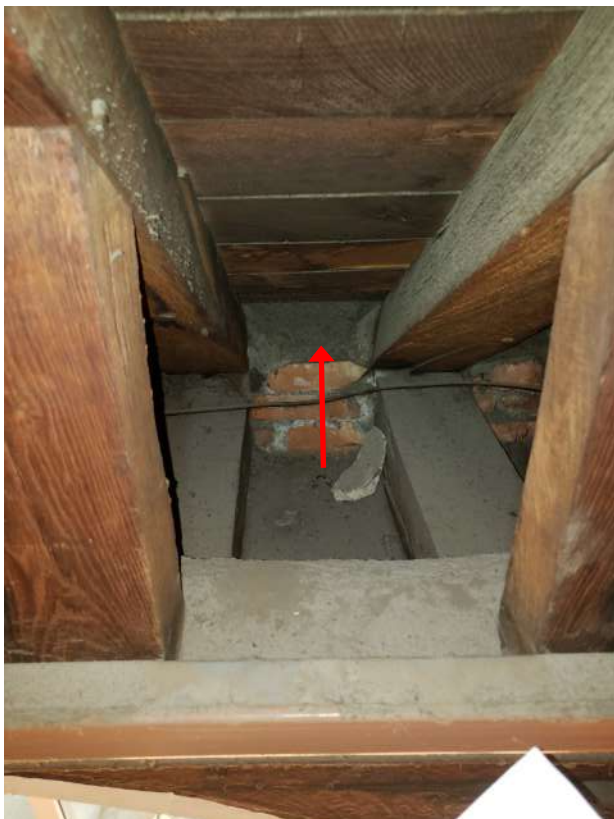
Fig 28:

St Andrew's Hall, Nave; showing a further image of the general condition and structural arrangement of timber elements on the south side of bay 9. Note no decay was detected upon investigation, however contemporary cementitious materials had been used to encapsulate the feet of the rafters which could prevent the evaporation of any trapped moisture, increasing the likelihood of the onset of biological decay organisms

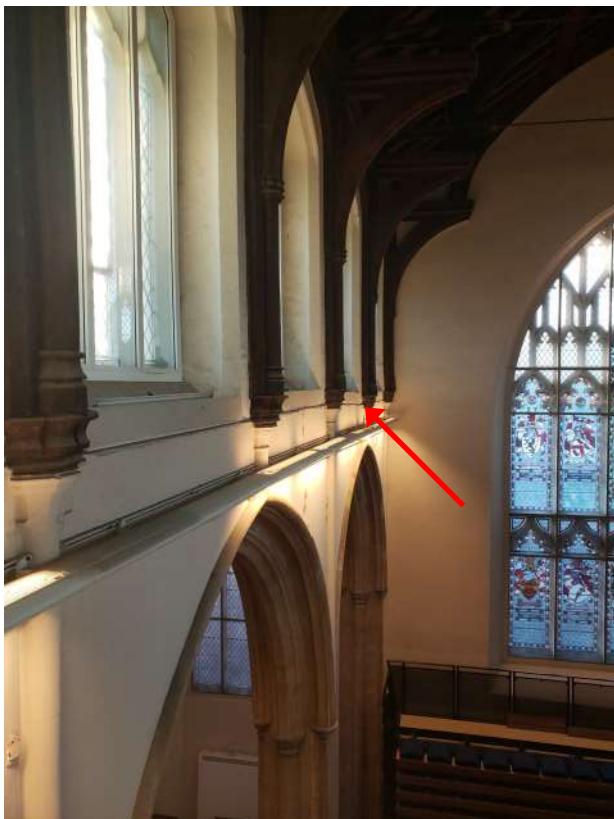
Fig 30:

St Andrew's Hall, Nave; showing a general image depicting the extent deflection to masonry forming the aisle, on the south side, at the west end. This deflection had not appeared to have caused any critical damaged to the timber roof structure above
