The Halls – Works Required Revision B

The Halls, St Andrews Plain, Norwich NR3 1AU

22.67 REV B

Building Survey / Feasibility

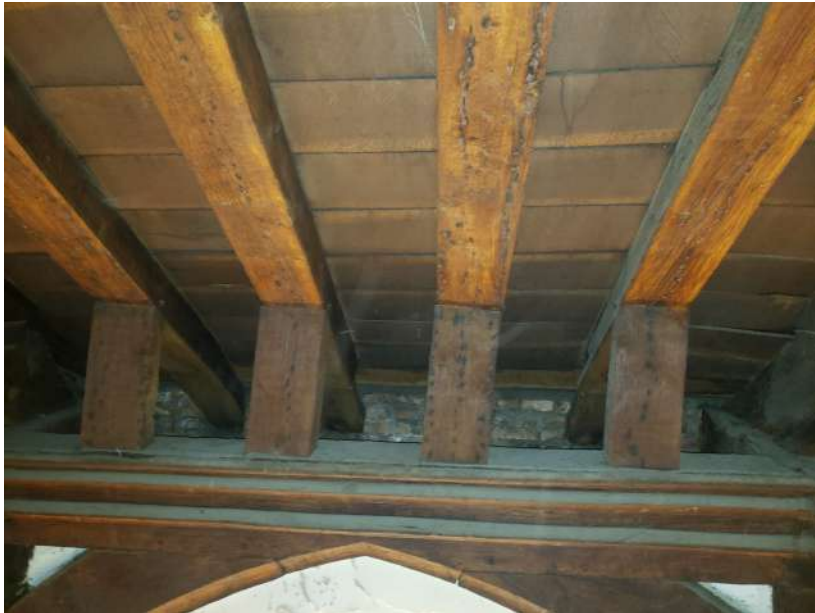
Fig 31:

St Andrew's Hall, Nave; showing a series of common rafters on the south side of bay 5 that display significant racking westward. Investigations did not identify any further issues and the common rafters appeared to be structurally sound at the time of survey

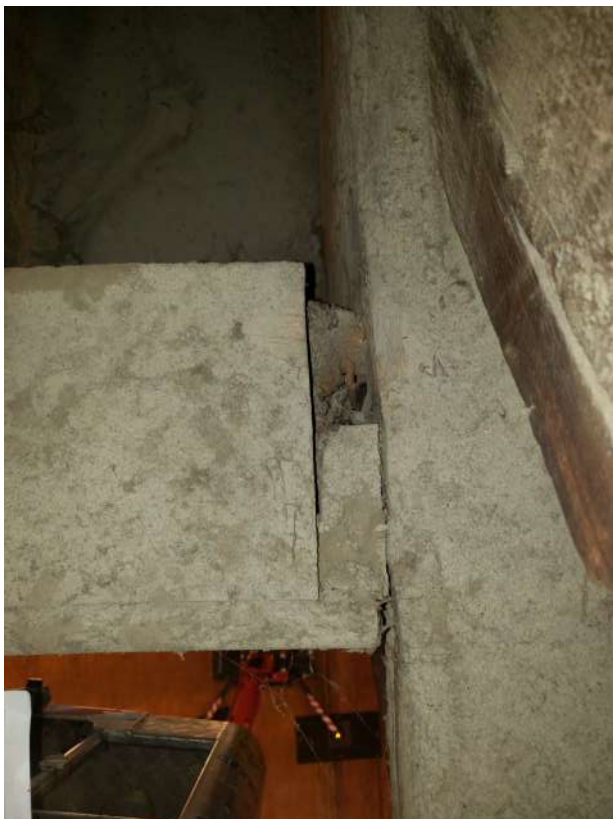
Fig 32:

St Andrew's Hall, Nave; showing a focused view of the west end of the moulded cornice on the south side of bay 5. Note the joint had separated ~45mm and the tenon appeared to have been decayed. Joint should likely undergo further strengthening using contemporary mechanical fixings

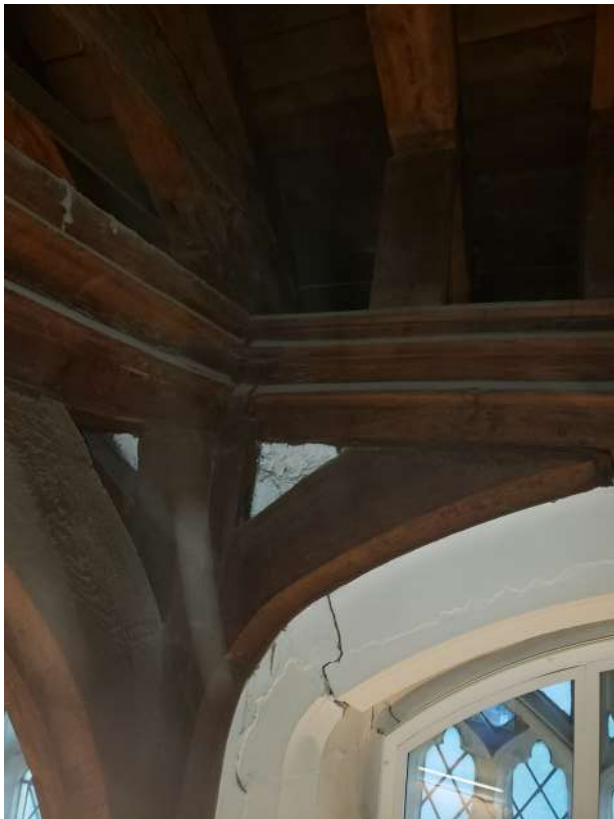
Fig 34:

St Andrew's Hall, Nave; showing fracturing to the masonry window arch beneath the timber roof structure on the south side of bay 5. Further investigations deduced that this had led to partial joint separation in certain areas, however no areas of significant concern were identified

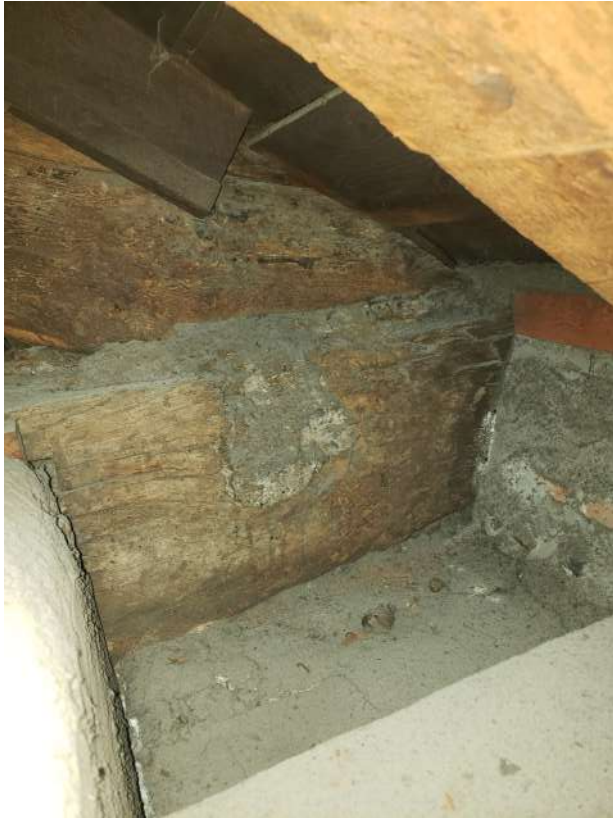
Fig 35:

St Andrew's Hall, Nave; showing the embedded bearing end of the hammer beam on the south side of bay 3 and the joint interface between the principal rafter and hammer beam. Note a large pocket of historic decay had been filled with a likely cementitious material. Further decay detection drilling ascertained the presence of further cavities in close proximity to the mass of cementitious material. The overall area of decay throughout the section of the hammerbeam meant that it was considered to be structural. Moisture readings were below the threshold for the onset and growth of biological decay organisms, therefore the decay was considered to be historic. Structural Engineer to comment

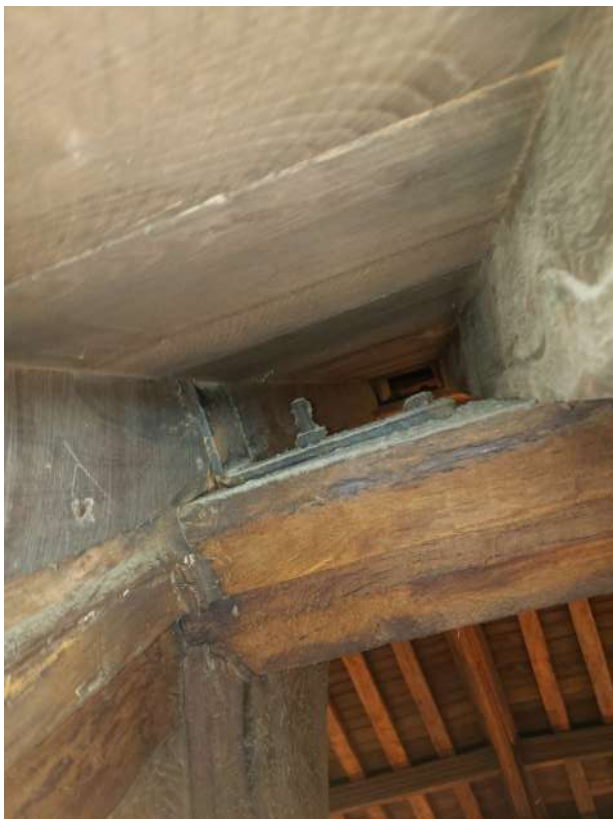
Fig 36:

St Andrew's Hall, Nave; showing a focused view of a contemporary metal 'L' bracket used to strengthen a joint between a purlin and principal rafter on the south side of bay 3. Note that the widespread use of contemporary metalwork had likely been installed during recent, previous phases of refurbishment to the roof structure

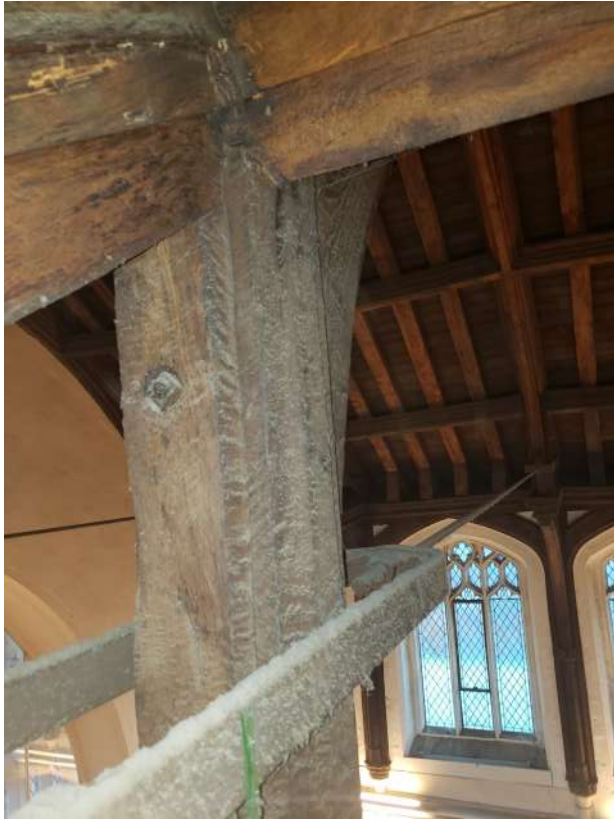
Fig 37:

St Andrew's Hall, Nave; showing a general view of the condition and type of contemporary metal tie bar used throughout the Nave roof

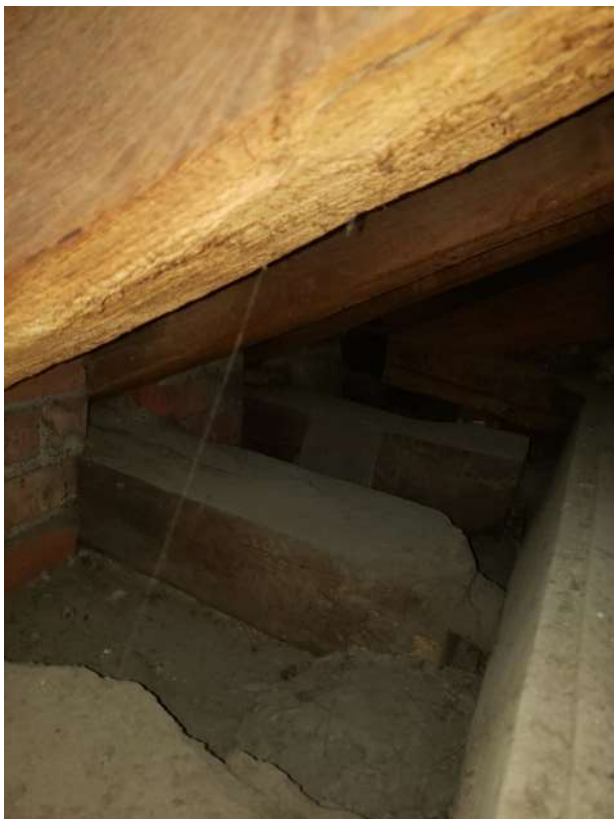
Fig 38:

St Andrew's Hall, Nave; showing a focused view of a sapwood band to the underside of a common rafter that had been historically decayed by a 'wet' rot fungal organism. Localised areas of historic decay to the sapwood on structural elements was seen throughout the roof structure. Moisture readings were below the threshold for the onset and growth of biological decay organisms

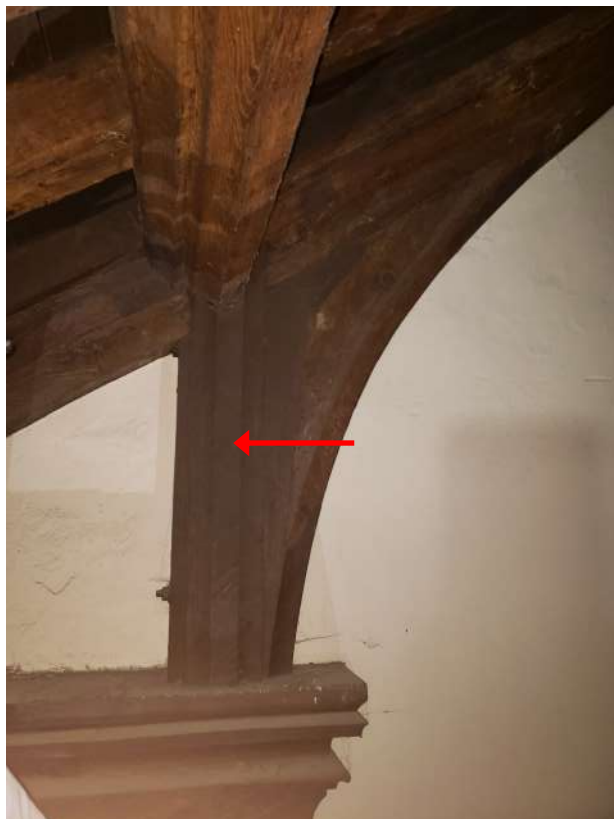
Fig 40:

St Andrew's Hall, Nave; showing truss elements on the south side of bay 1. Note the hammer post and other elements appeared to be of recent origin, possibly replaced during refurbishment works to the roof structure, or after the rebuilding of the west gable wall which likely happened during the 19th century

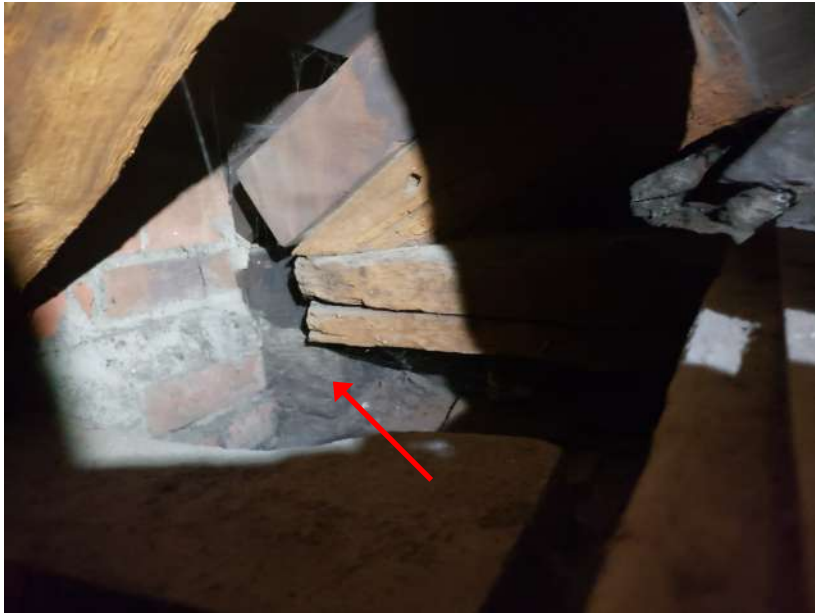
Fig 41:

St Andrew's Hall, Nave; showing a docked structural element, possibly a hammer beam on the south side of bay 1. Condition and quality of subsequent structural elements could only be partially inspected due to limited access. The use and quality of any mechanical fixings could not be ascertained at the time of survey

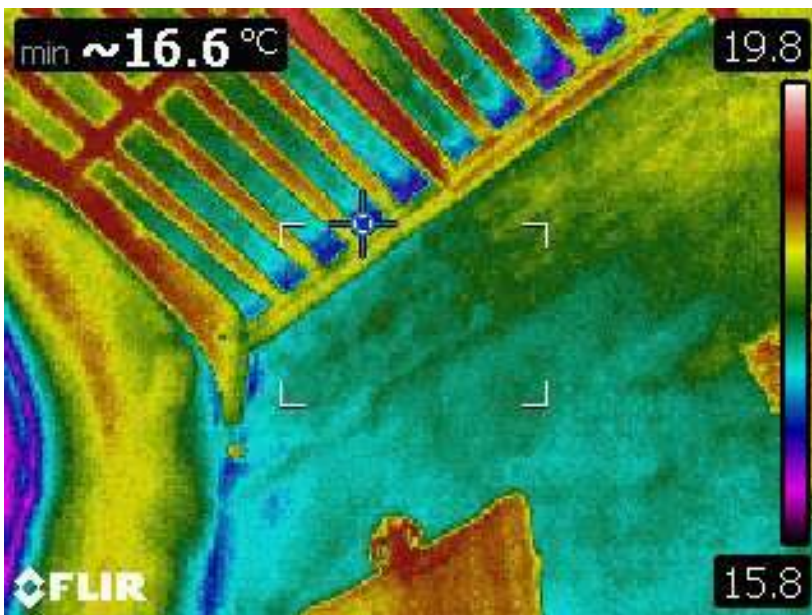
Fig 42:

St Andrew's, north aisle, west end; showing thermal image and slight indications of temperature differential at roof level, although no direct evidence of water penetration in this location

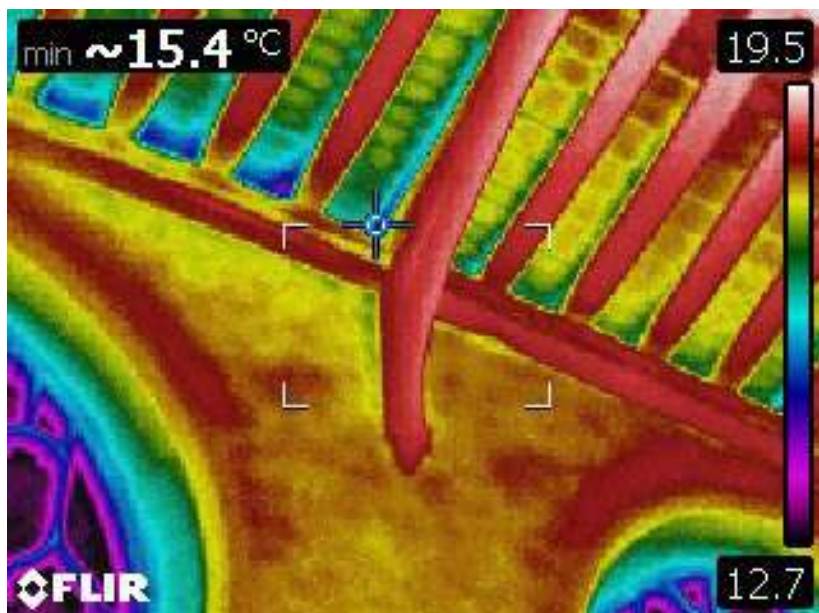
Fig 43:

St Andrew's, north aisle; showing thermal image and no suggestion of ongoing issues with water penetration that would result in temperature differential in masonry masses at high level

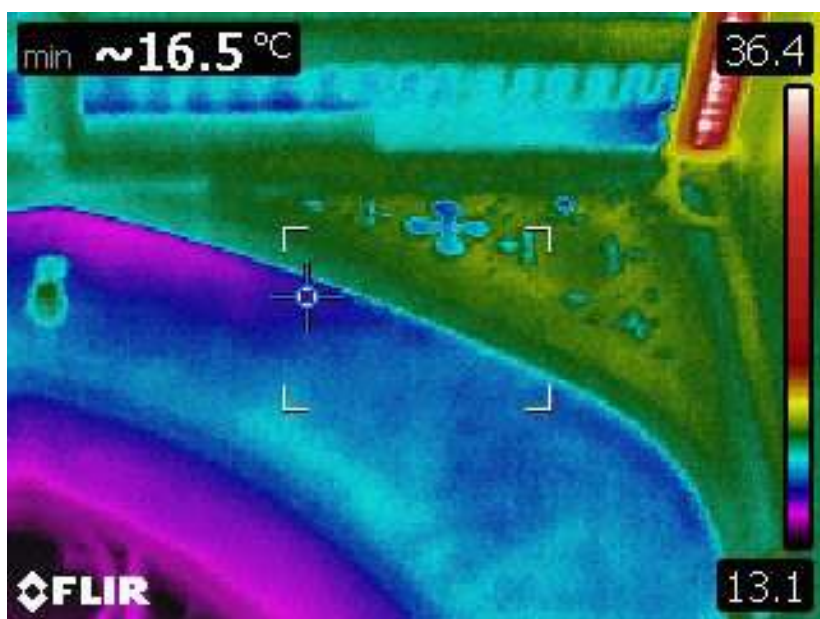
Fig 44:

St Andrew's, north aisle, east end; showing thermal image at extreme east end. Temperature differential well within 'normal' parameters

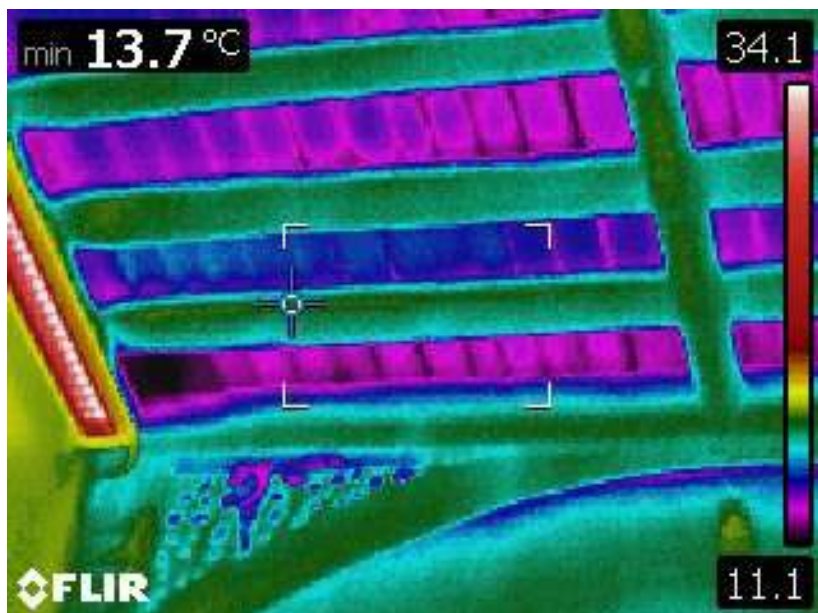
Fig 45:

St Andrew's, south aisle, east end; showing location of previously recorded suspicions of dry rot (*Serpula lacrymans*). Thermal imagery did not indicate issues with water penetration despite defects noted to roof finishes above

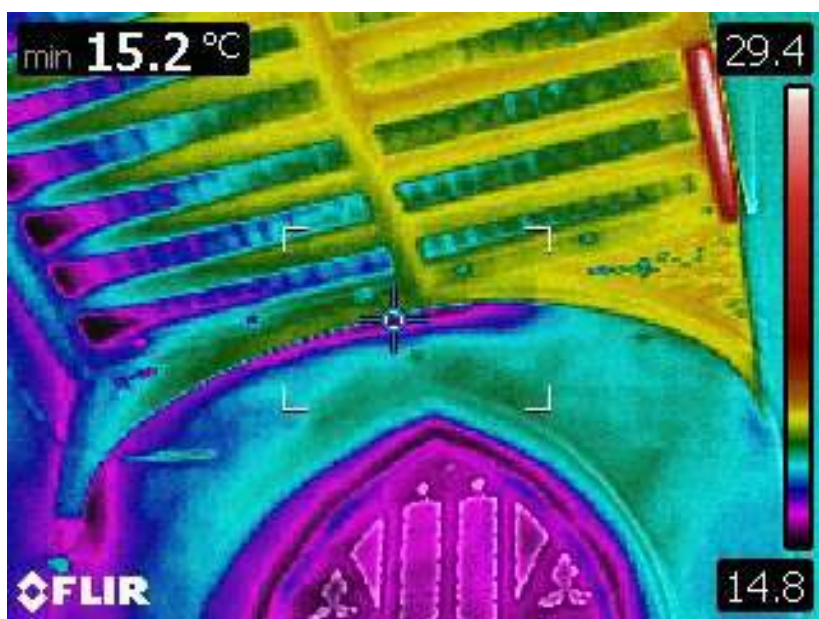
Fig 46:

St Andrew's, south aisle, east end; showing location of previously recorded suspicions of dry rot (*Serpula lacrymans*). Thermal imagery did not indicate issues with water penetration despite defects noted to roof finishes above

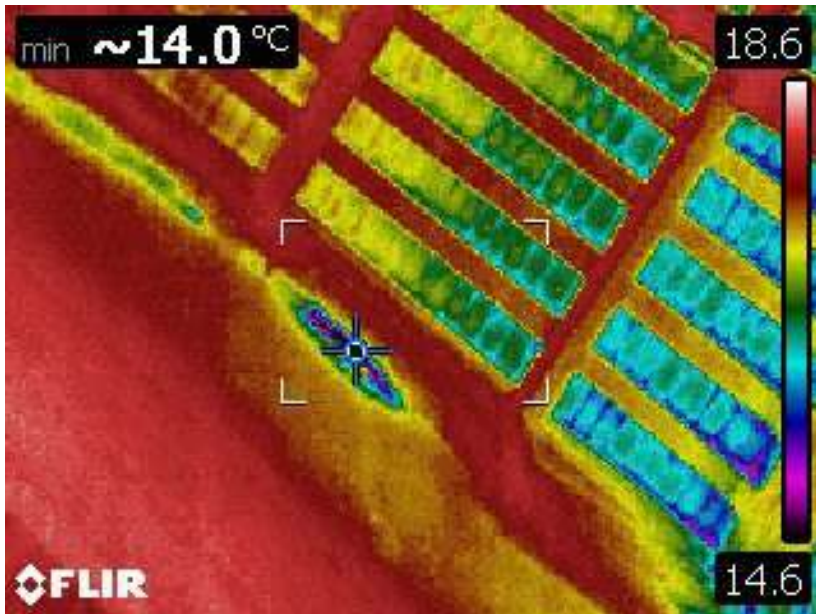
Fig 47:

Nave, east end, showing thermal image of area of potential dampness directly above organ. No evidence of water penetration on coverings below, and patch may be a result of hygroscopic salt efflorescence from historic water penetration causing plaster to fail locally

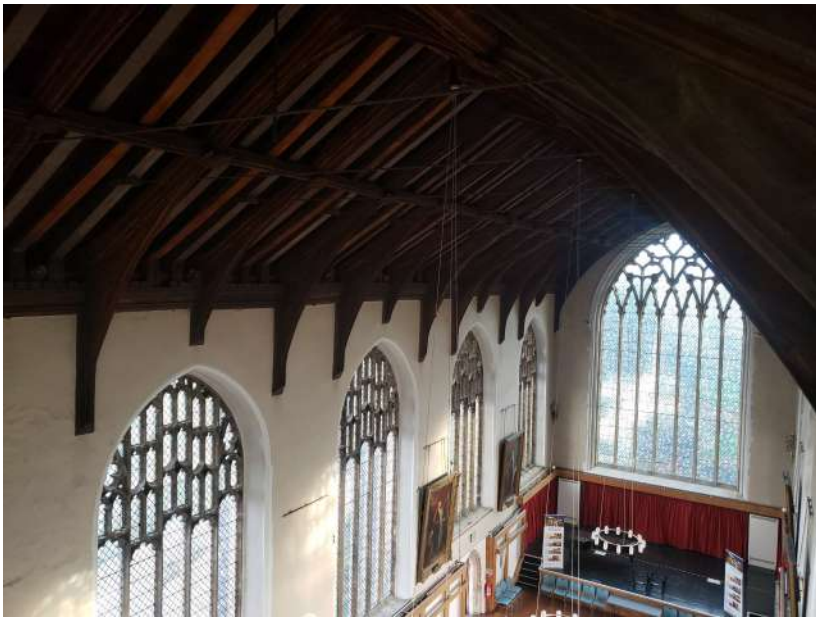
Fig 48:

Blackfriars' hall, bay 1; showing the general condition and structural arrangement of the roof structure, looking east

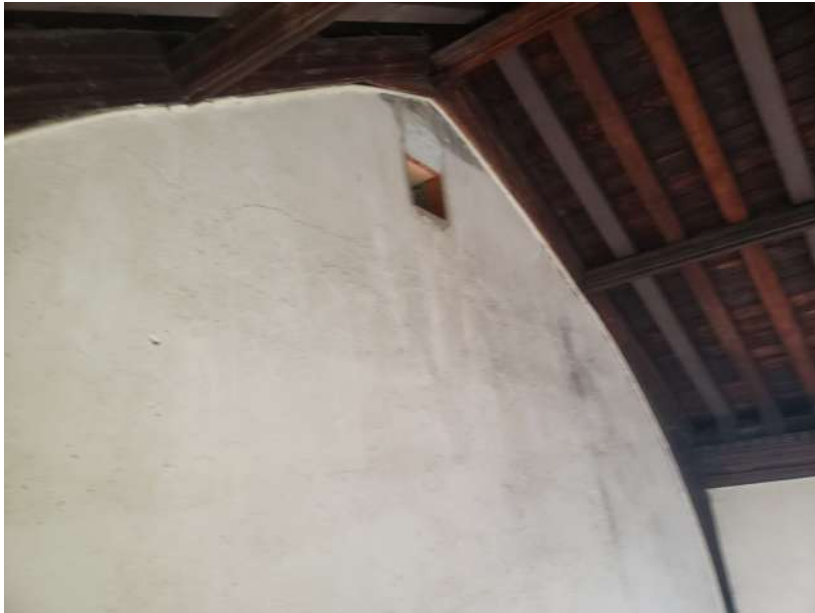
Fig 49:

Blackfriars', bay 1; showing the general condition and structural arrangement of truss no. 1, which was abutted against the west internal gable wall. Historic moisture staining to the wall was identified, however drill probing and investigations of the condition of the timber indicated only minor decay to structural elements at the time of survey. Moisture readings were below the threshold for the onset and growth of biological decay organisms

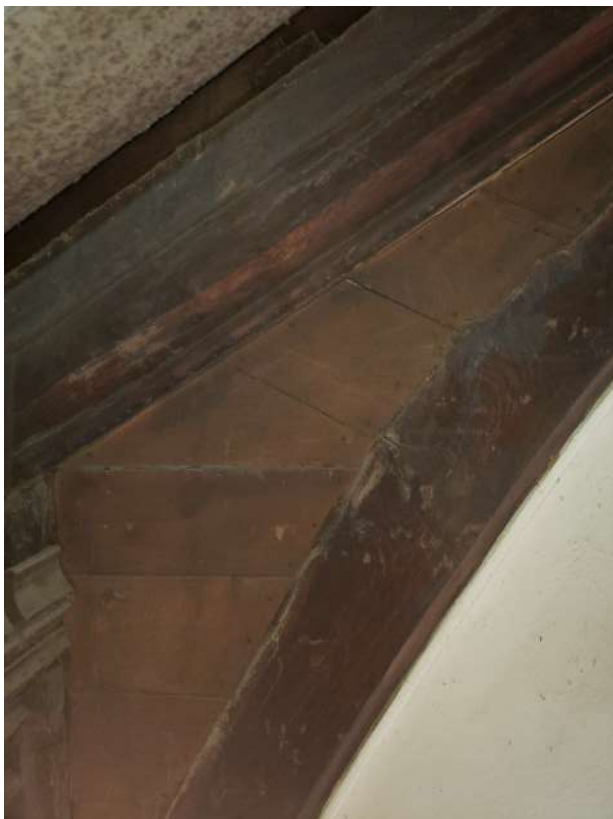
Fig 50:

Blackfriars', bay 1; showing what appeared to be replacement sections of boarding within the cavity between the brace, principal rafter and truss post on the south side. These were seen to be of contemporary origin due to the mechanised conversion marks on their surface

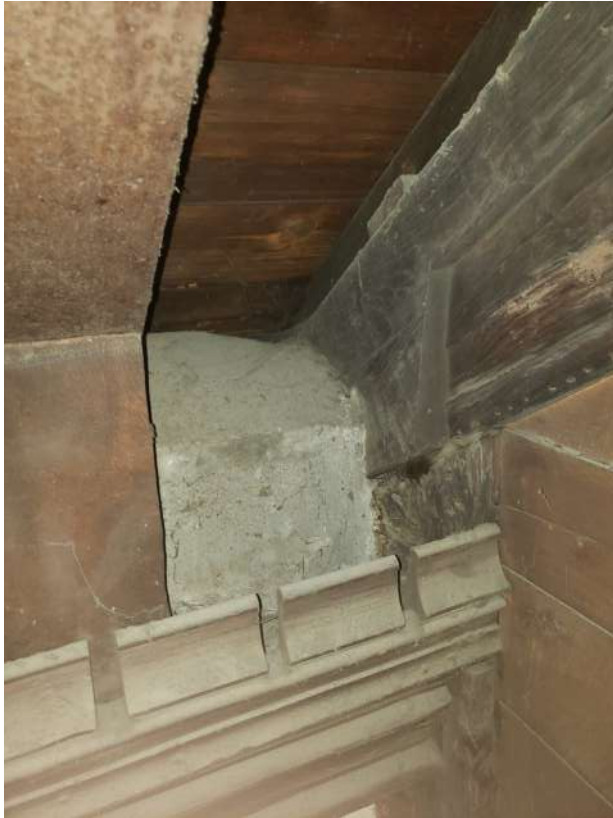
Fig 51:

Blackfriars', bay 1; showing the presence of contemporary cementitious material atop the wall head, encapsulating the feet of rafter elements on the south side. This contemporary addition was noted on both sides of the hall throughout it's length. The presence of cementitious materials would likely trap moisture in close proximity or contact with vulnerable timber elements, as well as hinder the ability for repairs to take place

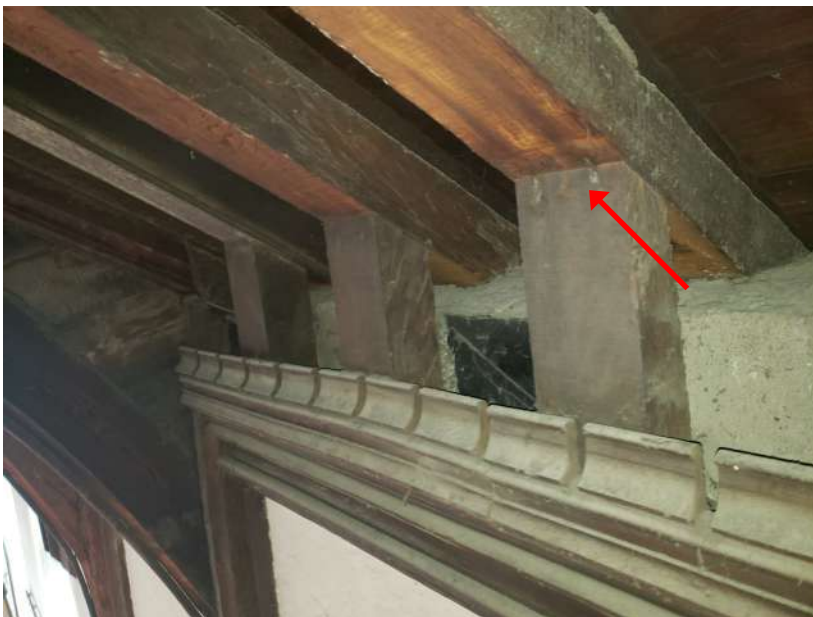
Fig 52:

Blackfriars', bay 1; showing the further condition and structural arrangement of common rafters at this location. Note the ashlar had been secured at their top mitred butt joints to timber common rafters using metal mechanical fixings

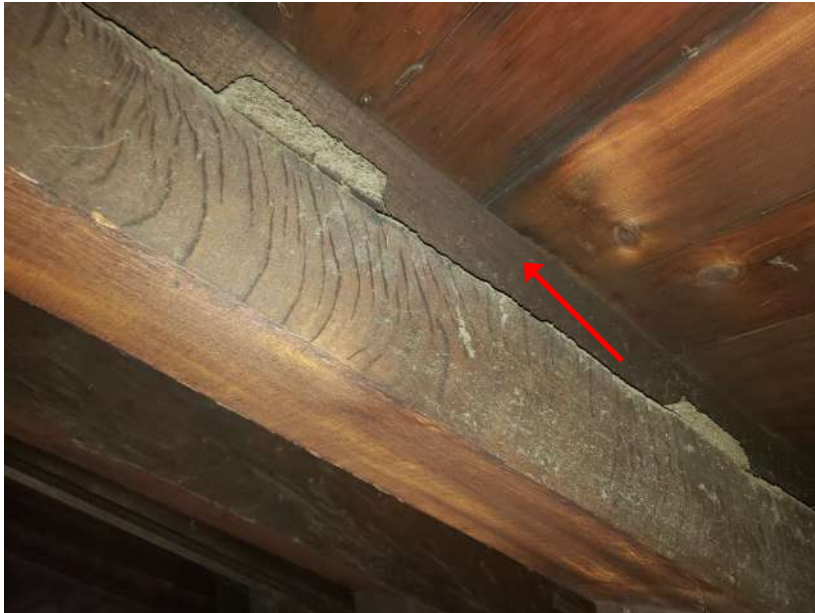
Fig 53:

Blackfriars', bay 1; showing the presence of a contemporary softwood timber batten positioned atop packers, on the upper face of a common rafter. This had been used to fractionally raise the height of the roof so that it was in line with the contemporary steel common rafters. This detail was seen throughout the entire roof structure

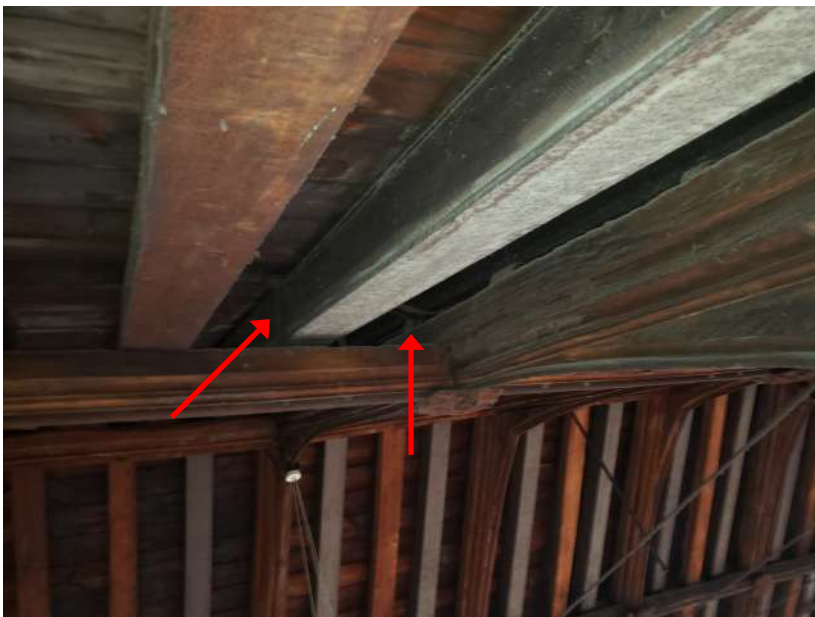
Fig 54:

Blackfriars', bay 1; showing a contemporary common rafter that was formed of a steel 'I'-beam and the metalwork connecting it to the adjacent historic principal rafter and purlin. Again this detail was seen throughout the roof structure

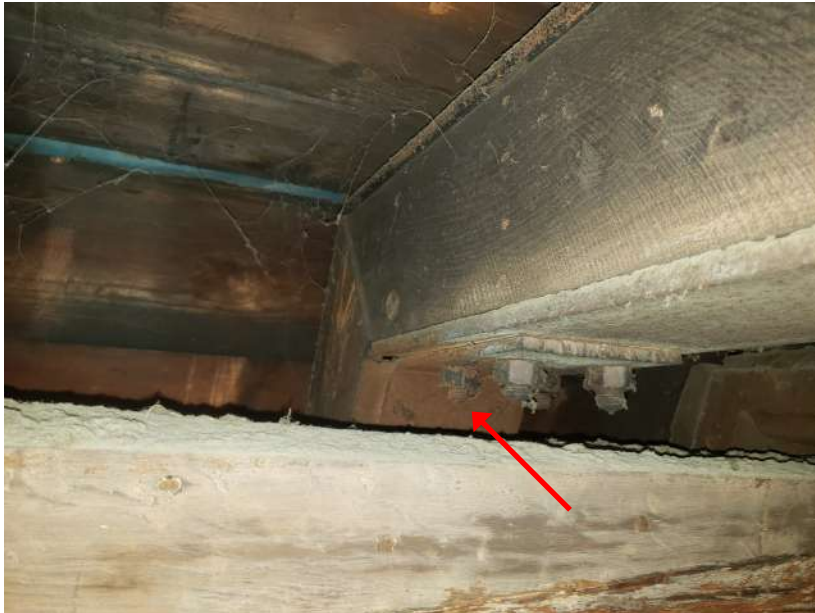
Fig 55:

Blackfriars', bay 1; showing the connection detail at the apex between two contemporary steel common rafters

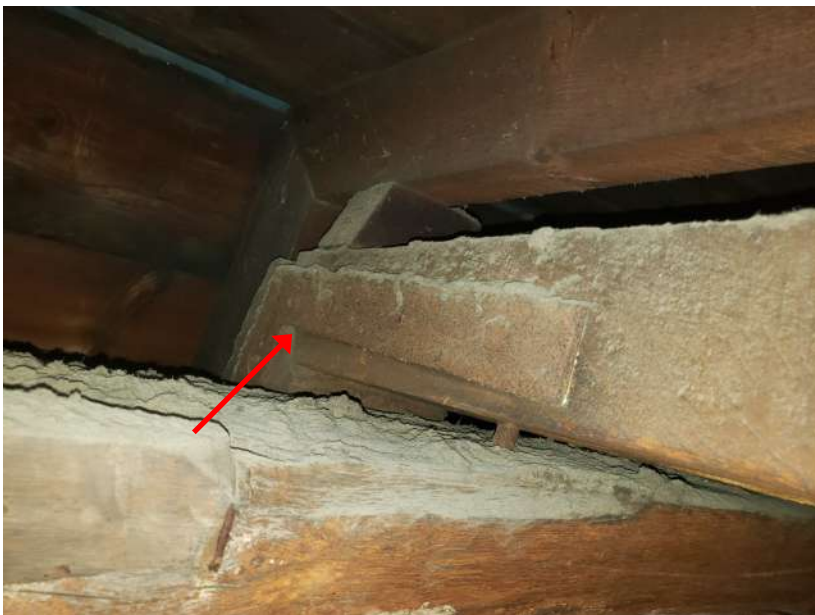
Fig 56:

Blackfriars', bay 1; showing the connection detail at the apex between two historic common rafters. Note the surface corrosion to the ferrous metal strap suggests that there were fluctuating levels of high humidity within the hall

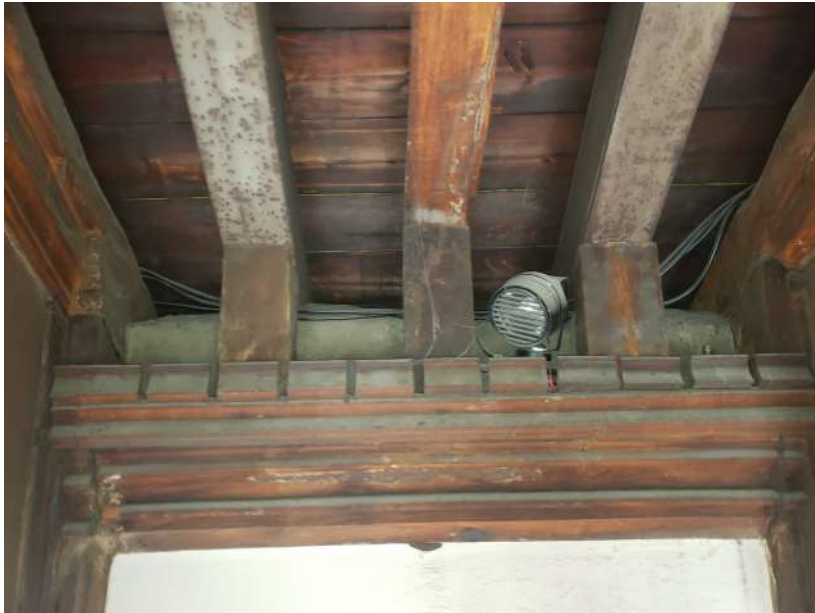
Fig 57:

Blackfriars', bay 3; showing the general condition and arrangement of structural roof members on the north side. Note the use of softwood sarking board, likely installed during recent refurbishment works

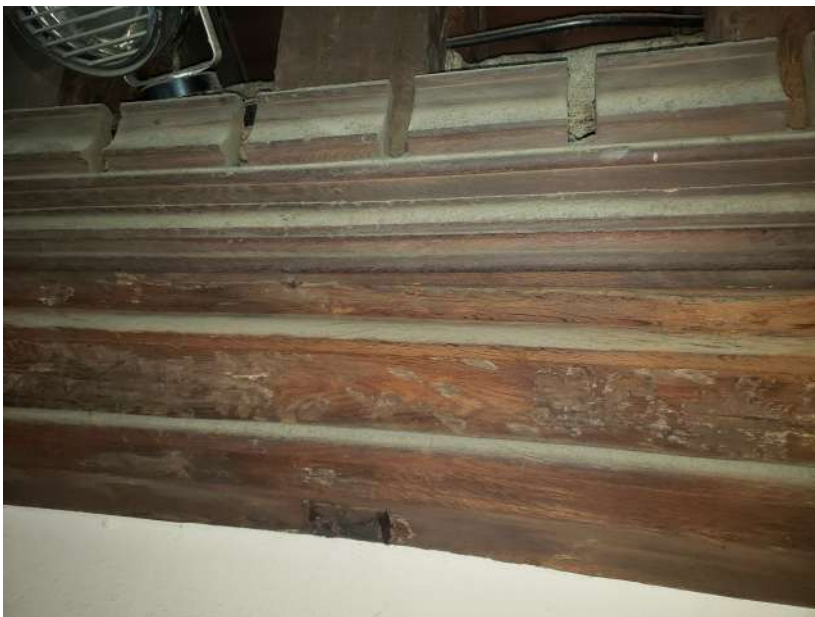
Fig 59:

Blackfriars', bay 3; showing partial separation of the moulded cornice/inner plate on the north side. This was not deemed to be critical. Also note the presence of frass beneath the joint, moisture readings taken at the time of survey indicated levels were below the threshold for the onset and growth of biological decay organisms

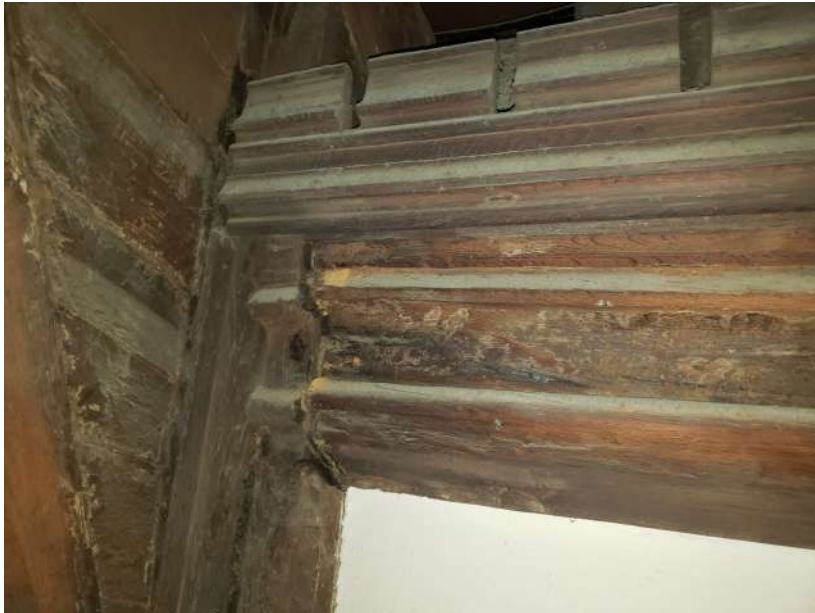
Fig 61:

Blackfriars', bay 3; showing the east end of the moulded cornice/plate on the south side, which was found to be partially decayed due to 'wet' rot and Death watch beetle (*Xestobium rufovillosum*). Moisture readings were below the threshold for the onset and growth of biological decay organisms, indicating that the decay was likely historic and no longer active

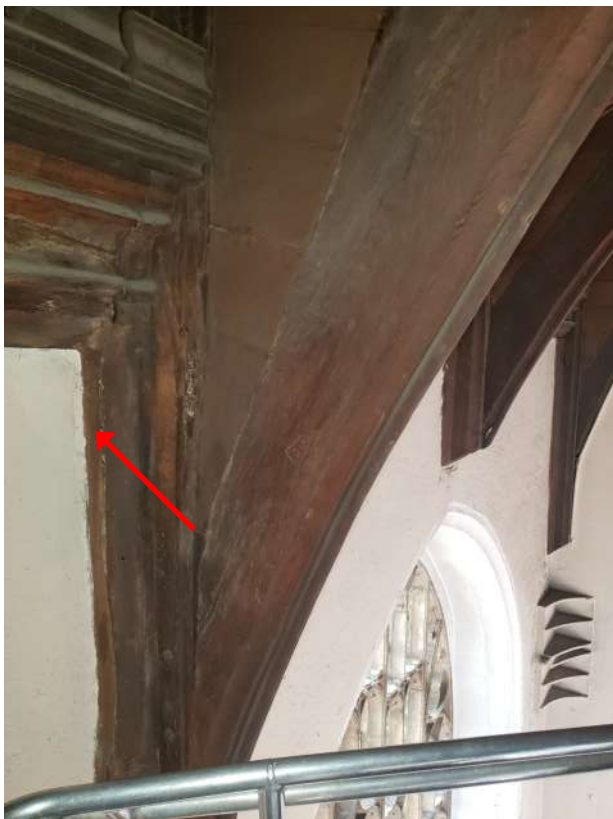
Fig 62:

Blackfriars', bay 3; showing the further use of a cementitious materials as a 'filler' between the historic timber truss post and the internal face of the masonry, on the south side. The use of such materials could prevent the evaporation of any trapped moisture, accelerating the onset and growth of biological decay organisms that would lead to decay of the structural timber component

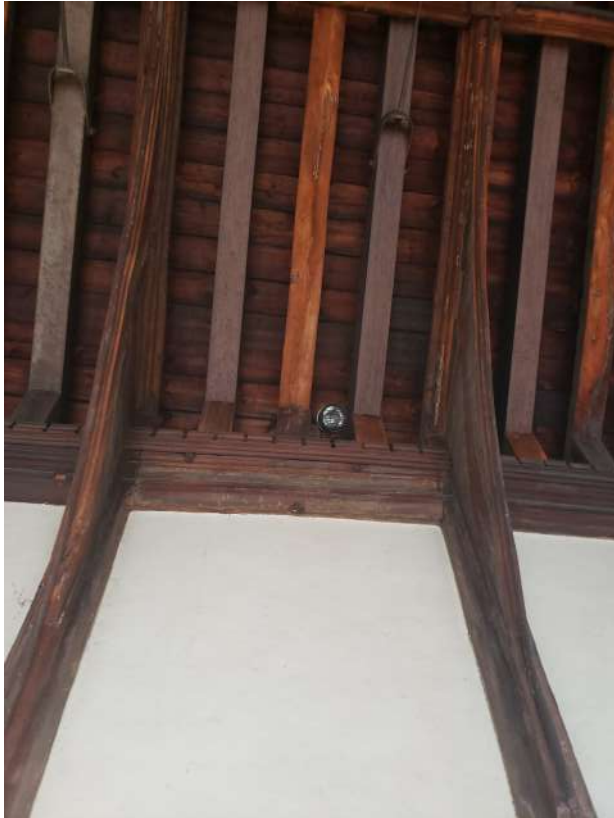
Fig 63:

Blackfriars', bay 6; showing the arrangement of historic and contemporary common rafters, this arrangement was typical throughout the roof structure

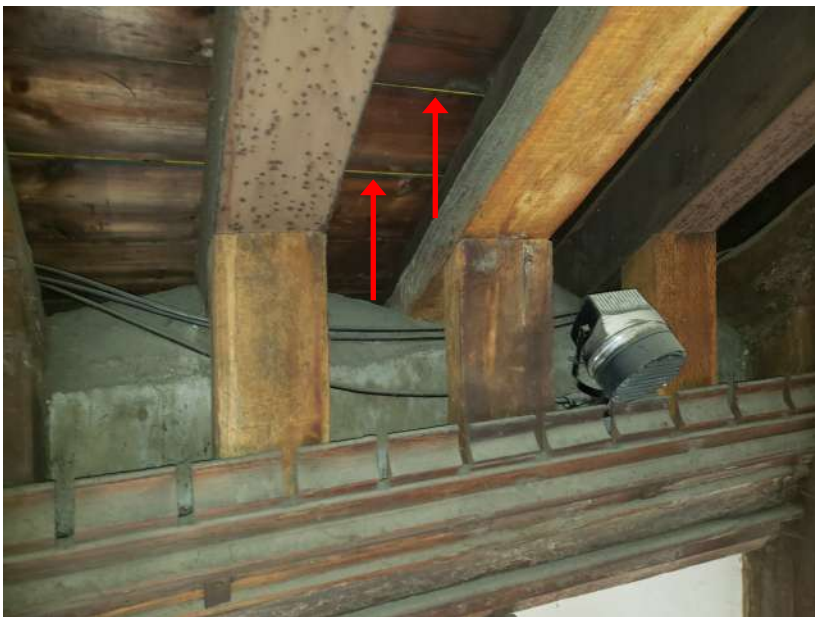
Fig 64:

Blackfriars', bay 6; showing the presence of contemporary roofing felt visible between contemporary sarking board elements on the north side. This further indicated recent refurbishment works had taken place

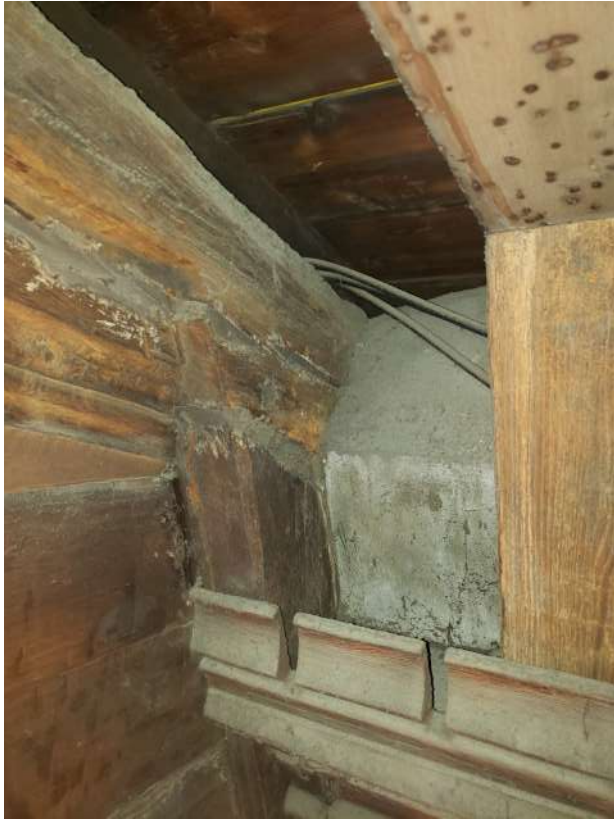
Fig 65:

Blackfriars', bay 6; showing the presence of historic superficial 'wet' rot decay to the sapwood on the historic structural elements on the north side, as well as the use of poorly applied and unsuitable contemporary resinous 'filler' materials

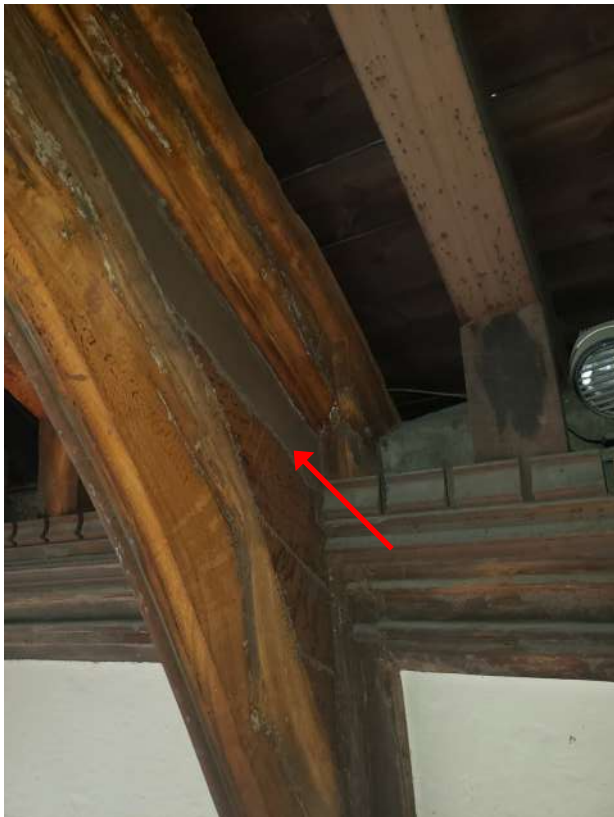
Fig 66:

Blackfriars', bay 6; showing the further use of improper resinous 'filler' materials throughout the roof structure. These were deemed to be detrimental to the historic aesthetic, as well as increase the likelihood of moisture becoming trapped in contact with structural timber elements, accelerating the onset of biological decay organisms

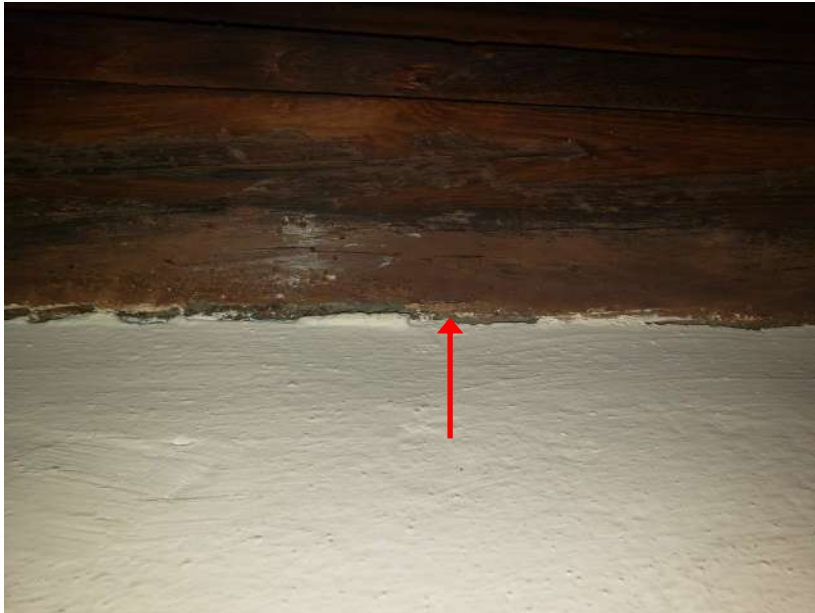
Fig 67:

Blackfriars', bay 6; showing the interface between the bottom of the moulded cornice/inner plate element and the internal masonry on the south side. Note the plate was not embedded into the masonry, however the internal plaster and paintwork was built-up above the timber by a matter of millimetres. This had likely prevented historic moisture build-up from escaping and led to the instance of minor decay to the timber at the point of contact with the masonry

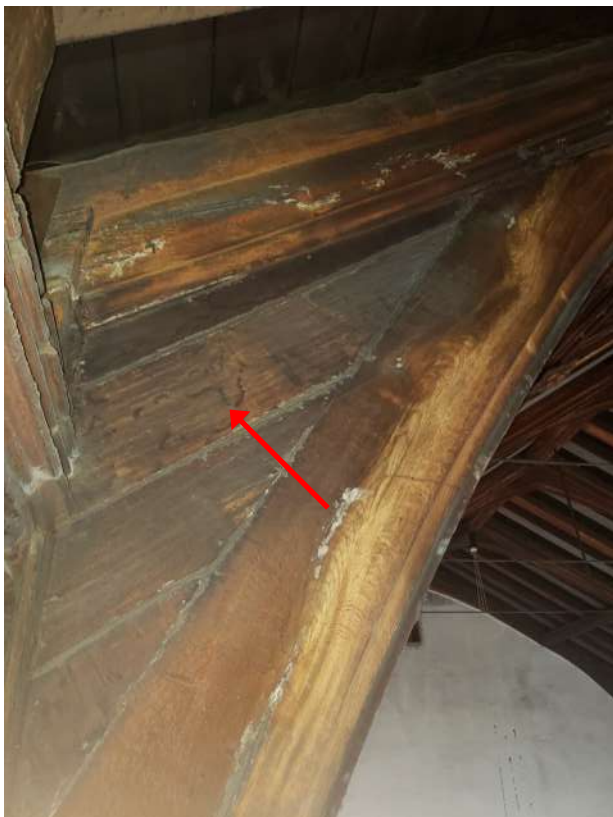
Fig 68:

Blackfriars', bay 6; showing the presence of hardwood boarding covering the aperture formed between the principal rafter, truss post and brace, on the south side. This suggested that this had been a feature of the roof structure prior to the recent refurbishment works, where modern timber boarding had been used in certain areas

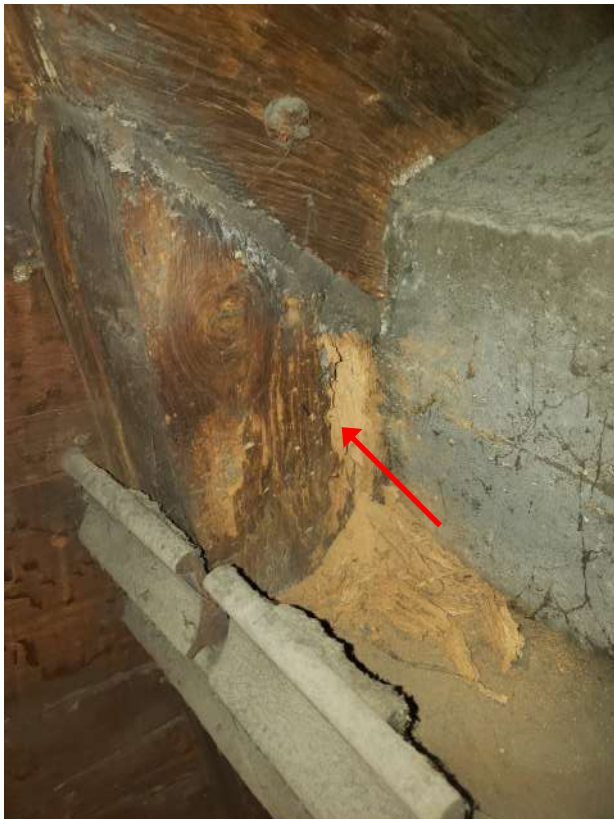
Fig 70:

Blackfriars', bay 9; showing the top of the north truss post of truss no. 9. The post had been structurally decayed by 'wet' rot that continued down its length for ~800mm

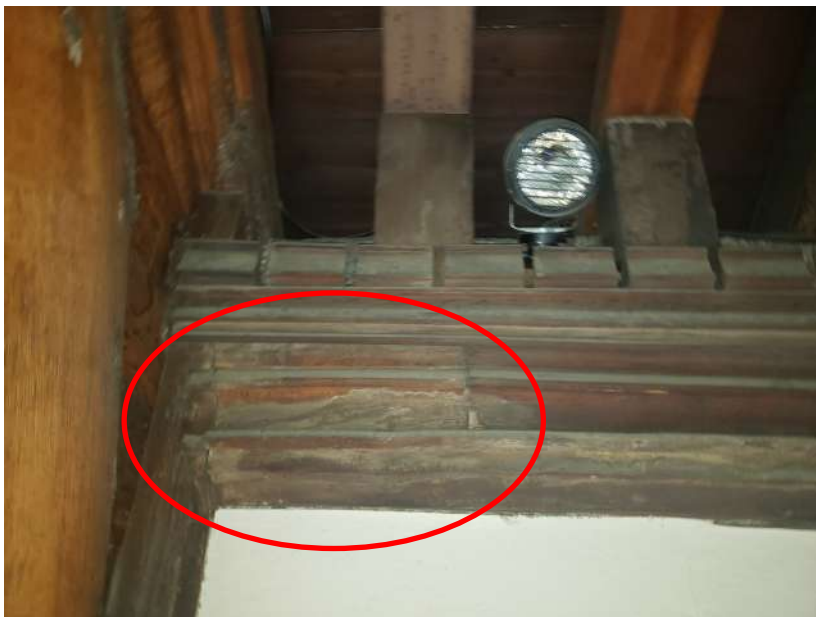
Fig 72:

Blackfriars', bay 9; showing the east end of the moulded cornice/inner plate on the south side. Note previous patch repairs had taken place where damage/decay had historically occurred

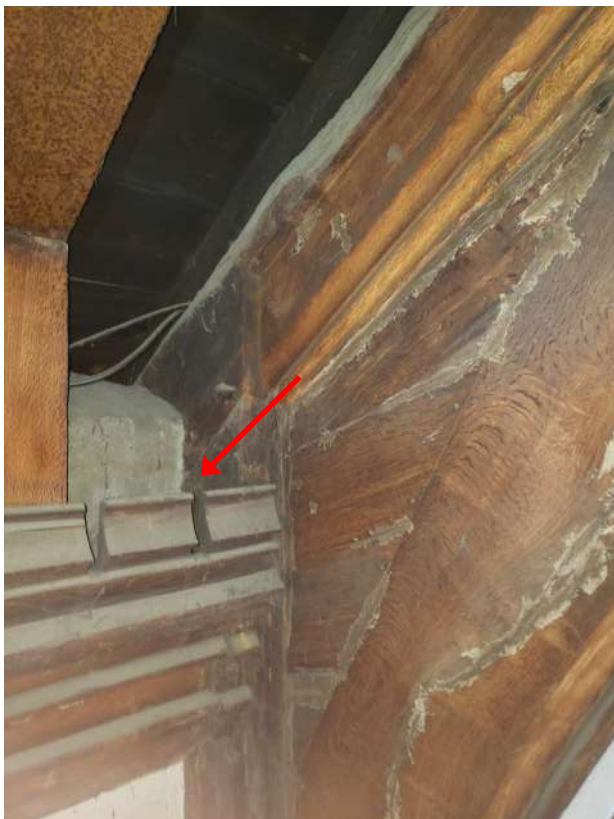
Fig 74:

Blackfriars', bay 12; showing the approximate location of partial decay to the top end of the post of truss no. 13, on the north side. Moisture readings were below the threshold for the onset and growth of biological decay organisms at the time of survey

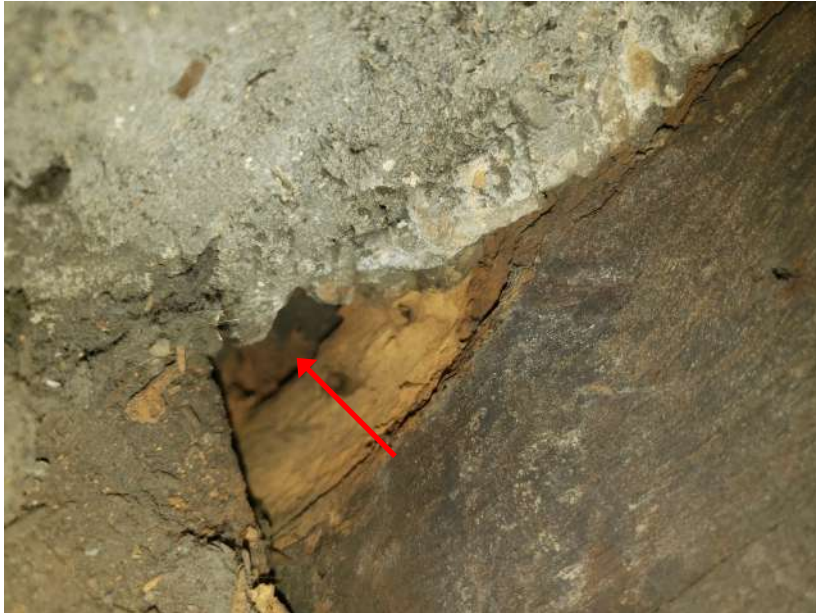
Fig 75:

Blackfriars', bay 12; showing the approximate location of a timber element behind the truss post of truss no. 13 on the north side. The additional timber element could likely be an outer plate. Upon decay detection drilling the outer plate was found to be likely partially decayed due to the density of the timber and the amount of resistance displayed by the drill

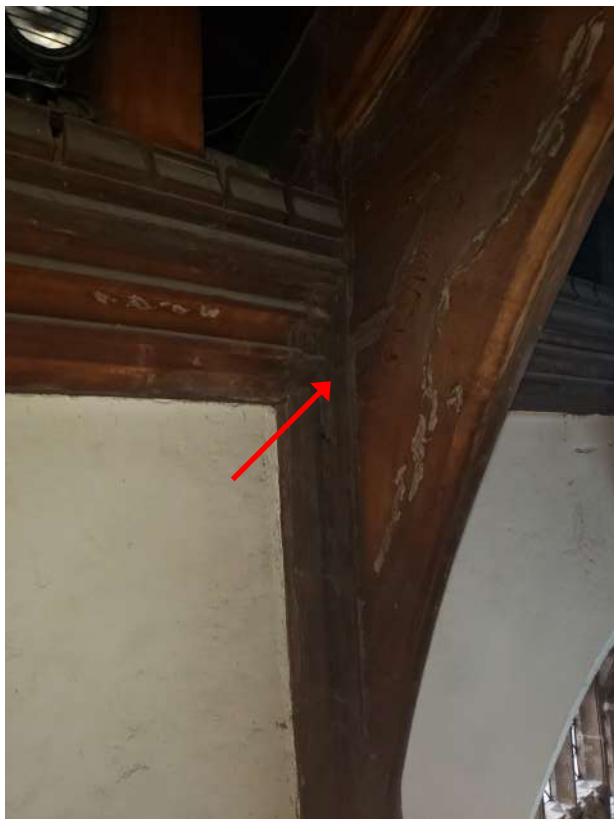
Fig 76:

Blackfriars', bay 12; showing the north side of truss no. 13. The truss post was found to be decayed from the top down for ~630mm. The severity of the decay was deemed to be on the threshold between partial and structural. Moisture readings were below the threshold for the onset and growth of biological decay organisms at the time of survey
