The Halls – Works Required Revision B

The Halls, St Andrews Plain, Norwich NR3 1AU

22.67 REV B

Building Survey / Feasibility

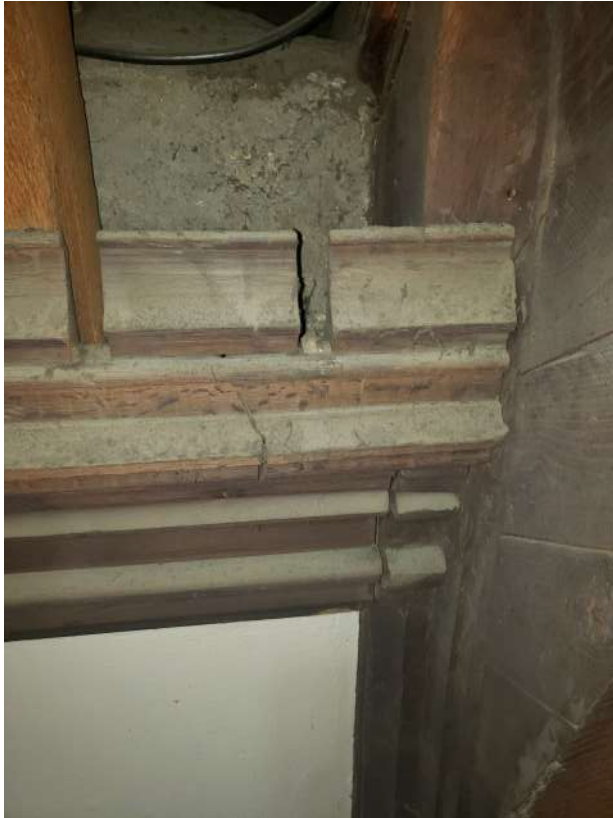
Fig 77:

Blackfriars', bay 12; showing minor transverse cracking to west end of moulded cornice, on south side of bay 12

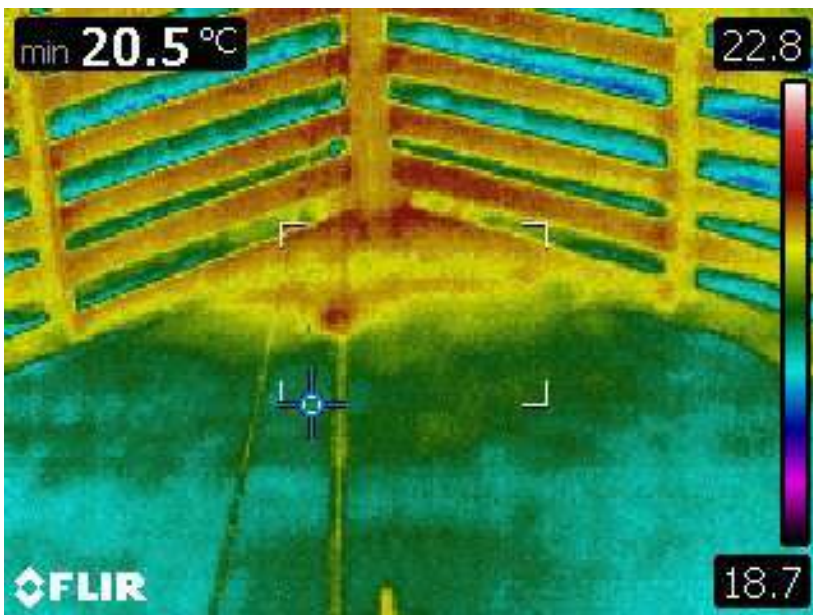
Fig 78:

Blackfriars', West gable end; showing slight temperature differential at high level, although no evidence of issues with water penetration

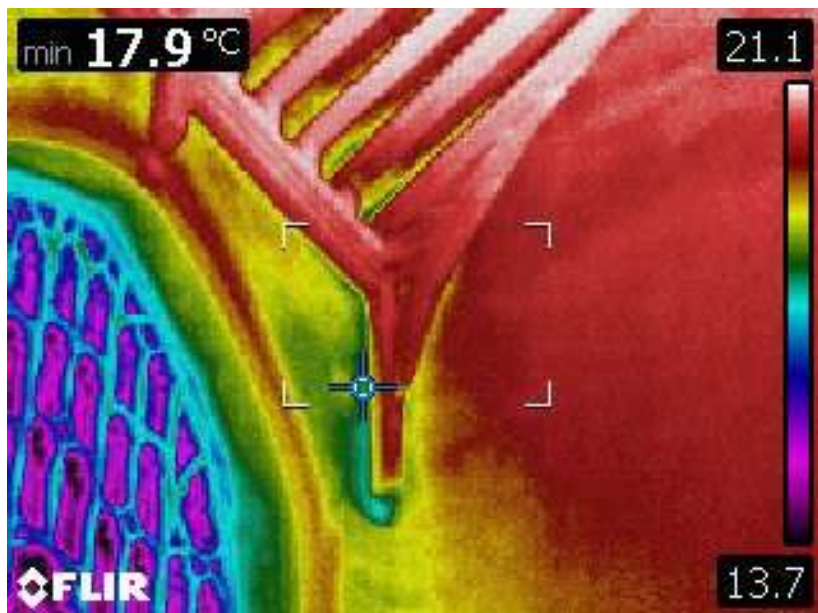
Fig 79:

Blackfriars', South-west corner; showing thermal image and temperature differential well within 'normal' parameters

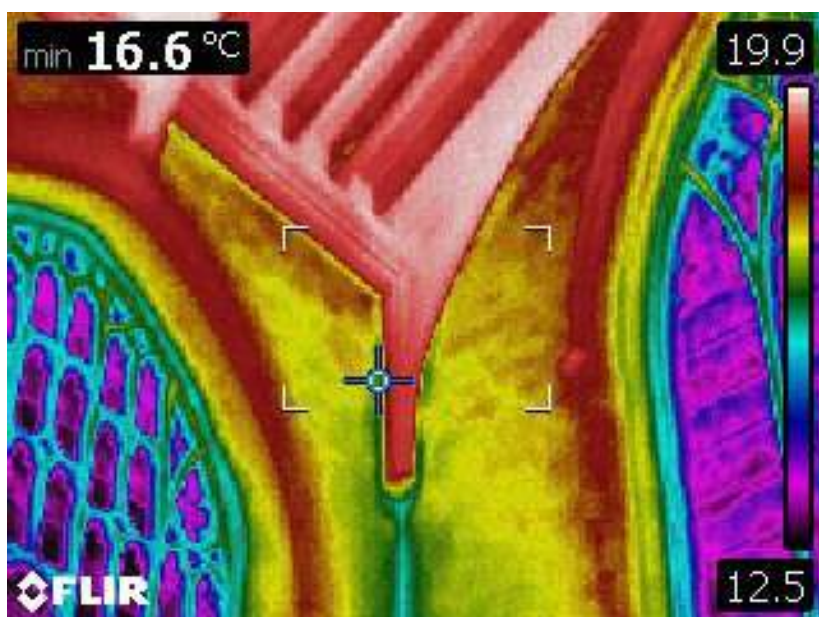
Fig 80:

Blackfriars', North-east corner; showing thermal image and temperature differential well within 'normal' parameters

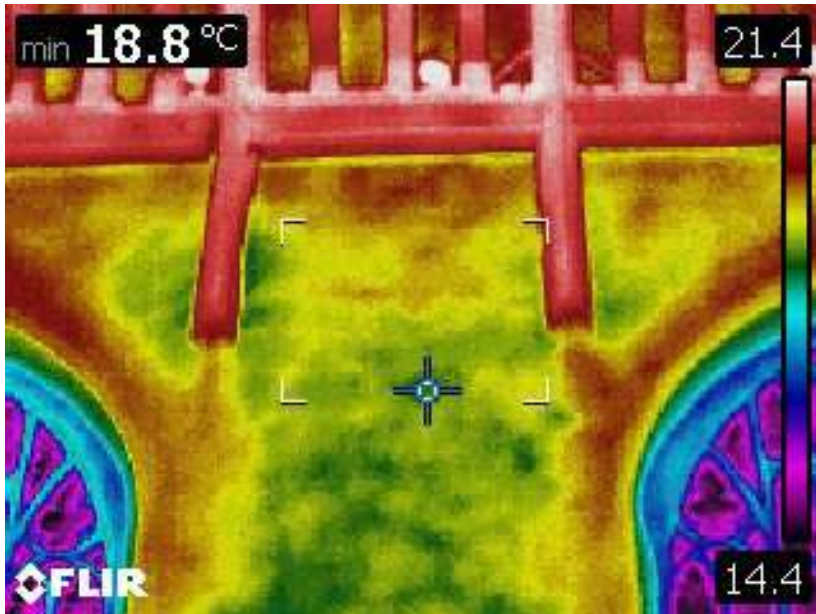
Fig 81:

Blackfriars', Central elevation, north side; showing slight temperature differential suggesting increased levels of moisture within masonry masses

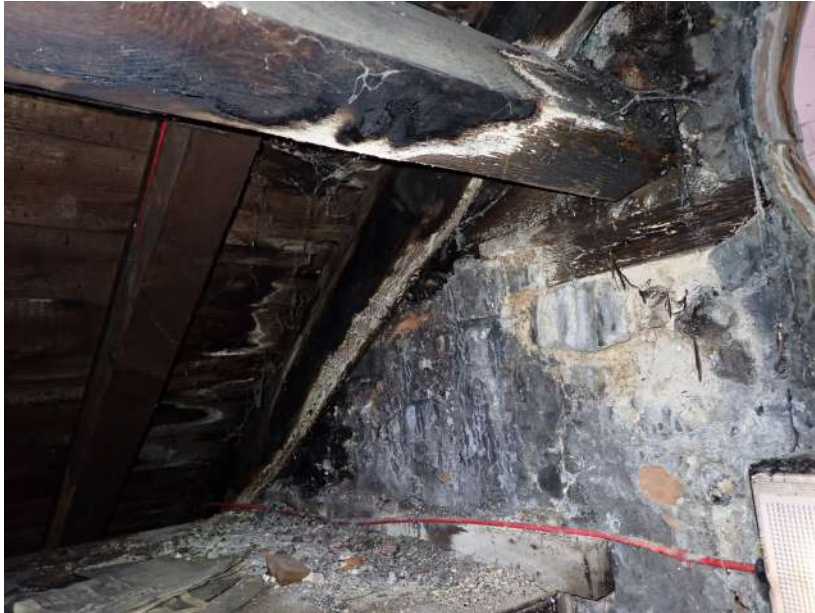
Fig 83:

Central roof structure over organ loft; showing water-staining and hygroscopic salt efflorescence on timbers and masonry directly over head of spiral stairway. No structural decay to timbers detected at roof leel, and moisture content readings too low for decay to occur

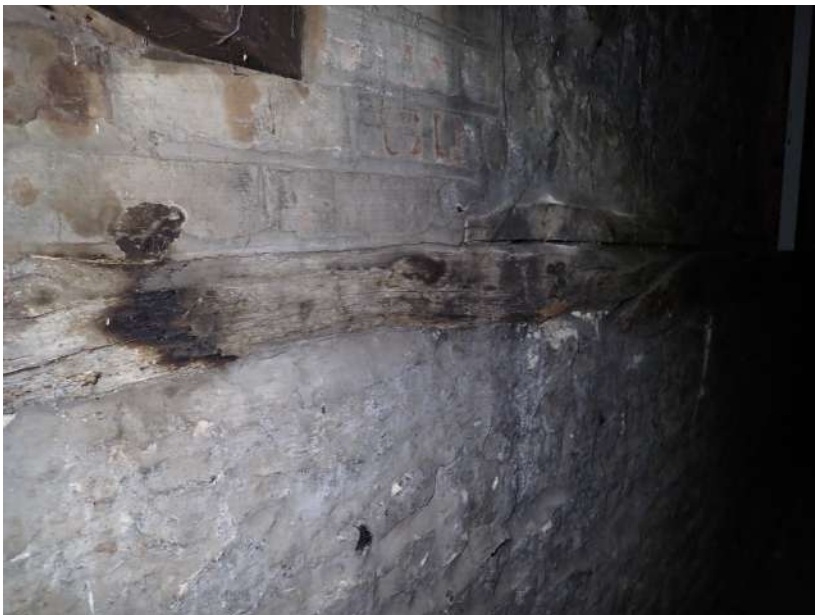
Fig 84:

Central roof structure over organ loft; showing section of decayed embedded timber at landing of stone spiral stairway

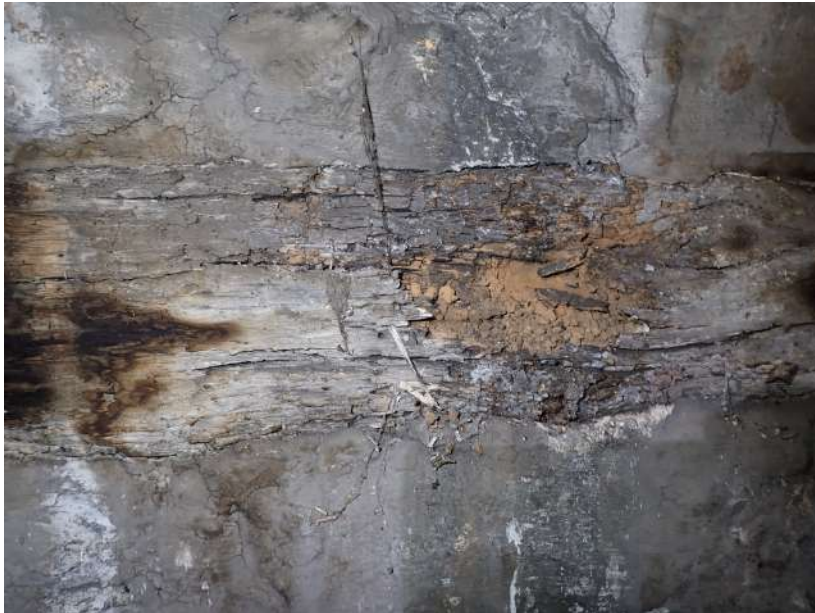
Fig 83:

Central roof structure over organ loft; showing localised wood-boring beetle decay to embedded timber. Moisture content readings at surface below decay threshold, although deep moisture content at level high enough to sustain wood-boring beetle activity and fungal decay

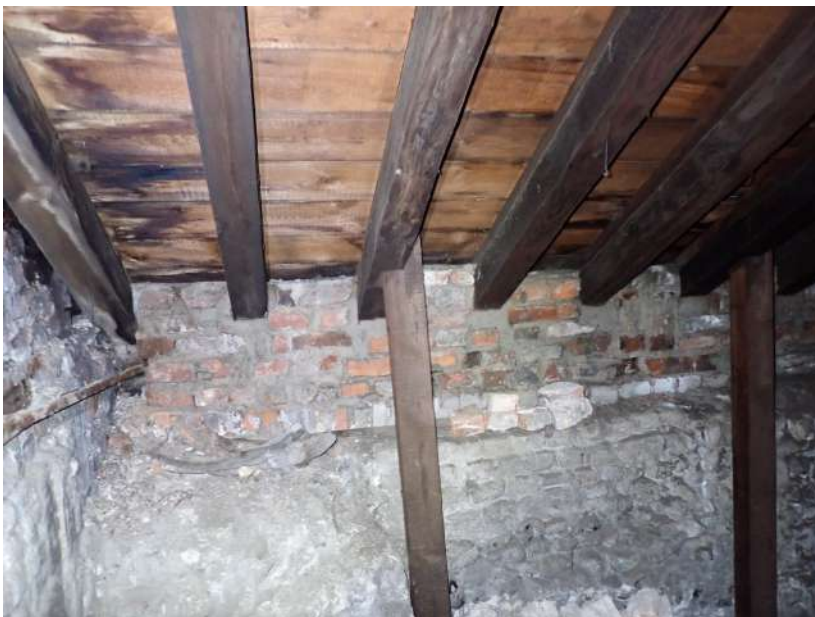
Fig 84:

Central roof structure over organ loft; showing rafters embedded into masonry at south side. Plate section also fully embedded although no decay detected, and moisture content readings below decay thresholds

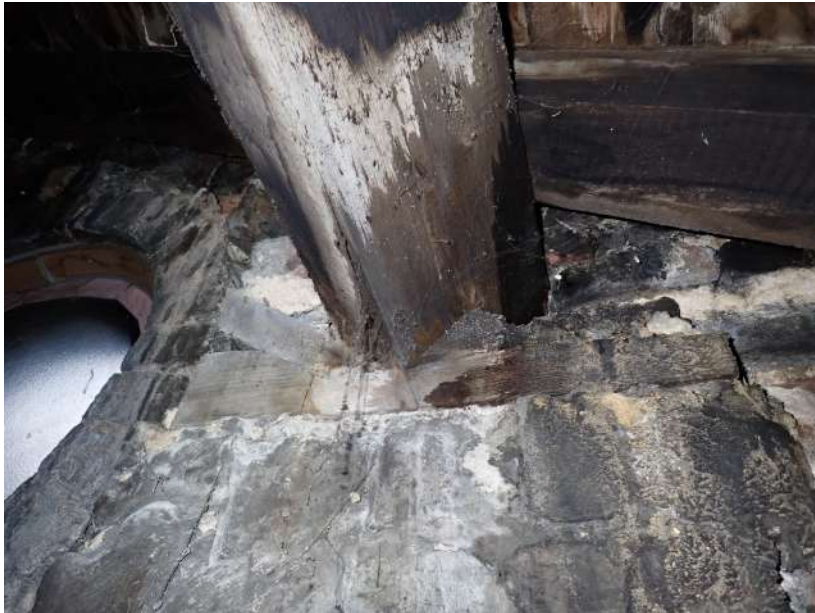
Fig 85:

Central roof structure over organ loft; showing purlin embedded into masonry to east. No decay detected to purlin bearing end, although elevated moisture content readings of timber pad below suggest issues with penetrating dampness through gable wall

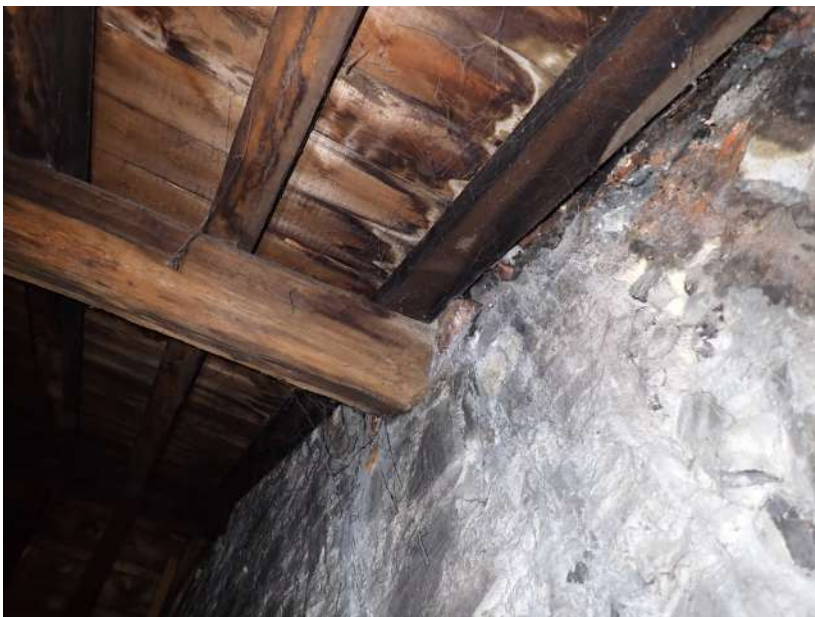
Fig 86:

Central roof structure over organ loft; showing upper purlin embedded into masonry. No safe access for inspection although elevated moisture content readings throughout area suggest issues with dampness penetrating masonry wall to east side

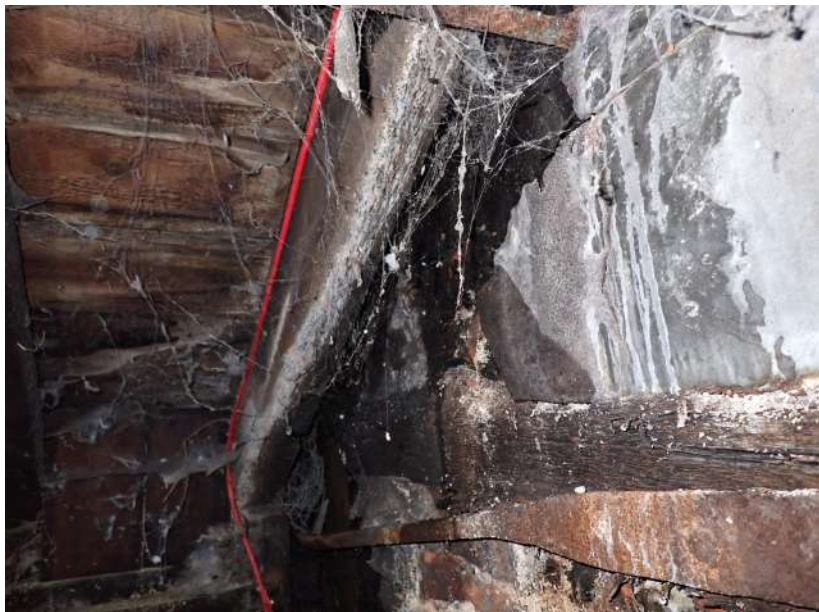
Fig 87:

Central roof structure over organ loft;
showing extreme north-east corner and
extent of staining

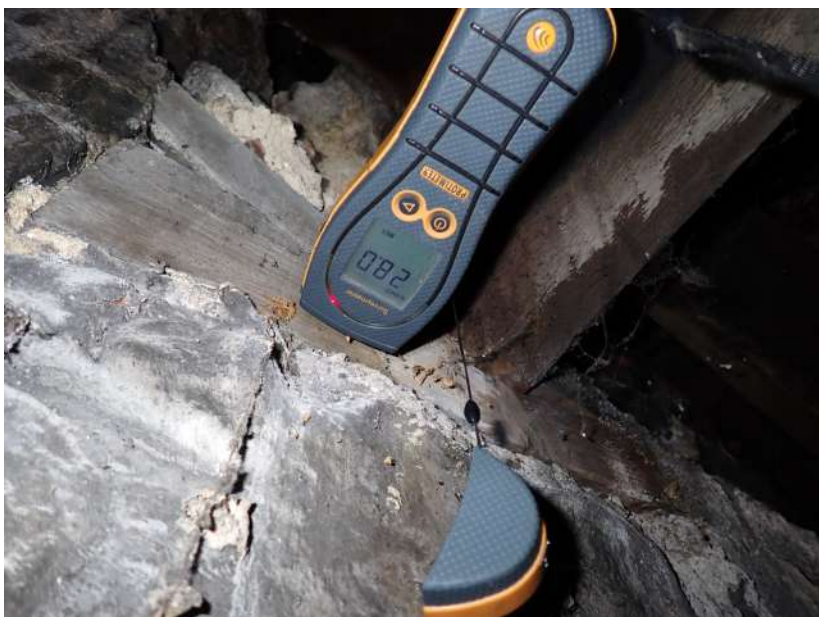
Fig 88:

Central roof structure over organ loft;
showing moisture content readings
from timber pad below lower purlin on
south pitch at over the decay threshold
of ~20 per cent w/w

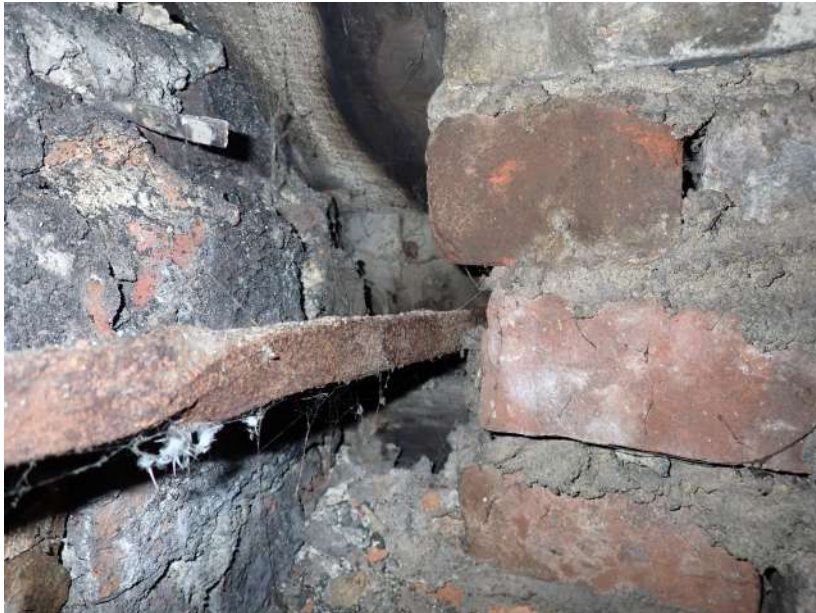
Fig 89:

Central roof structure over organ loft; showing iron strengthening in south-east corner, likely implemented due to decay of historic embedded timbers

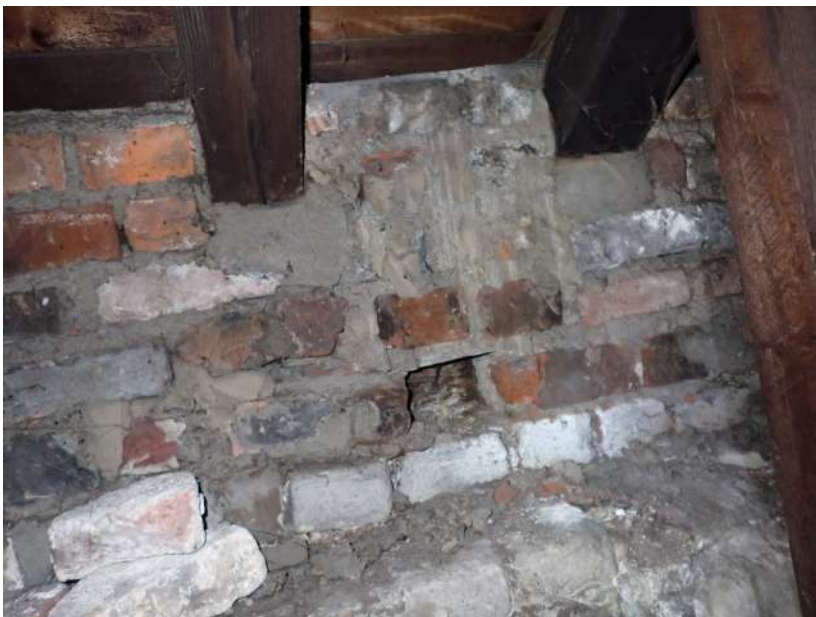
Fig 90:

Central roof structure over organ loft; showing small openings in relatively modern brick infill between rafter feet, allowing inspection (drilling and probing) of the timber plate. Decay detected at the time of survey

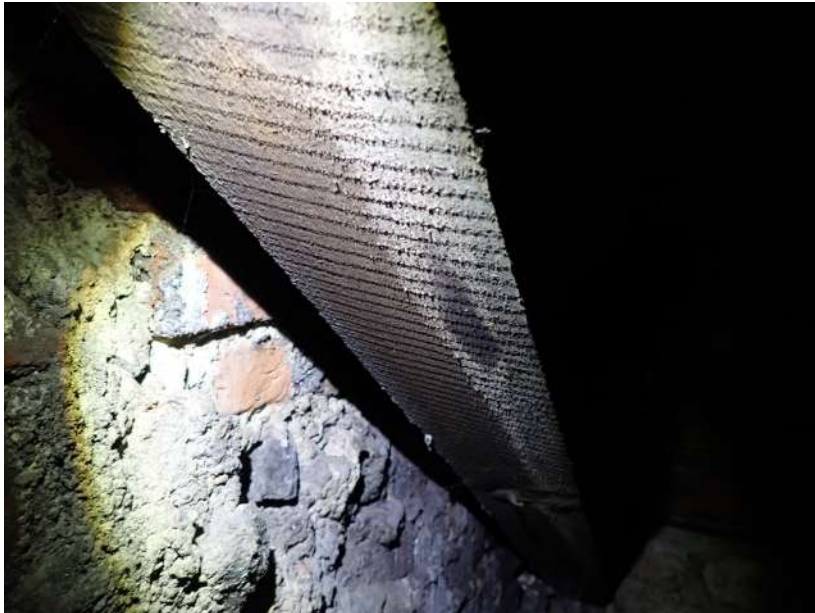
Fig 91:

Central roof structure over organ loft; showing conversion markings on undersides of rafters consistent with mechanised circular saw suggesting late 19th onwards manufacture

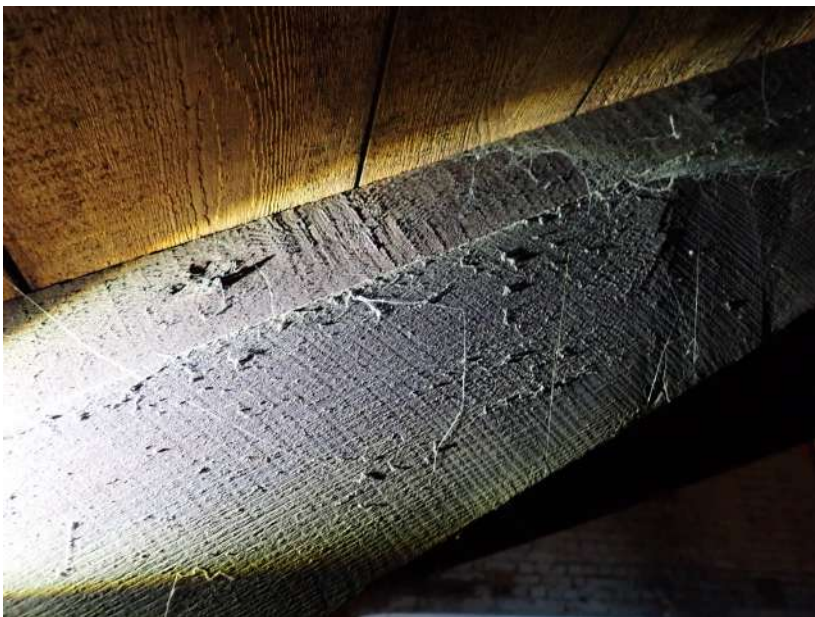
Fig 92:

Central roof structure over organ loft; showing conversion markings on face of rafters consistent with mechanised circular saw and bandsaw markings on additional timber over, suggesting late 19th onwards manufacture

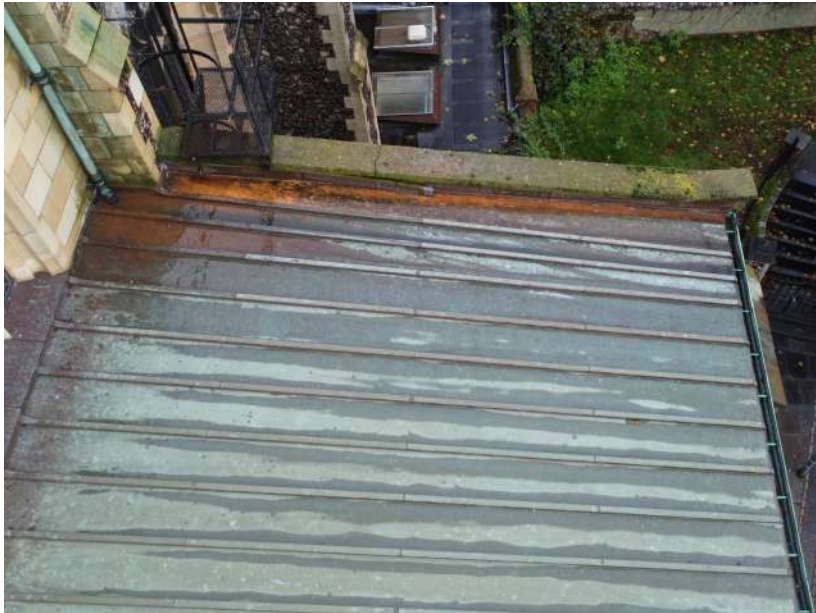
Fig 93:

Drone image; showing roof defects at east end of south aisle. No evidence of recent water penetration internally; however, historic water-staining indicated this area was vulnerable. It was unclear at the time of survey the cause of the discolouration, although likely connected to access provisions

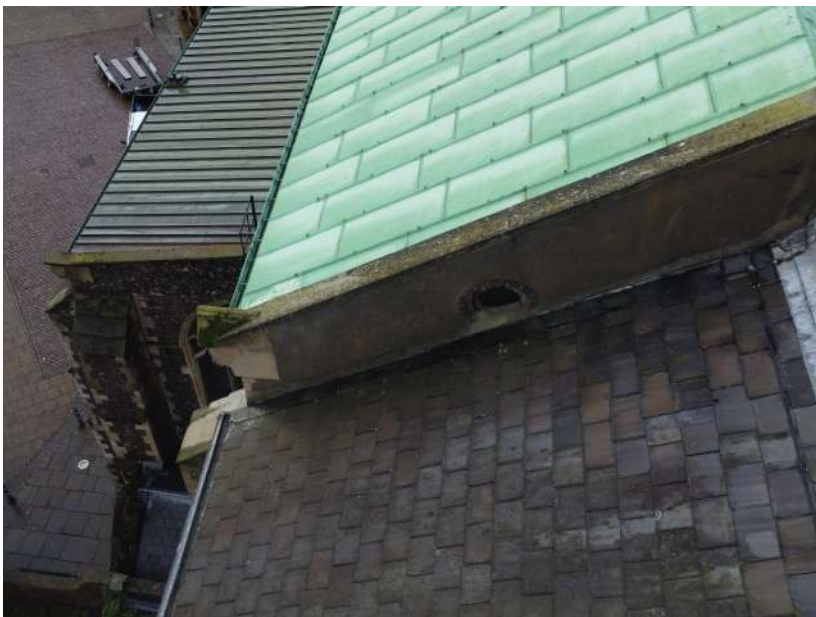
Fig 94:

Drone image; showing exposed gable wall of roof structure between St Andrew's and Blackfriars Halls. Cementitious render likely to be retaining moisture within masonry masses, raising moisture content readings of timbers embedded

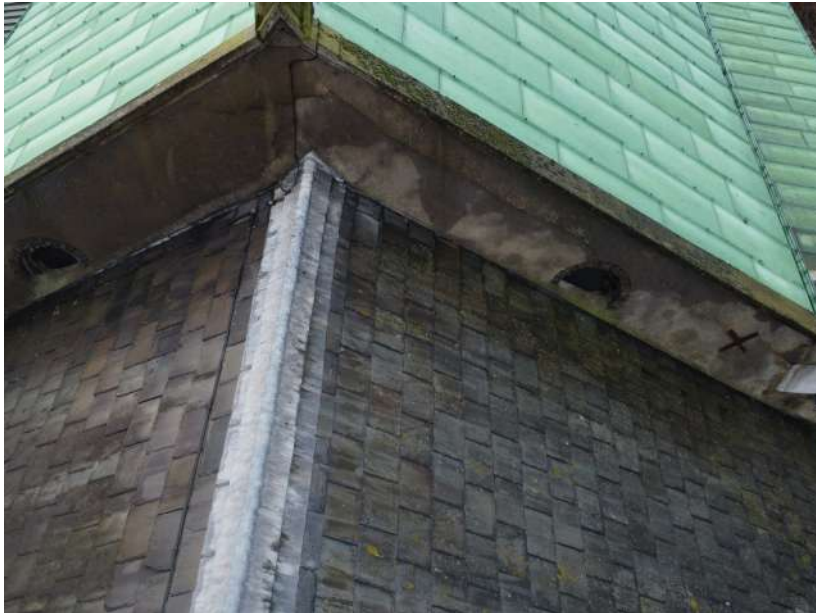
Fig 95:

Drone image; showing further cementitious render to exposed gable masonry between the two halls. Noticeable cracking to the north side

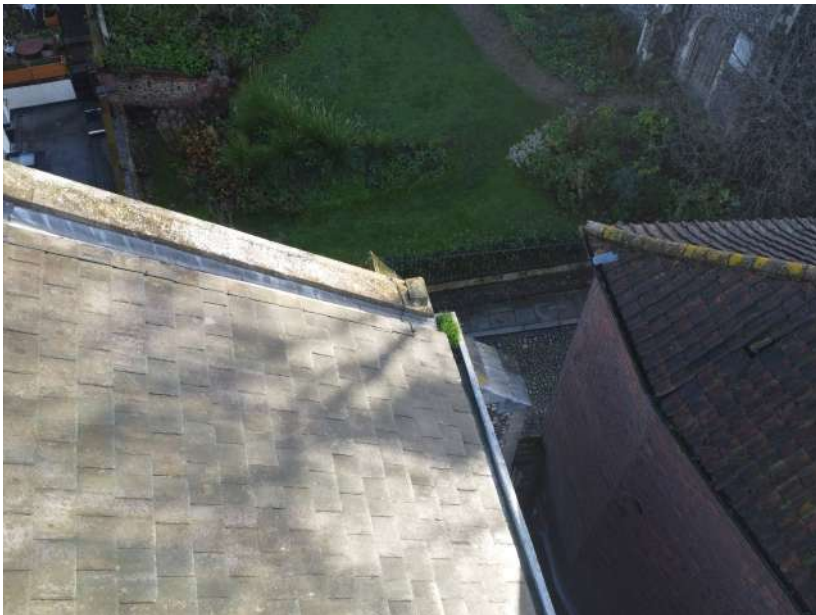
Fig 96:

Drone image; showing gutter blockage at south-east corner of Blackfriars roof, likely resulting in chronic overcharging and saturation of masonry below

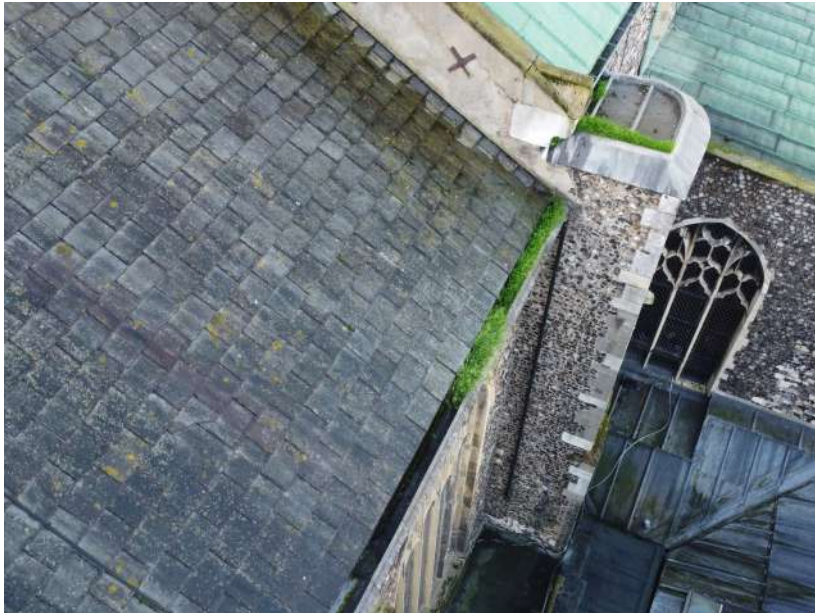
Fig 97:

Drone image; showing significant blockage of rainwater guttering at west end of north side of Blackfriars Hall, again, likely saturating masonry below during periods of heavy rain

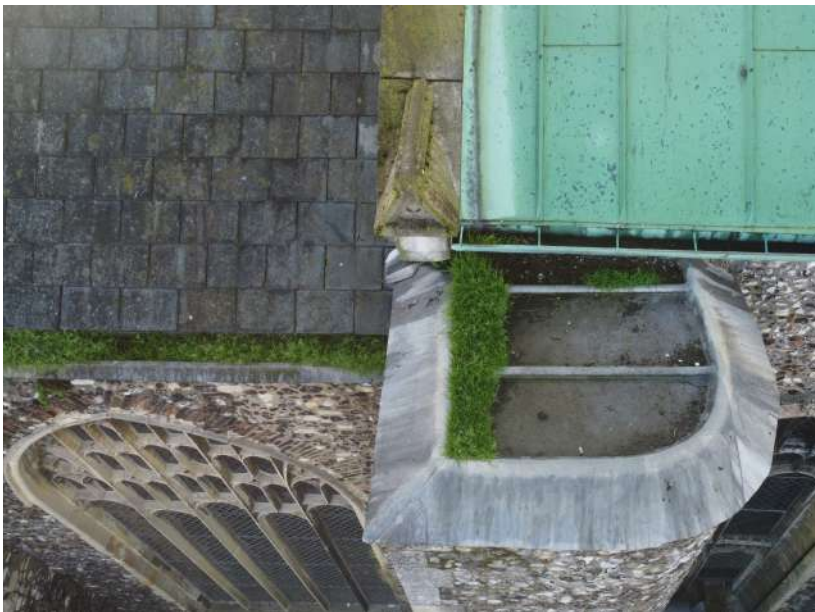
Fig 98:

Drone image; showing again blockage of rainwater goods at west end of north pitch of Blackfriars Hall. Also note significant plant growth on head of spiral stone stairway section indicating inadequate drainage in this location

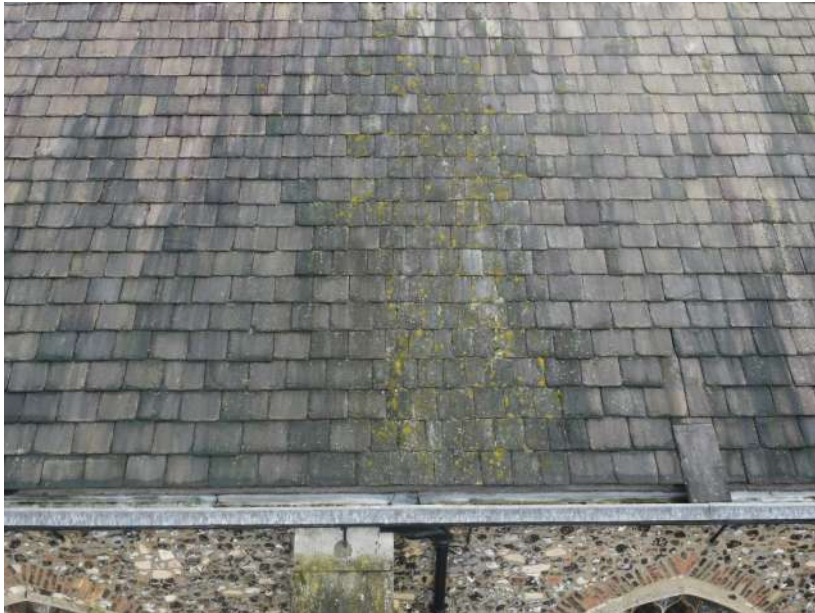
Fig 99:

Drone image; showing slipped slate on north pitch of Blackfriars Hall, likely reducing drainage capabilities of guttering. Also note clear algal/ biological growth centrally of roof coinciding with location of temperature differential internally noted during thermography

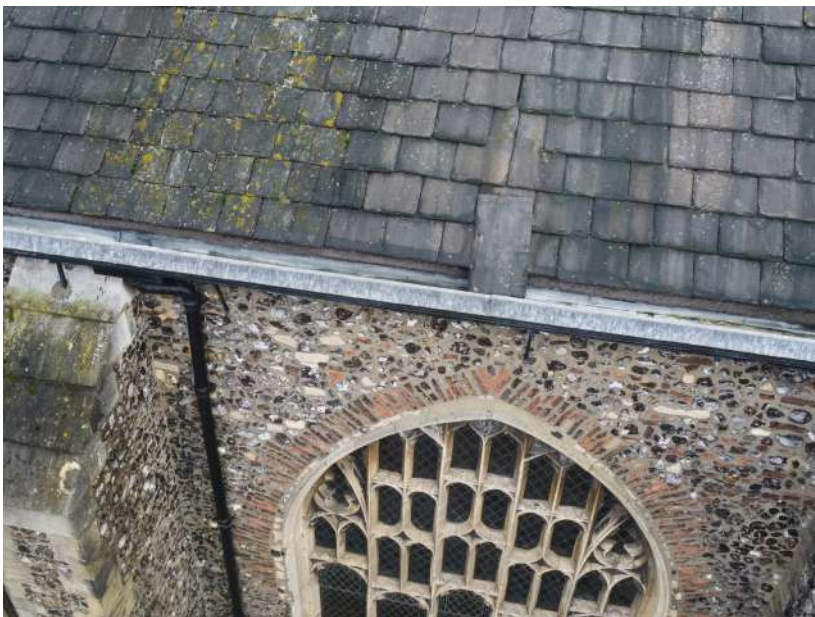
Fig 100:

Drone image; showing closer view of slipped slate and localised exposure of roof to direct water ingress

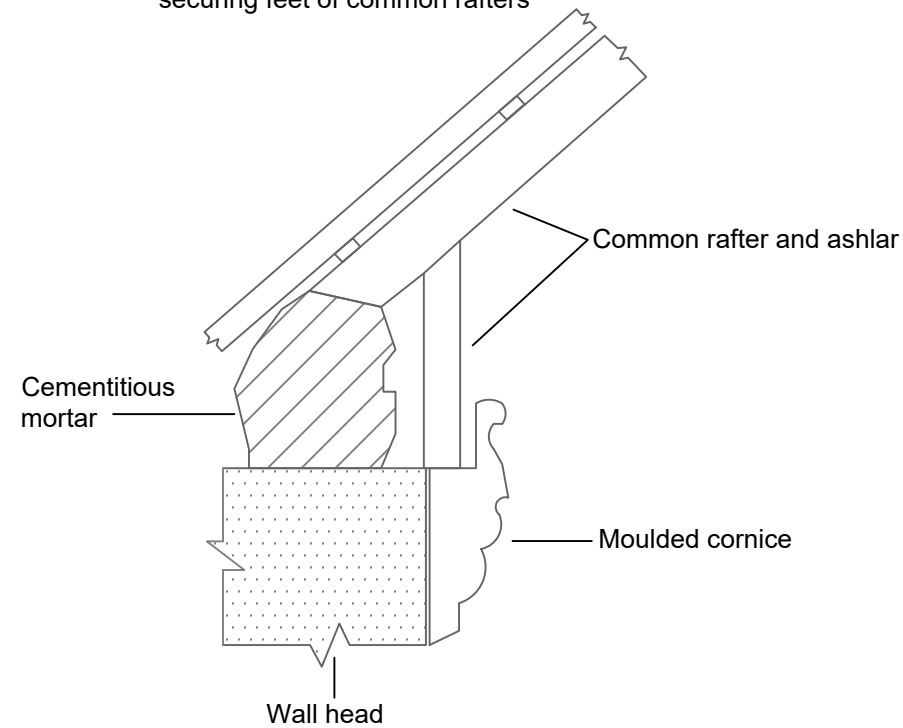
Blackfriars' Hall:
Cross-sectional detail of the eaves. Note the presence of a large amount of cementitious mortar atop the wall head, securing feet of common rafters

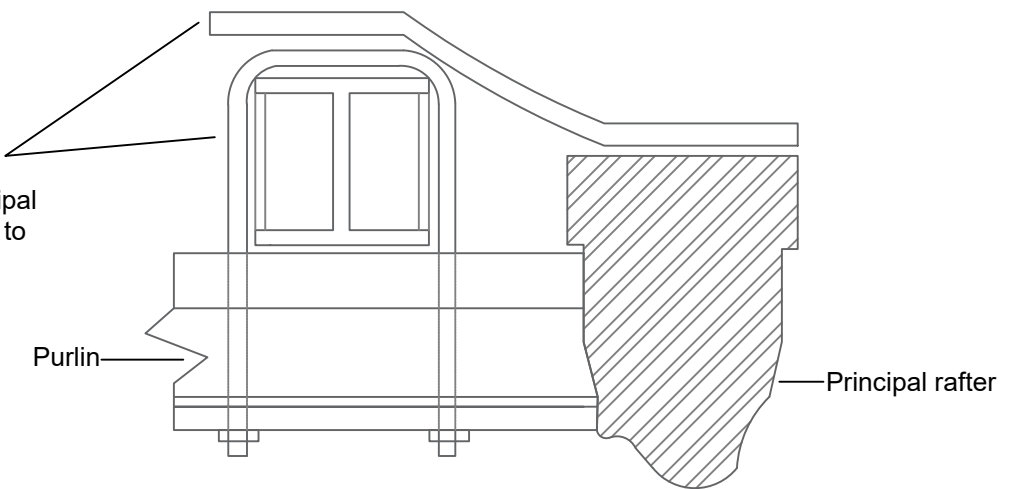
Blackfriars' Hall:
Showing a cross section detail of the historic principal rafter and adjoining purlin, with the contemporary common rafter and metal work

Contemporary metal 'U bolt' and strapping securing contemporary common rafter to purlin and principal rafter and likely providing support to historic structure
